ROAD CLASSIFICATION
Medium duty
Light duty
Unimproved dirt
State Route
BYRDSTOWN, TENN.-KY.
SW/4 BYRDSTOWN 15' QUADRANGLE
N3630-W8507.5/7.5
1962
PHOTOREVISED 1979

LANDSLIDES AND RELATED FEATURES
OF THE BYRDSTOWN, TENN.-KY., QUADRANGLE
by
Alfred R. Taylor and Roger E. Thomas
1982
U.S. Geological Survey
OPEN FILE MAP 82-653 (E-7)

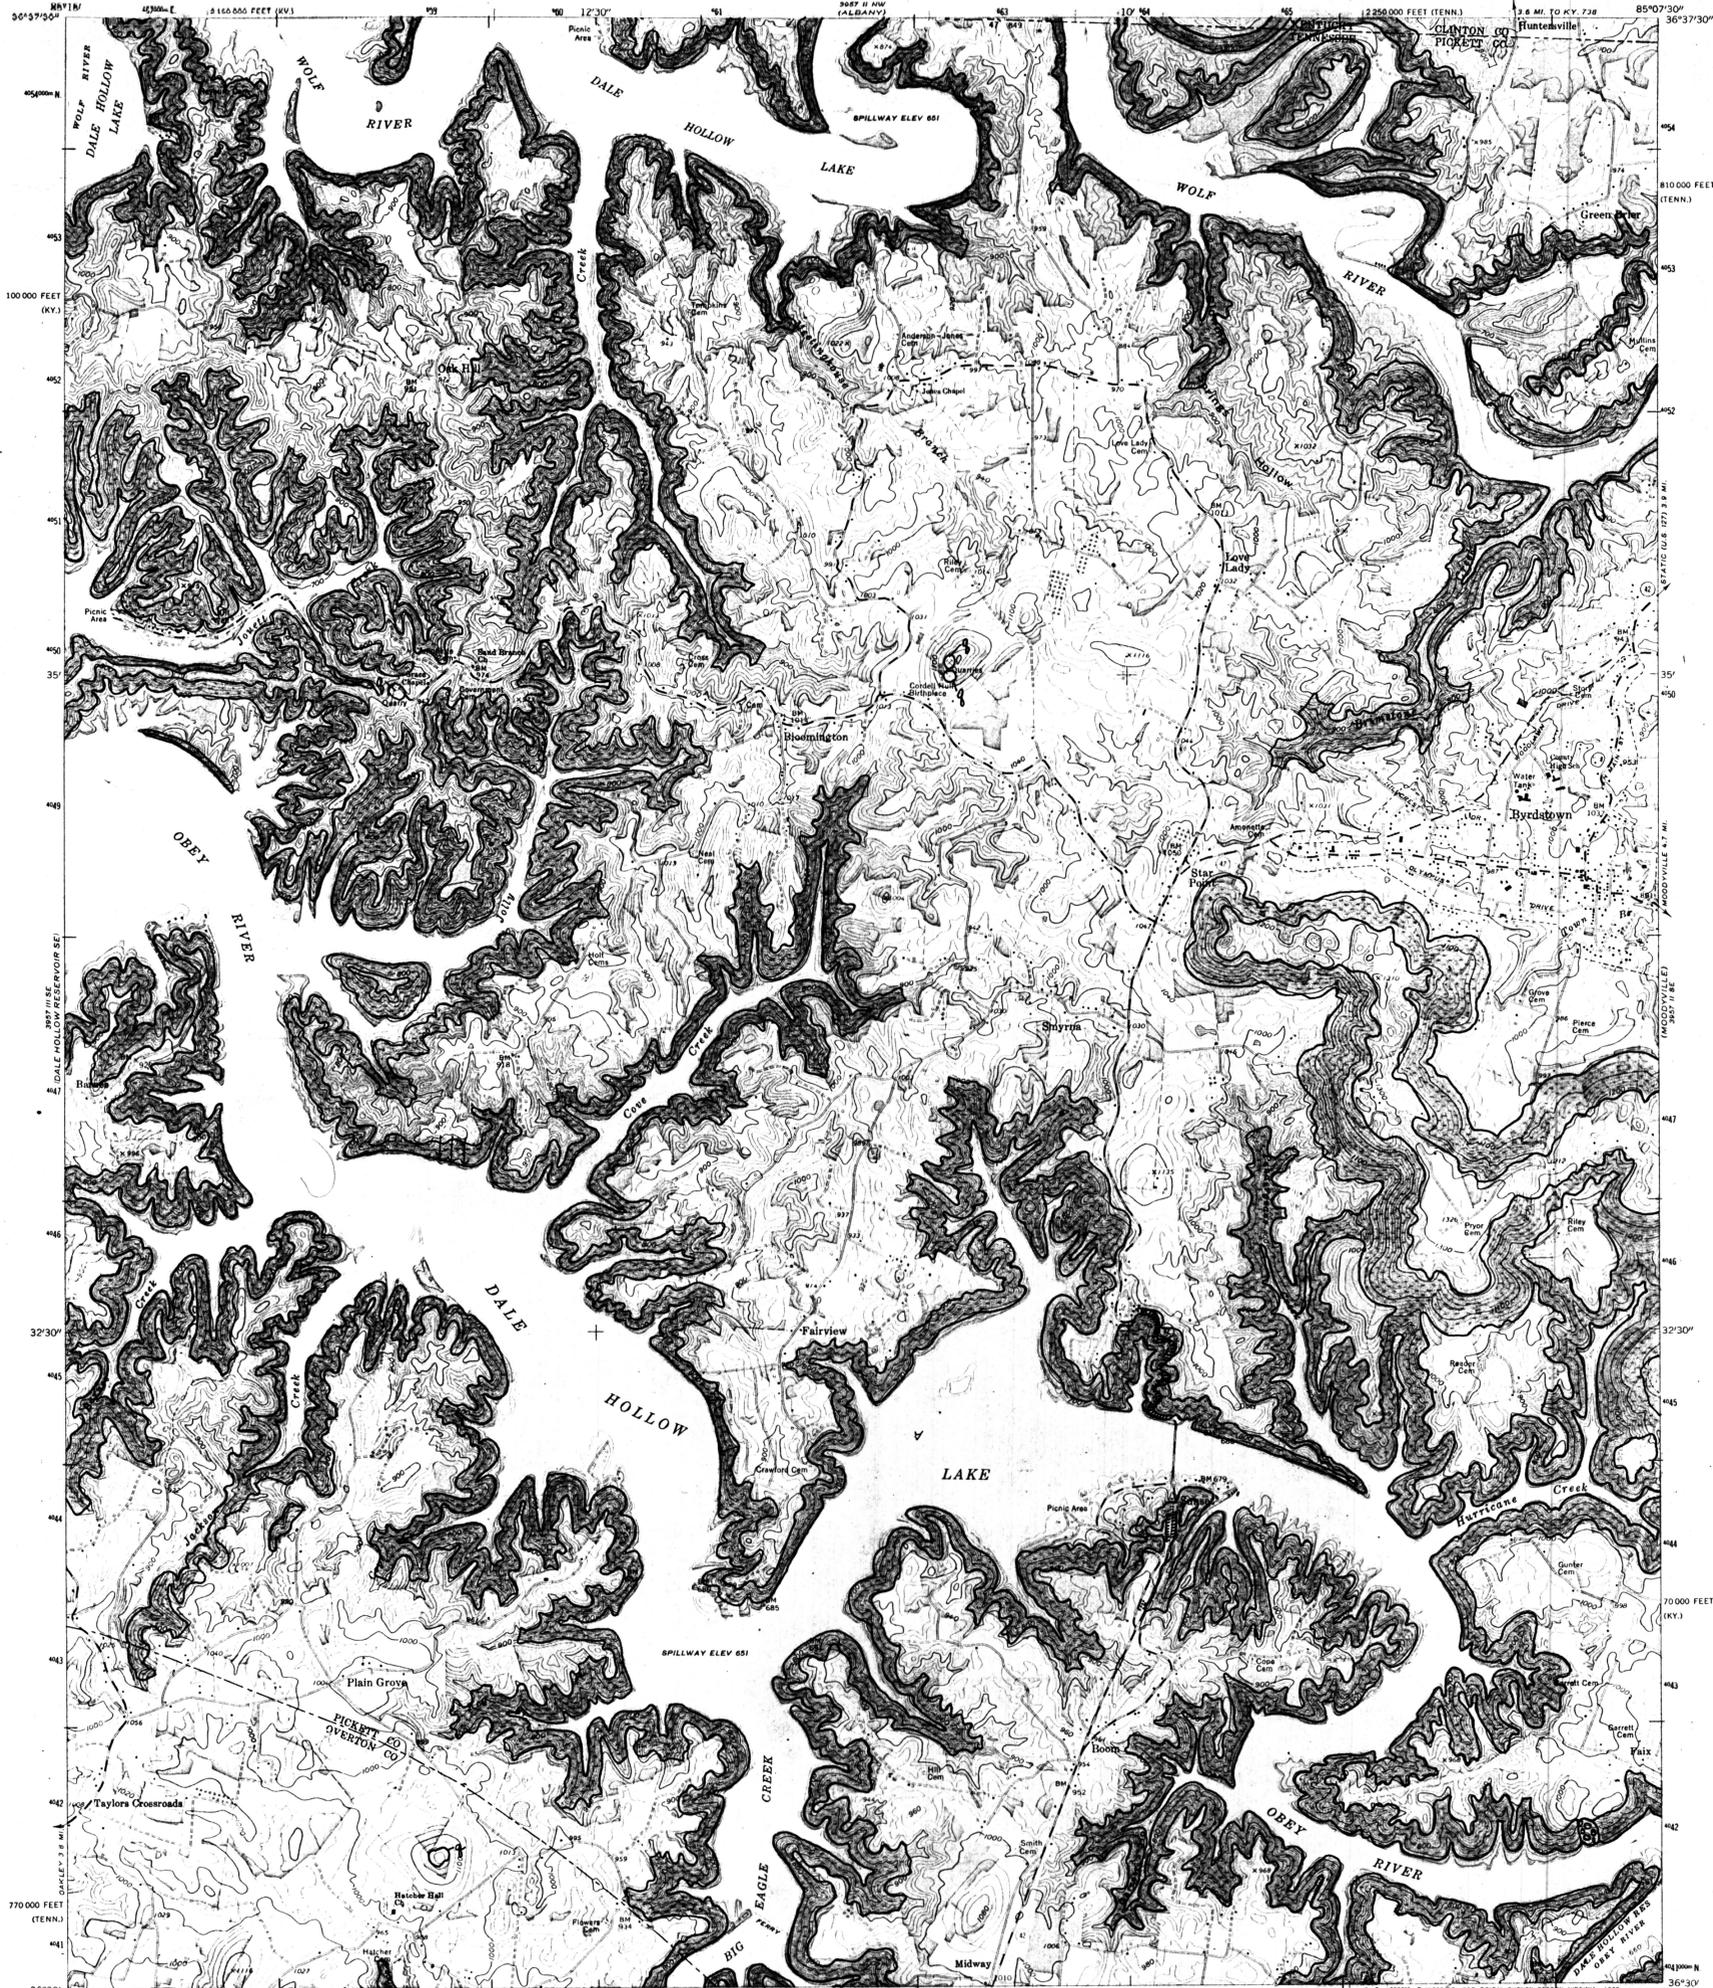
Landslides and related features interpreted
from field check 1979-1980
Photointerpretation from:
1:40,000 (Black and White) 1978
1:80,000 (Black and White) 1975
This report is preliminary and has not
been reviewed for conformity with U.S.
Geological Survey editorial standards.

- ACTIVE OR RECENTLY ACTIVE LANDSLIDE**
Complex landslide composed of earthflow, debris
slide, earth and rock slump. Identified from
historical records, and from scars, debris and
other field evidence. Ground extremely unstable;
sliding accelerated by excavation, loading and
changes in drainage conditions. May include
areas with several active slides too small to
be shown separately. Questioned where doubtful.

- OLD LANDSLIDE**
Area of extensive hummocky ground caused by
earthflow and earth and rock slump. Lacks
clear evidence of active sliding. Relatively
stable in natural, undisturbed state,
generally not affected by small structures properly
sited in areas away from the edge of the toe;
can be reactivated by extensive, rapid exca-
vation, loading, and changes in ground water and
surface water conditions. Area of old landslide
probably includes recent ones not identified
from field evidence or otherwise documented.
Upslope boundary of landslide generally defined
by modified scarp, but downslope (toe) may be
gradational and not well defined. Questioned
where doubtful.

- COMBINATION LANDSLIDE**
Area of recent and old slides in which
individual slides are not identified.
- COLLUVIAL SLOPE**
Valley wall along major streams with slope as
steep as 40° (85%); stony, clayey silt soil up
to 50 ft. (15 m) thick; commonly buttressed by
a terrace or bench at the toe of the slope; very
susceptible to sliding by cutting of toe area,
removal of terrace or bench, and overloading;
slide commonly activated without apparent cause.

- COLLUVIAL SLOPES WITH LANDSLIDES**
Landslides too small or obscure to map
individually.
- AREAS SUSCEPTIBLE TO DEBRIS FLOWS AND DEBRIS
AVALANCHES**
Primarily shallow, narrow ravines and chutes with
accumulation of stony colluvium generally 10 ft.
(3 m) or less in thickness; susceptible to rapid
movement during intense rainfall. Most ravines
and chutes designated show evidence of former
debris flows and avalanches.

- AREAS SUSCEPTIBLE TO ROCKFALL**
Steep, locally vertical, natural and man-made
slopes and cliffs, 15 ft. (4.5 m) or more high;
formed dominantly of sandstone, limestone, sandy
shale, mudstone and claystone. Interbedded mud-
stone, claystone and shale weather rapidly leaving
sandstone and limestone rock faces unsupported.

- SOIL AND ROCK SUSCEPTIBLE TO LANDSLIDING**
Soil and rock similar to that involved in land-
slides elsewhere in map area; primarily areas
underlain by claystone, mudstone and shale
associated with other rock types. Rock weathers
rapidly on exposure forming clayey soil highly
susceptible to sliding. Includes coves (U-shaped,
shallow valleys) containing thick layers of clayey
soil that are very susceptible to sliding where
excavation breaks continuity of slope and where
overloaded by artificial fill.

- AREAS LEAST PRONE TO LANDSLIDES**
Map areas in which no patterns or symbols are shown;
primarily valley floors, ridge tops and broad
benches; modification by excavation and fill may
lead to local landslides.
