Figure 8  
BIG CARRIZO DAM SITE  
Geology by E.B.Eckel—1939

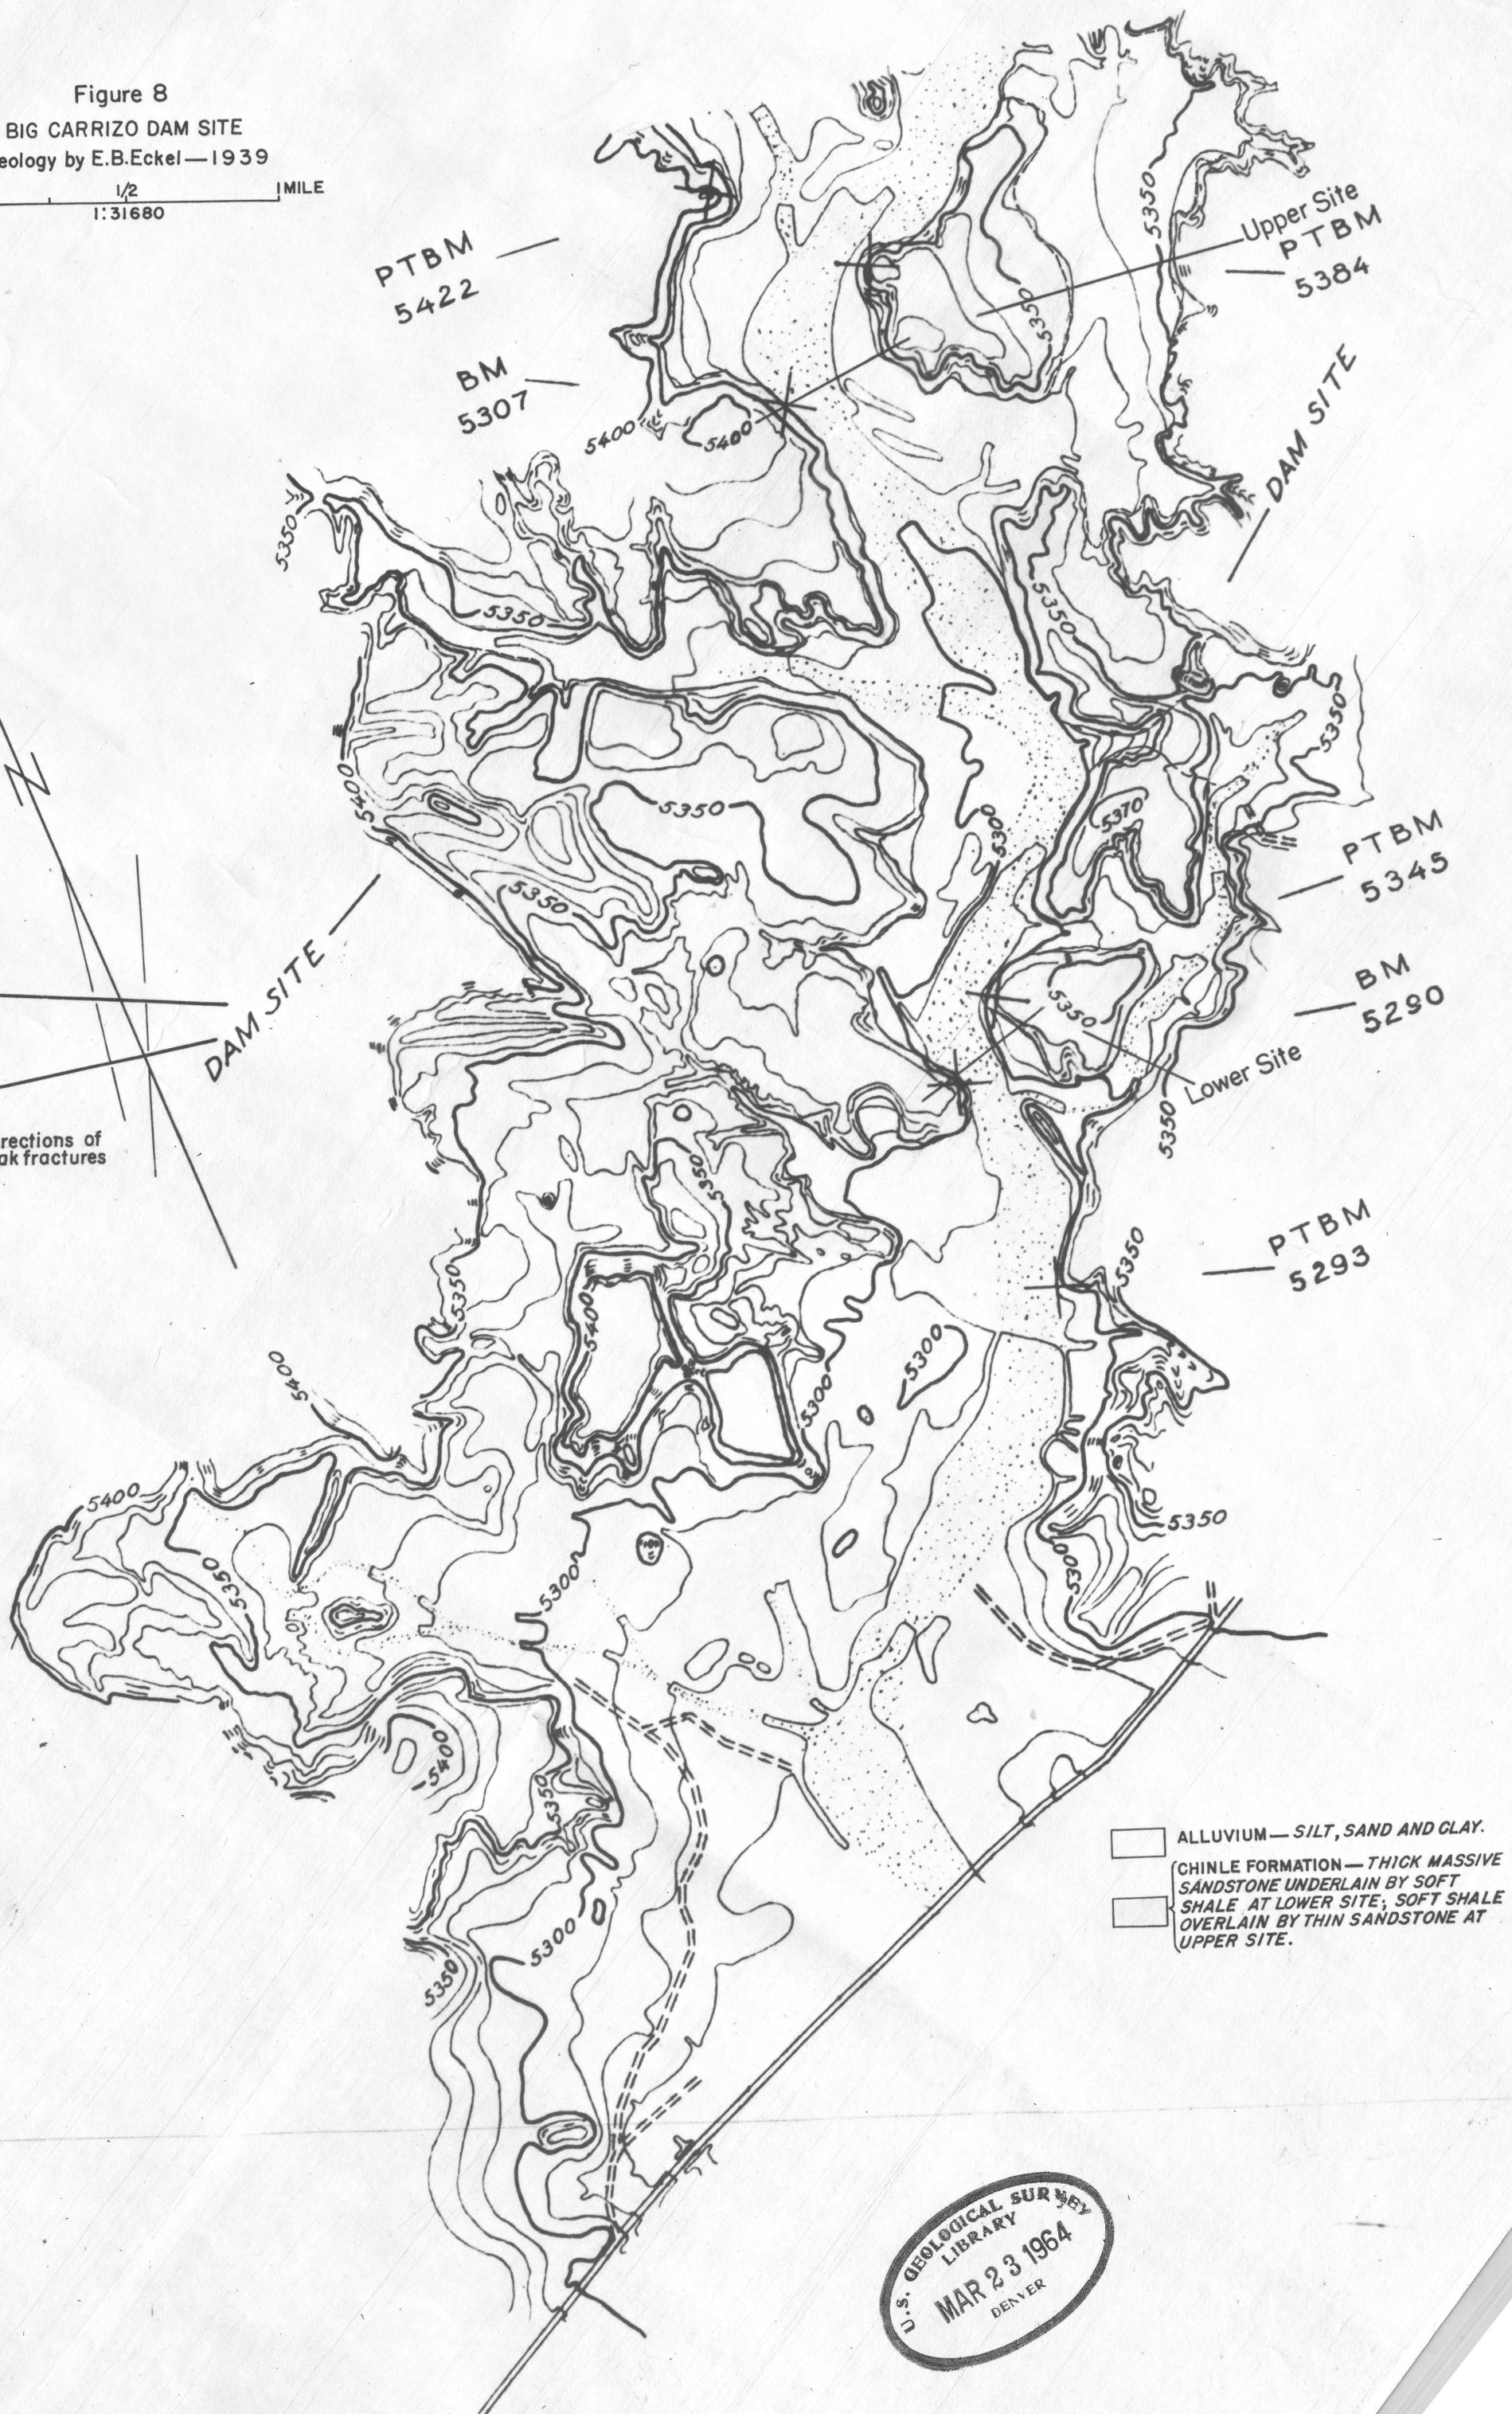
Principal directions of  
strong and weak fractures  
in bedrock.
