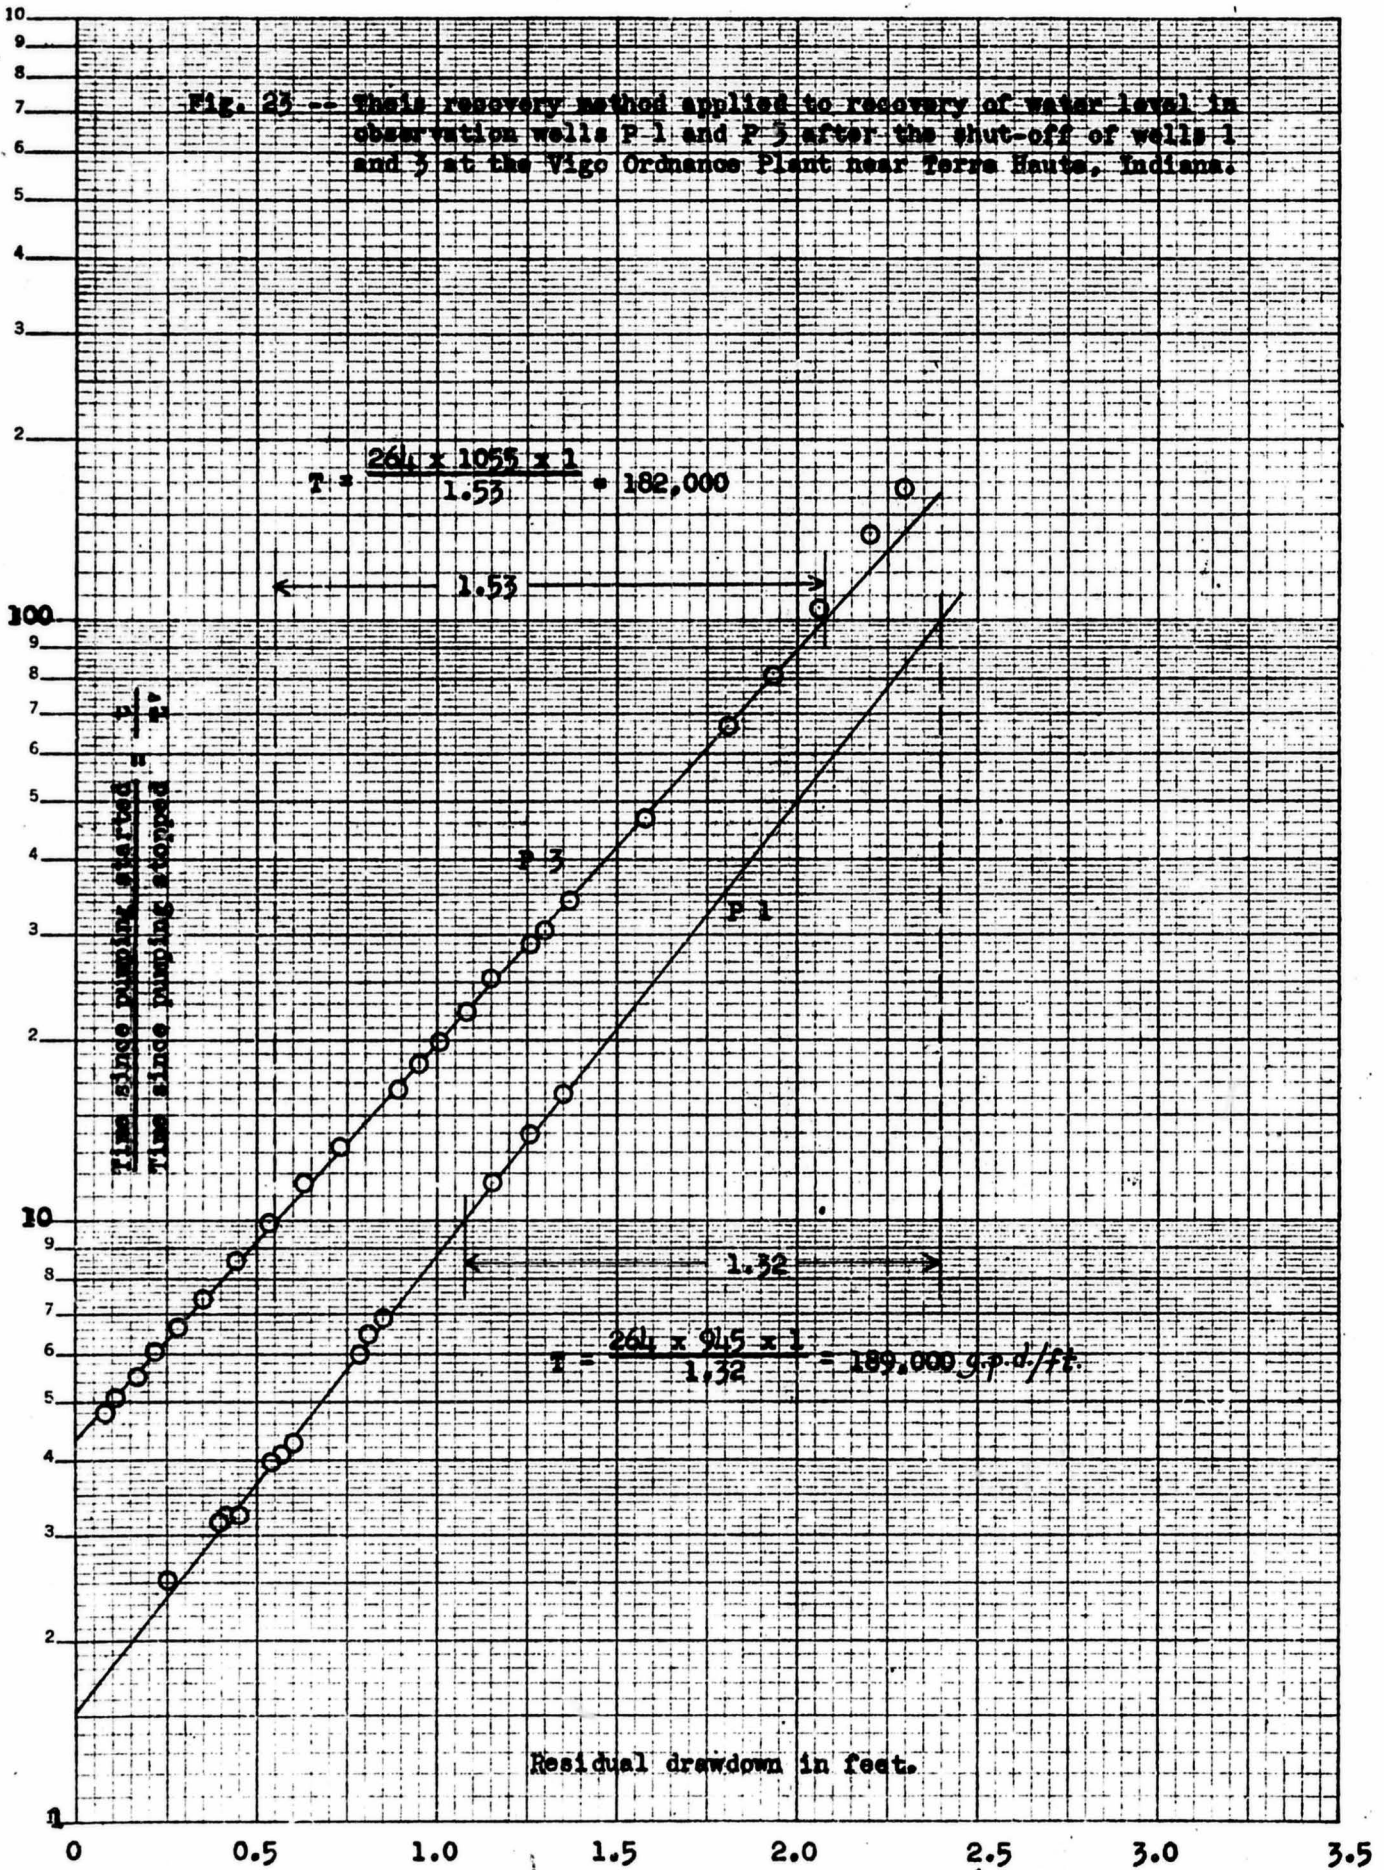
Fig. 23 -- This recovery method applied to recovery of water level in observation wells P-1 and P-3 after the shut-off of wells 1 and 3 at the Vigo Ordnance Plant near Terre Haute, Indiana.
