(200)
R290
no. 972

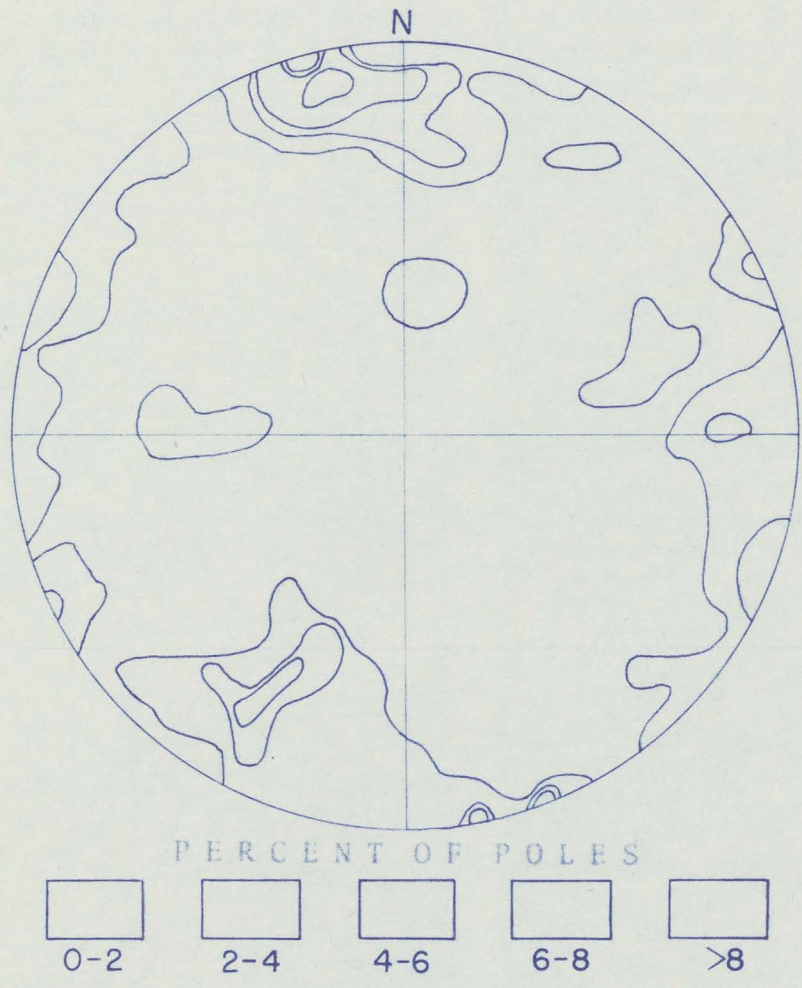
Figure 6 - Contour diagram of poles of 127 joints measured in the Tye Lake powersite area. Poles plotted on lower hemisphere. Contoured on percent of poles. (Billings, 1954, p. 108-114)
