FIGURE 4.-Electrical resistivity profile along lines B-B' and C-C'

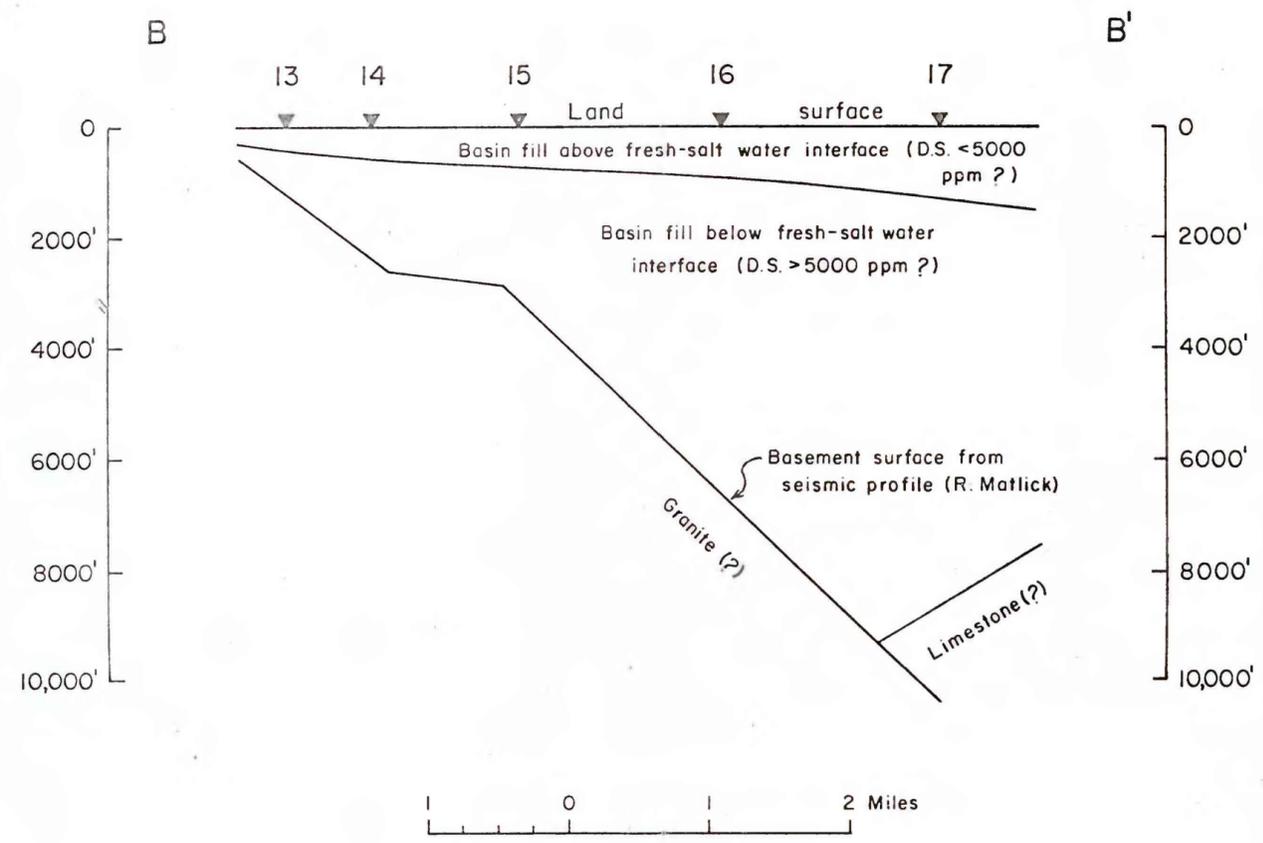
Resistivity profile along line near Texas-New Mexico state line

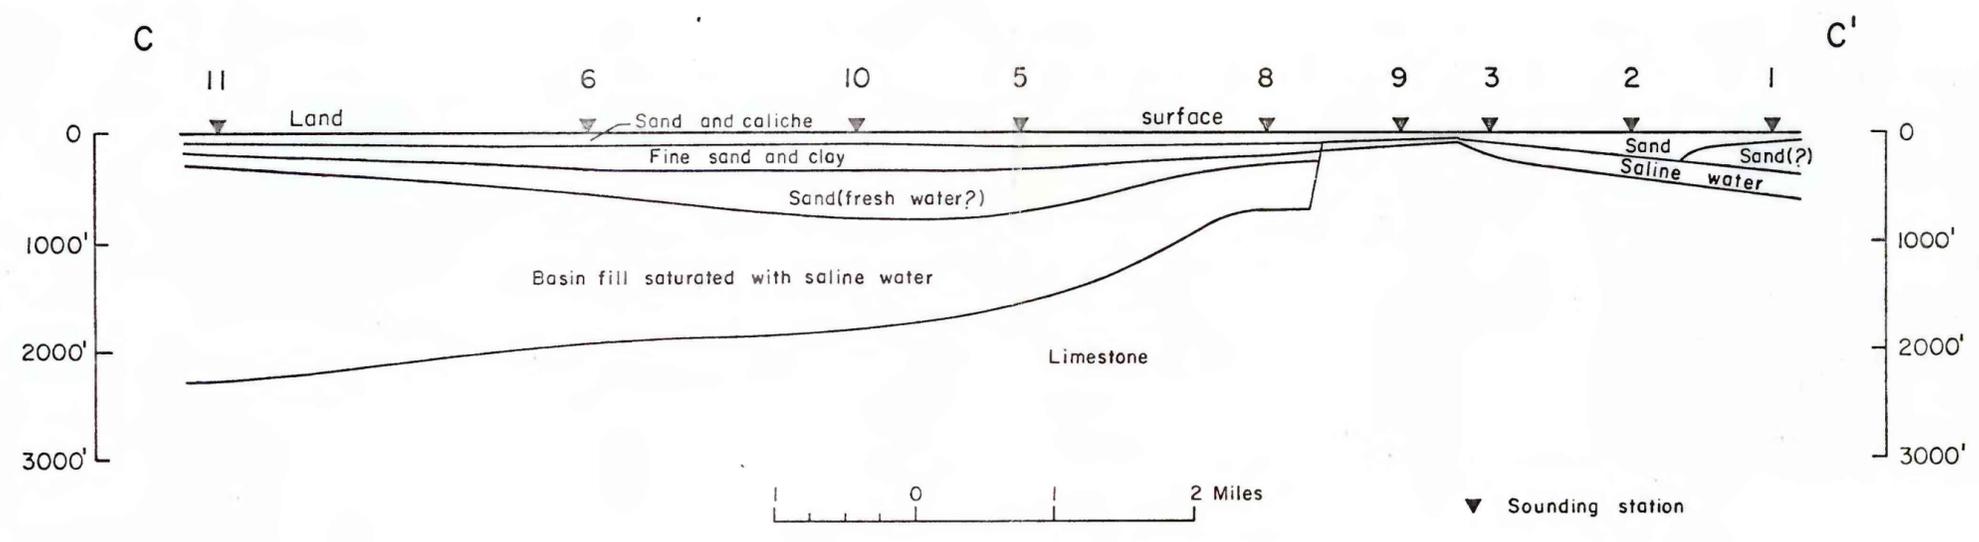
Resistivity profile along Horizon Boulevard in southeastern El Paso County, Texas
