68-138

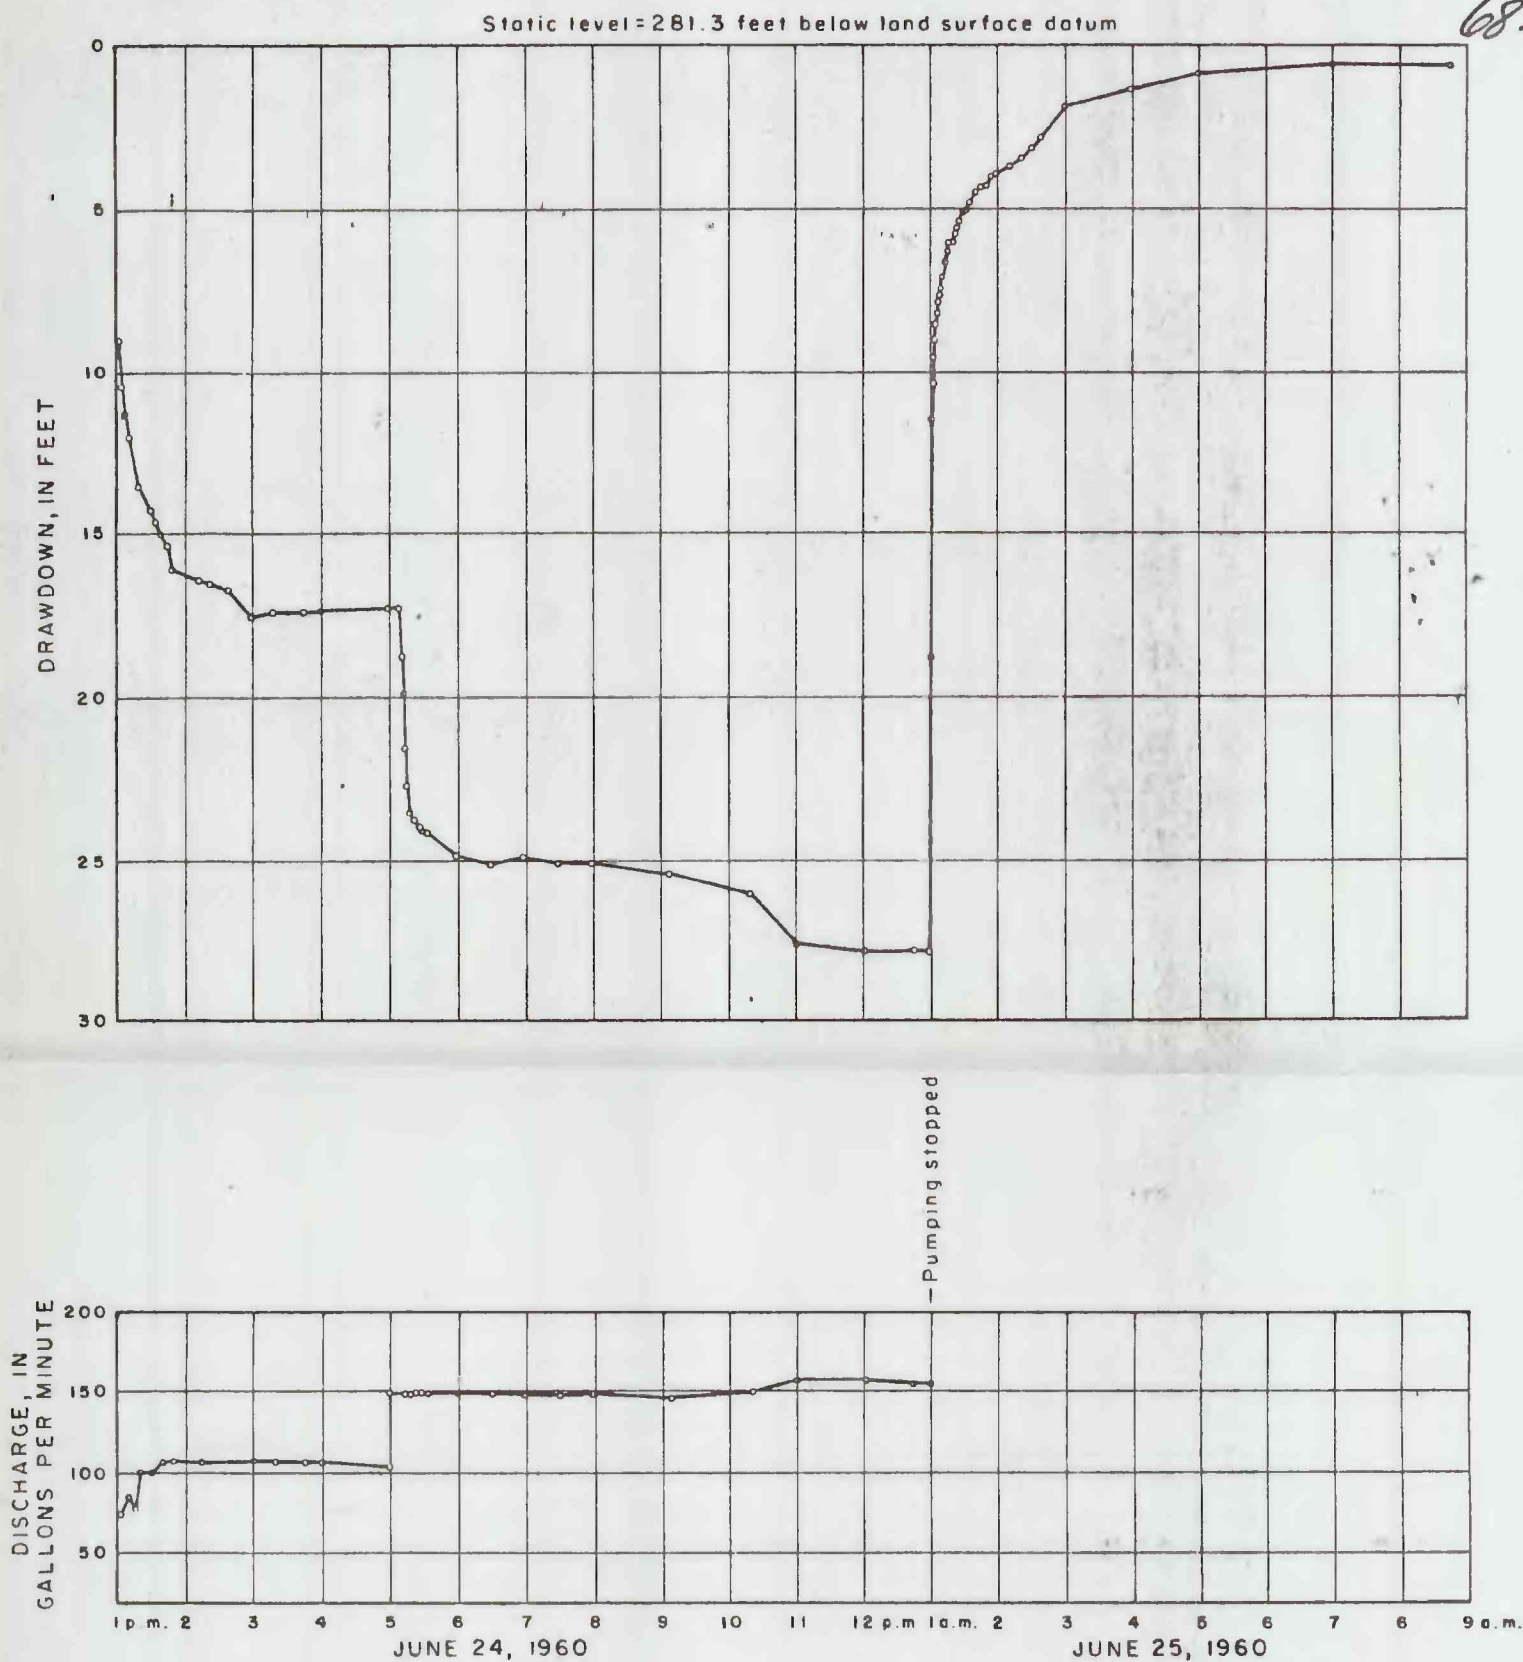
Figure 13.--Water level during drawdown and recovery and the rate of discharge during performance test of well SMR-1 (21.5.16.132), White Sands Missile Range, N. Mex.
