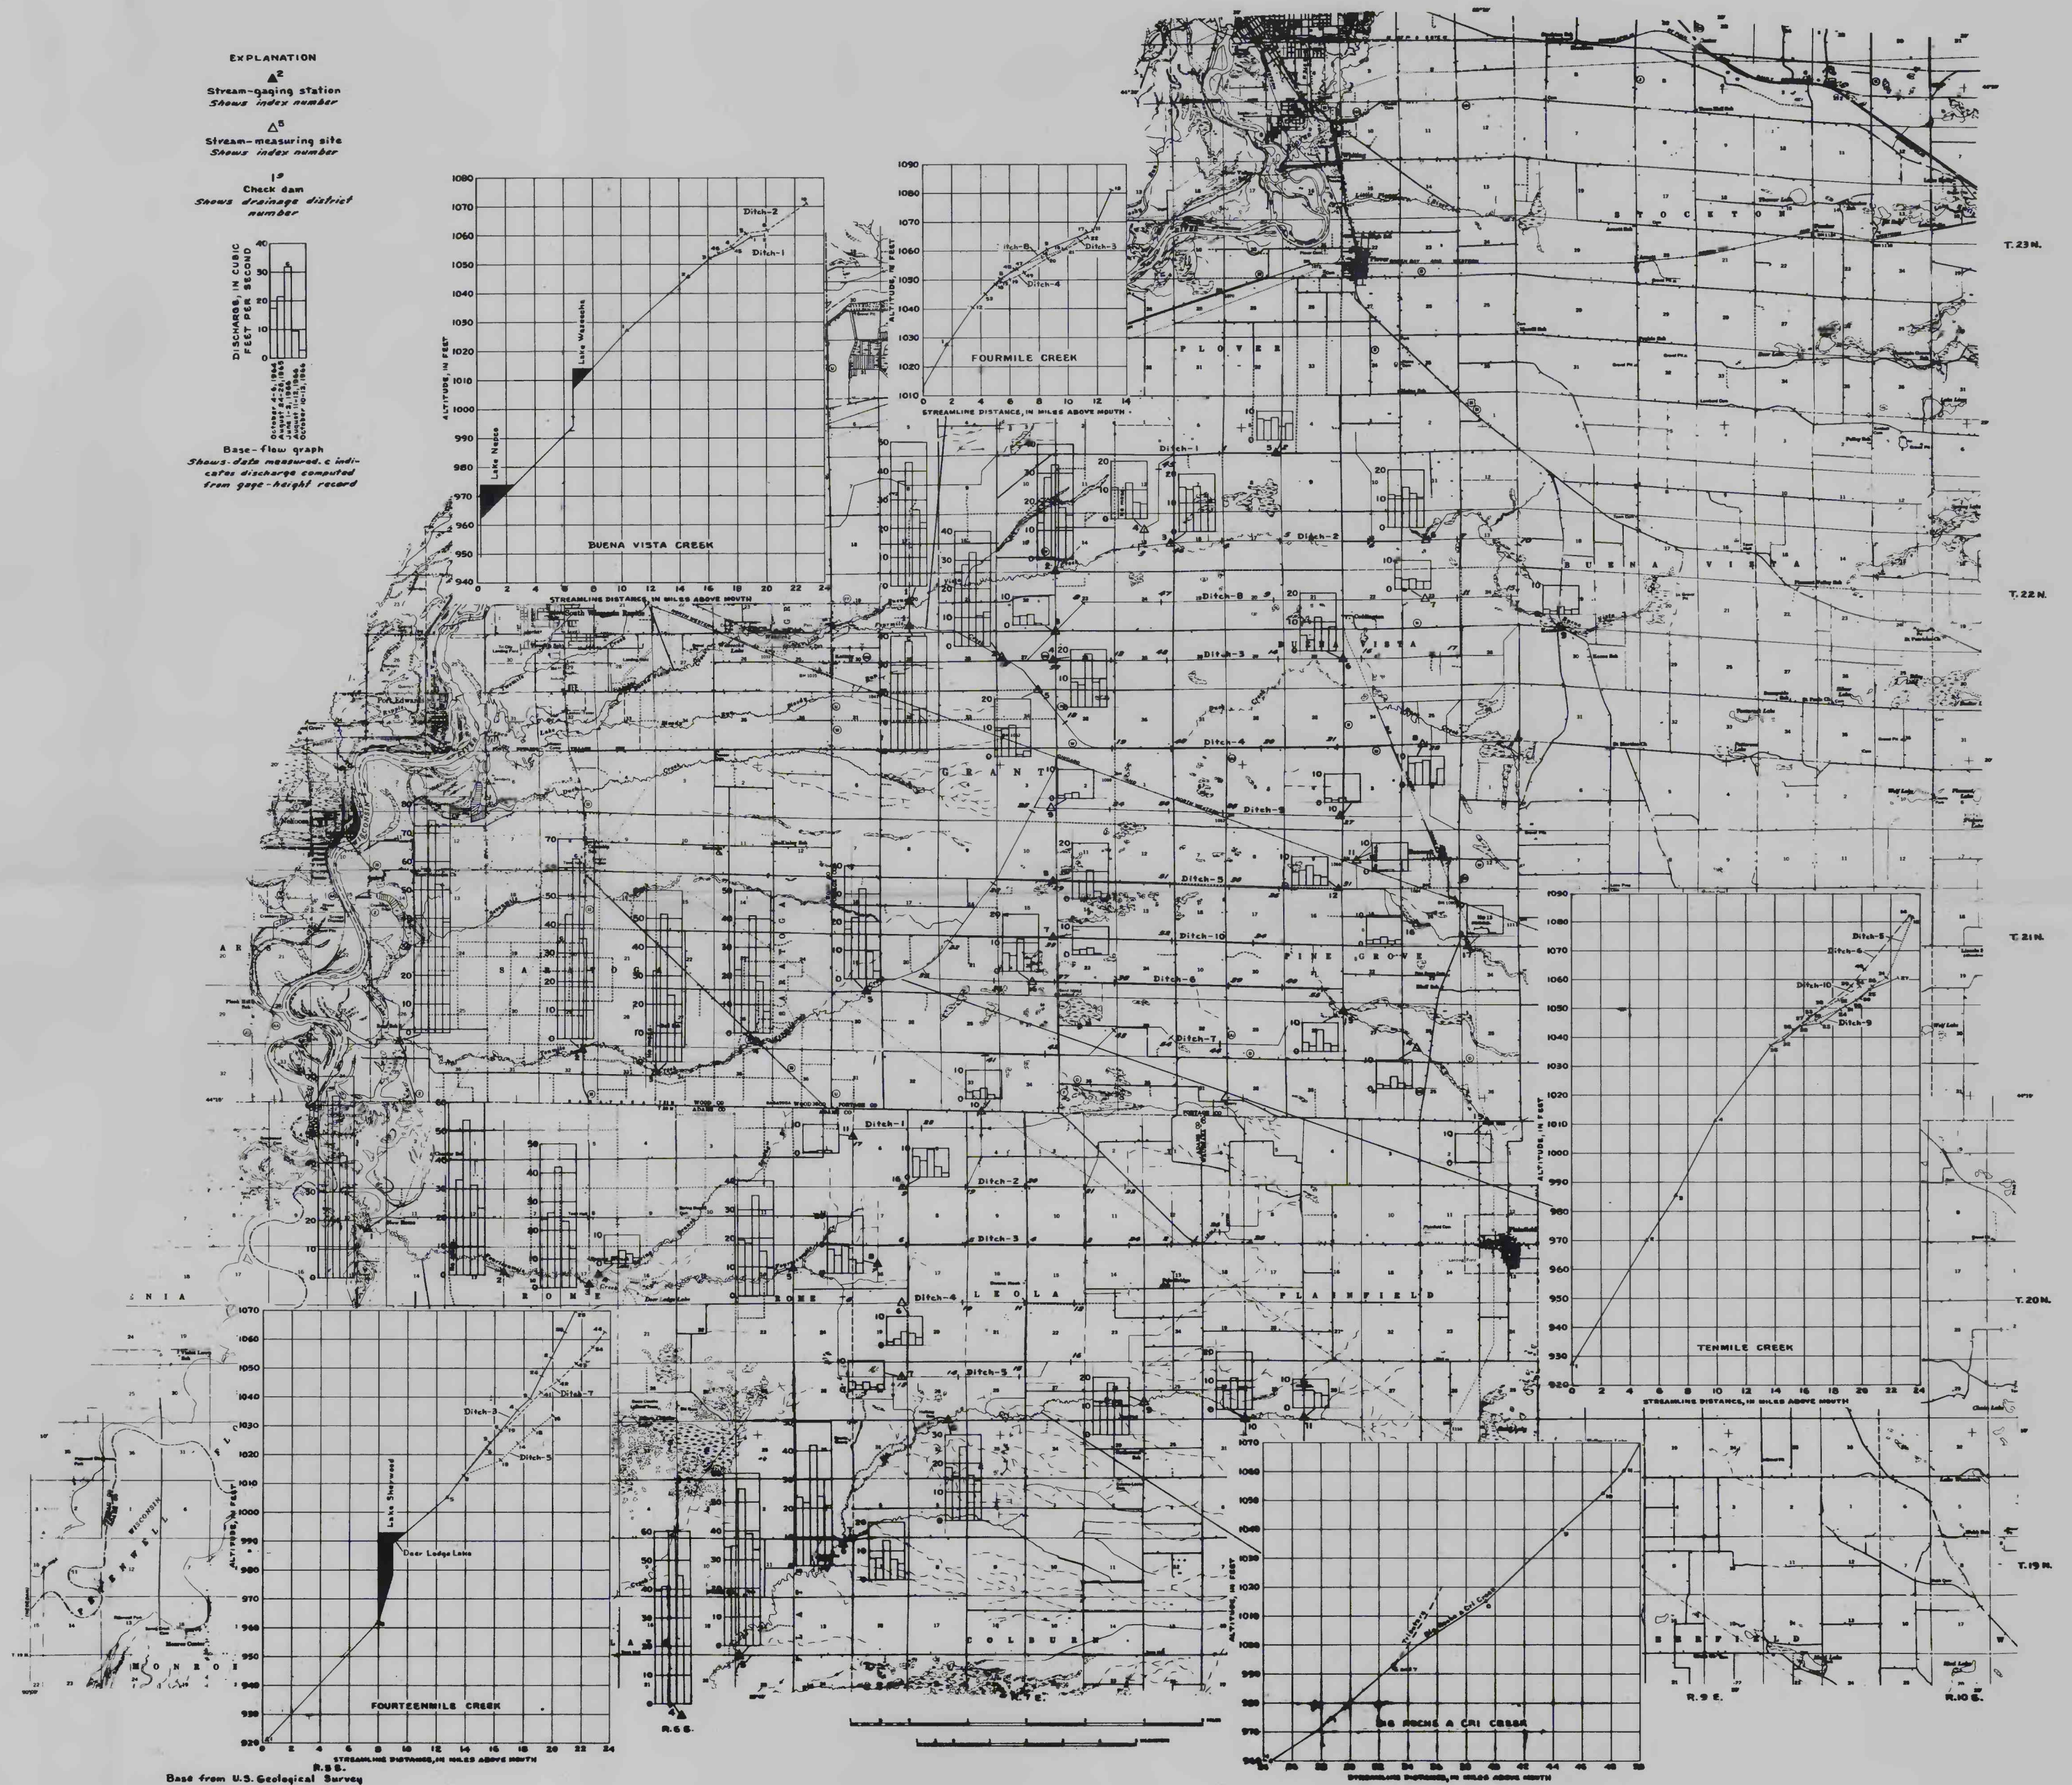
Figure 12.—Map showing locations of stream-gaging stations, measuring sites, and check dams; profiles for the gaged streams; and graphs showing flow at all sites during five periods of dry weather in 1964, 1965, and 1966 in part of the sand plain area of central Wisconsin.
