FLOODS IN
STARKWEATHER CREEK BASIN
MADISON, WISCONSIN

1972

Prepared by U.S. Geological Survey
in cooperation with the
City of Madison
and Wisconsin Department of Natural Resources

Sheet 5 of 5--River and Bank Profiles
East Br. Starkweather Creek

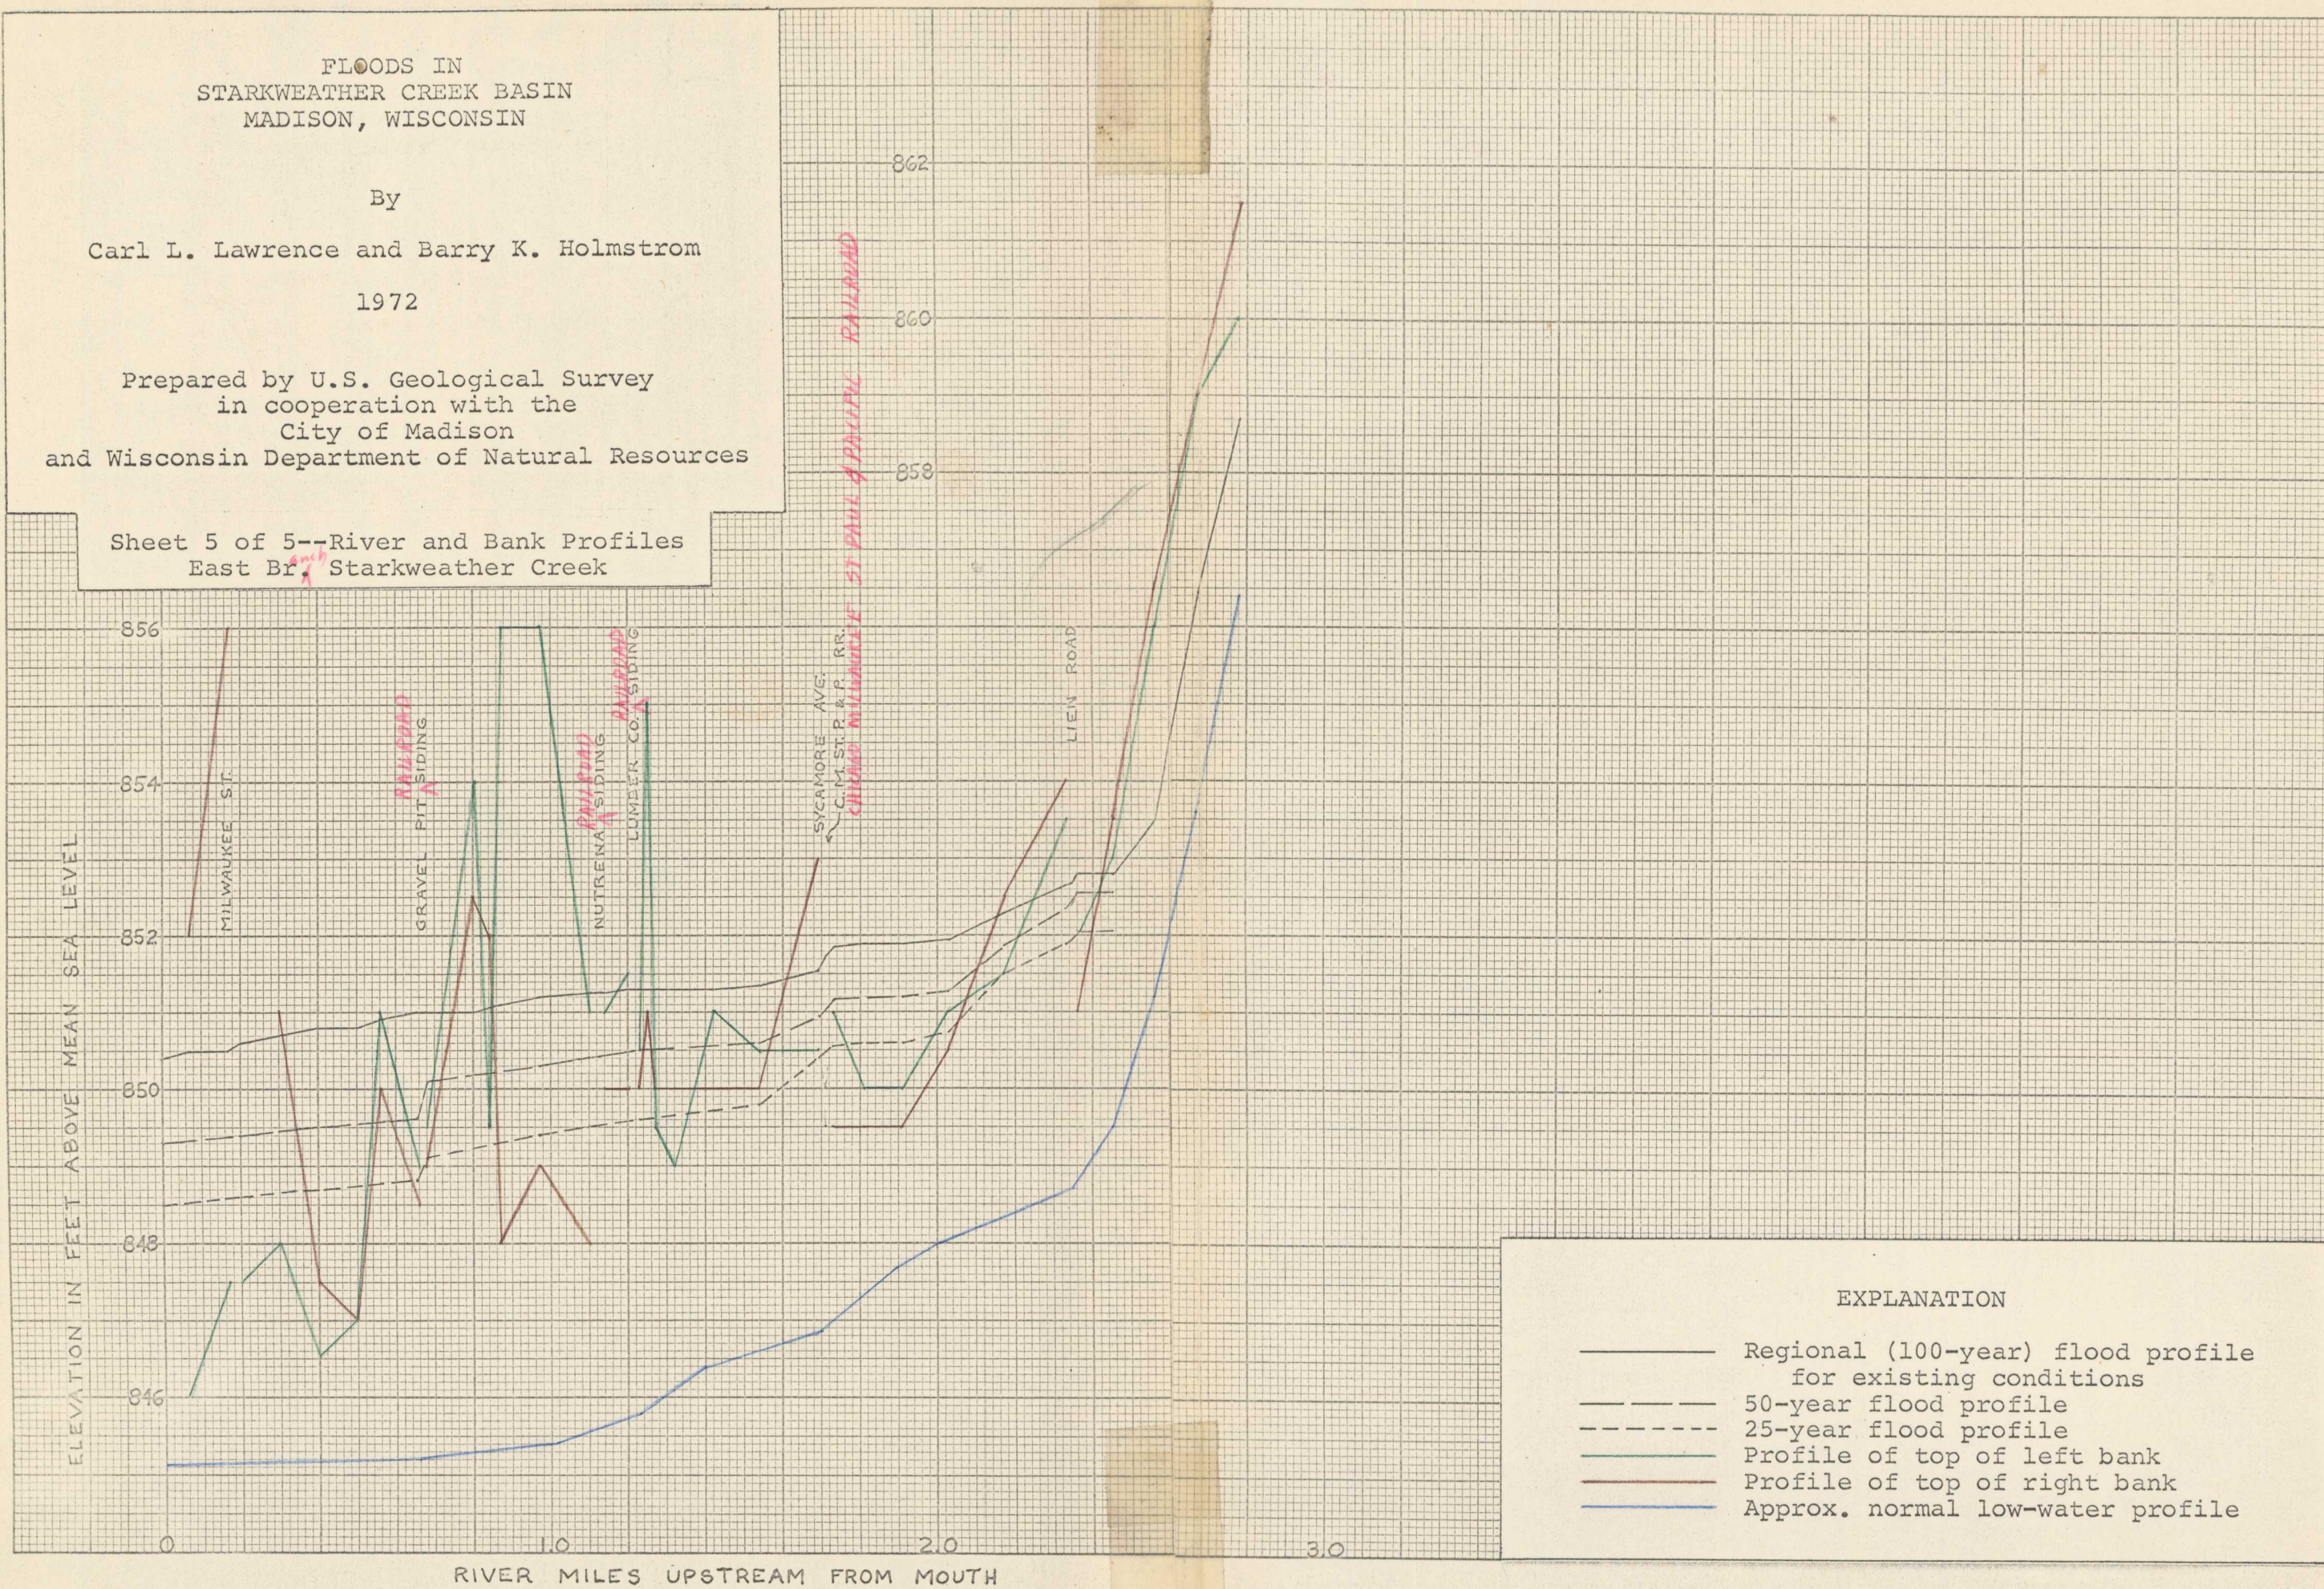
- Regional (100-year) flood profile for existing conditions
- - - 50-year flood profile
- · - · 25-year flood profile
- Profile of top of left bank
- Profile of top of right bank
- Approx. normal low-water profile
