MAP SHOWING SATURATED THICKNESS OF THE VALLEY-FILL AQUIFER IN THE STERLING REACH OF THE SOUTH PLATTE RIVER VALLEY, COLORADO, MARCH 1968
By
Paul A. Schneider, Jr.,
1972

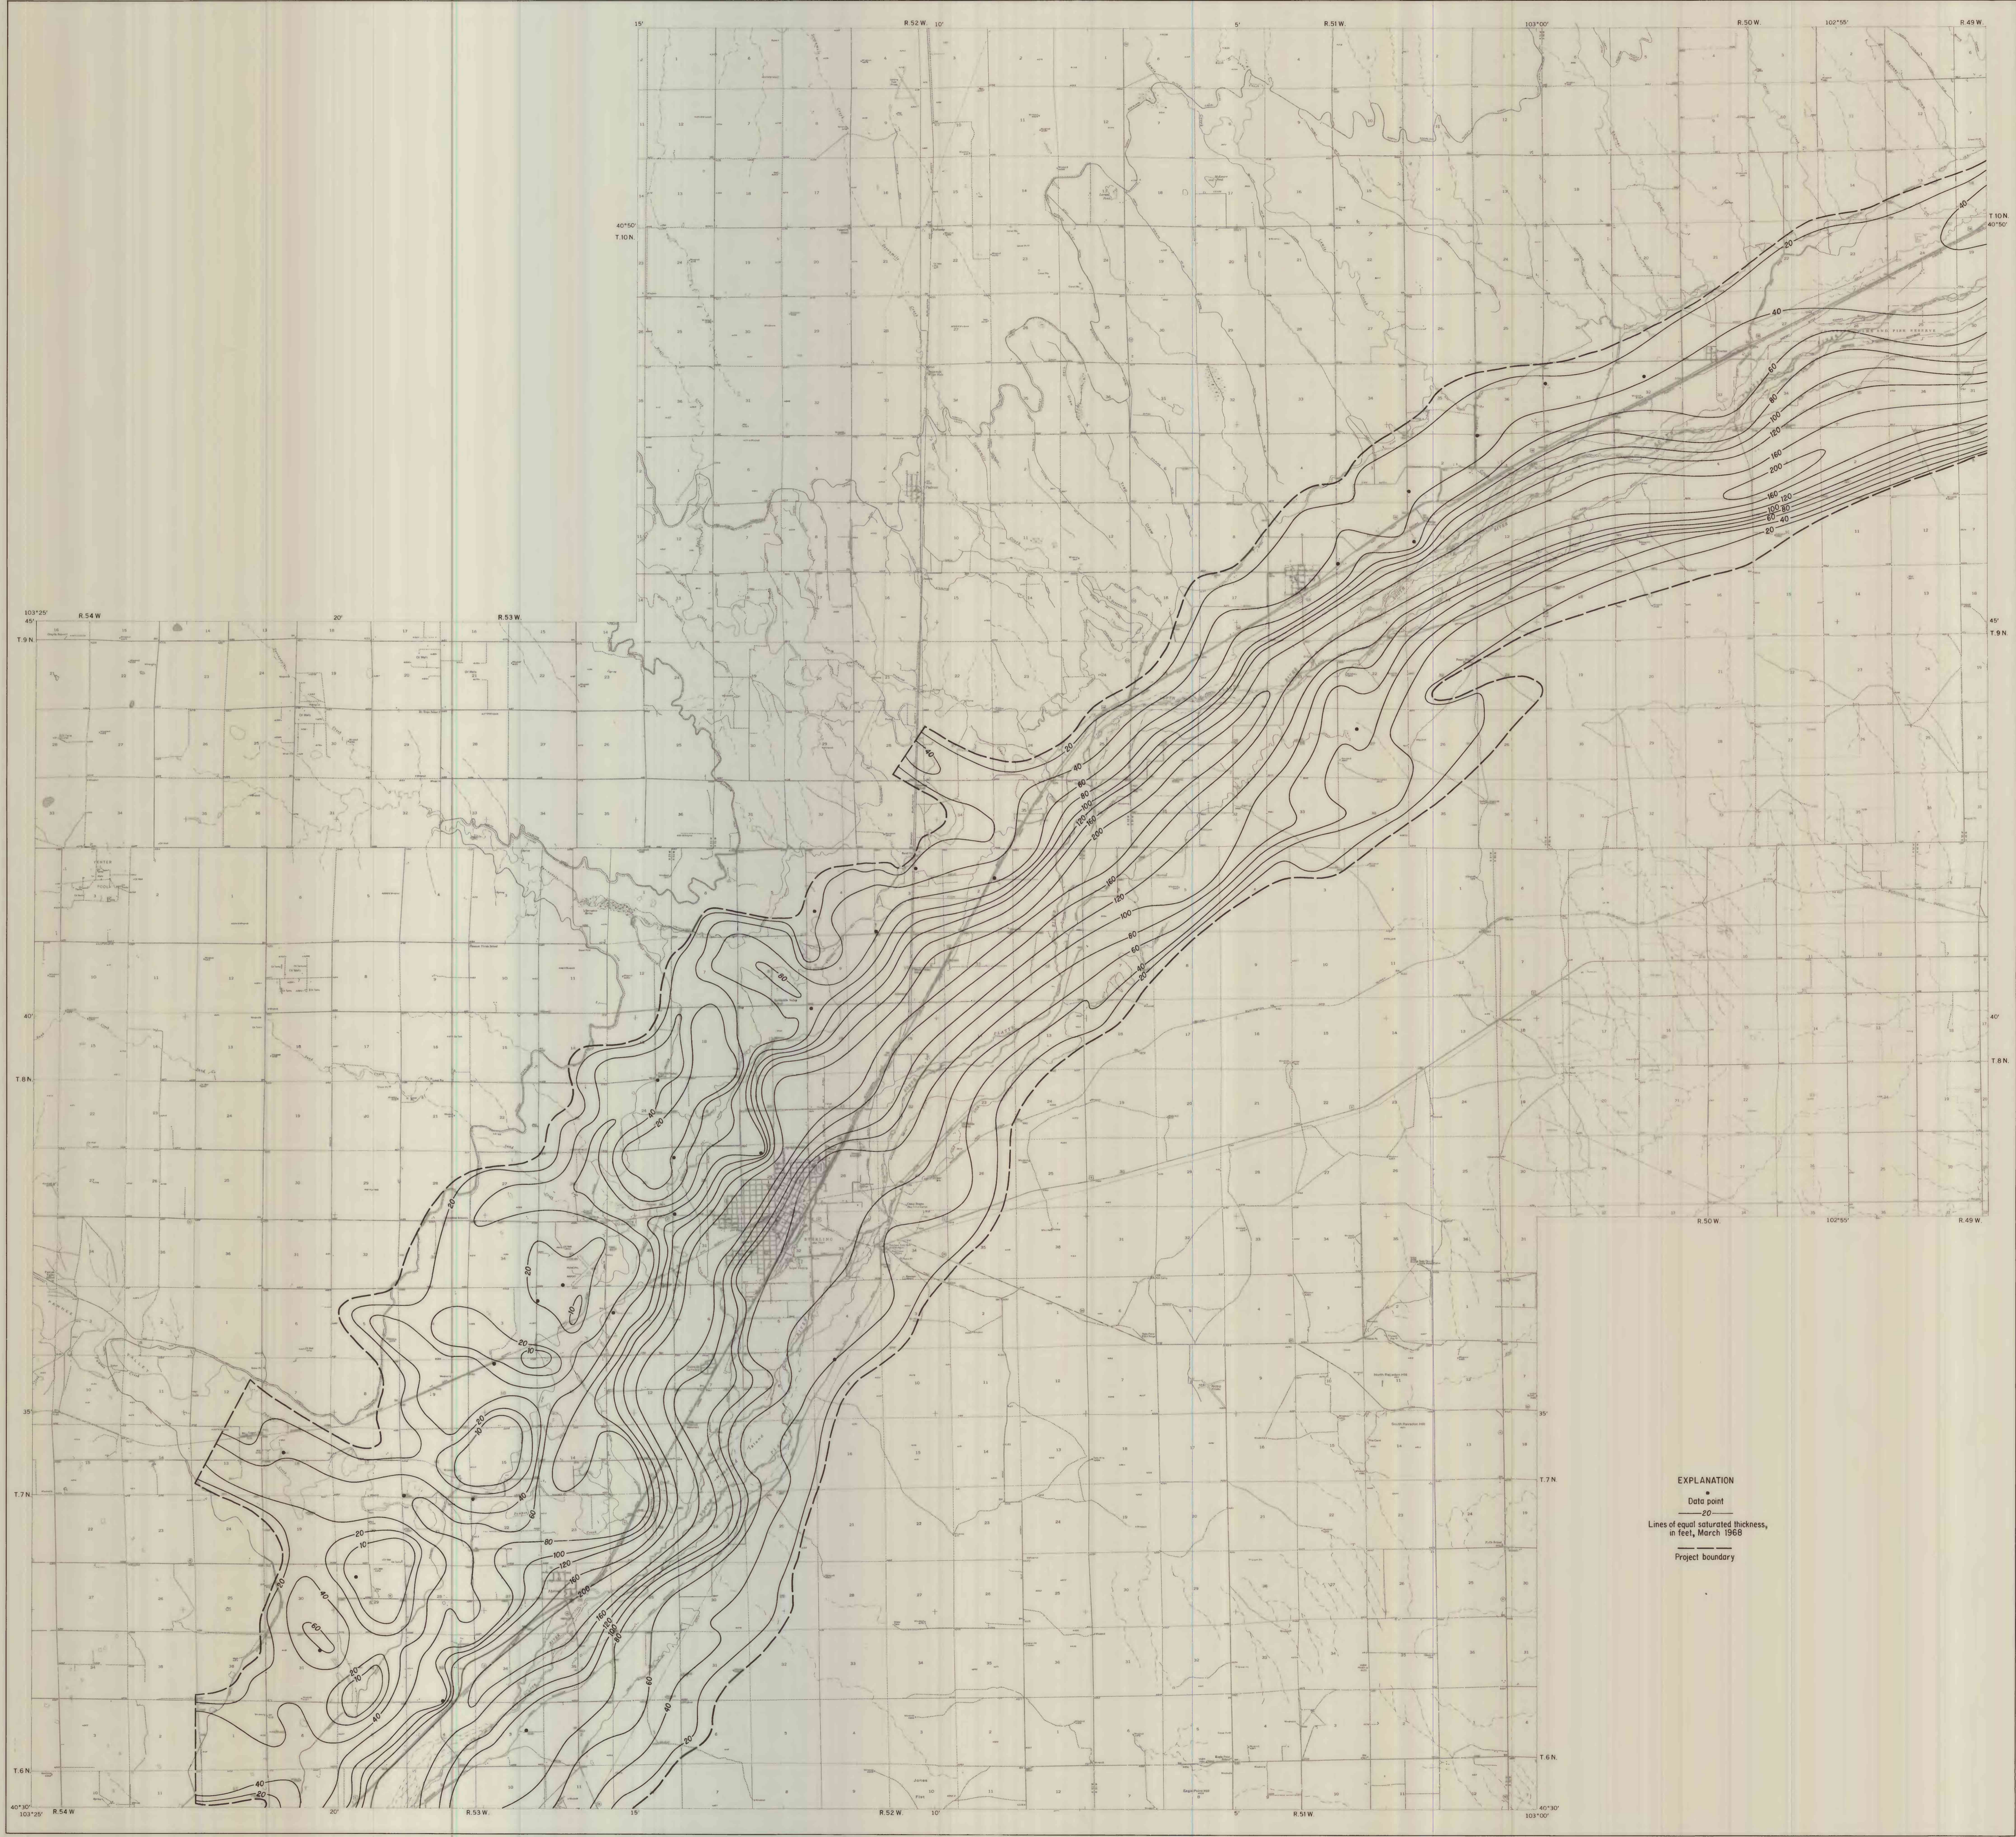
EXPLANATION
Data point
—20—
Lines of equal saturated thickness,
in feet, March 1968
Project boundary
