U. S. Geological Survey  
OPEN FILE MAP 74-234  
This map is preliminary and has  
not been edited for conformity  
with Geological Survey standards  
or nomenclature.

LANDSLIDE SUSCEPTIBILITY AND LAND MODIFIED BY MAN  
MAP OF PART OF THE CLINTON 7 1/2' QUADRANGLE,  
ALLEGHENY COUNTY AND VICINITY, PENNSYLVANIA  
by J.S. Pomary  
1974

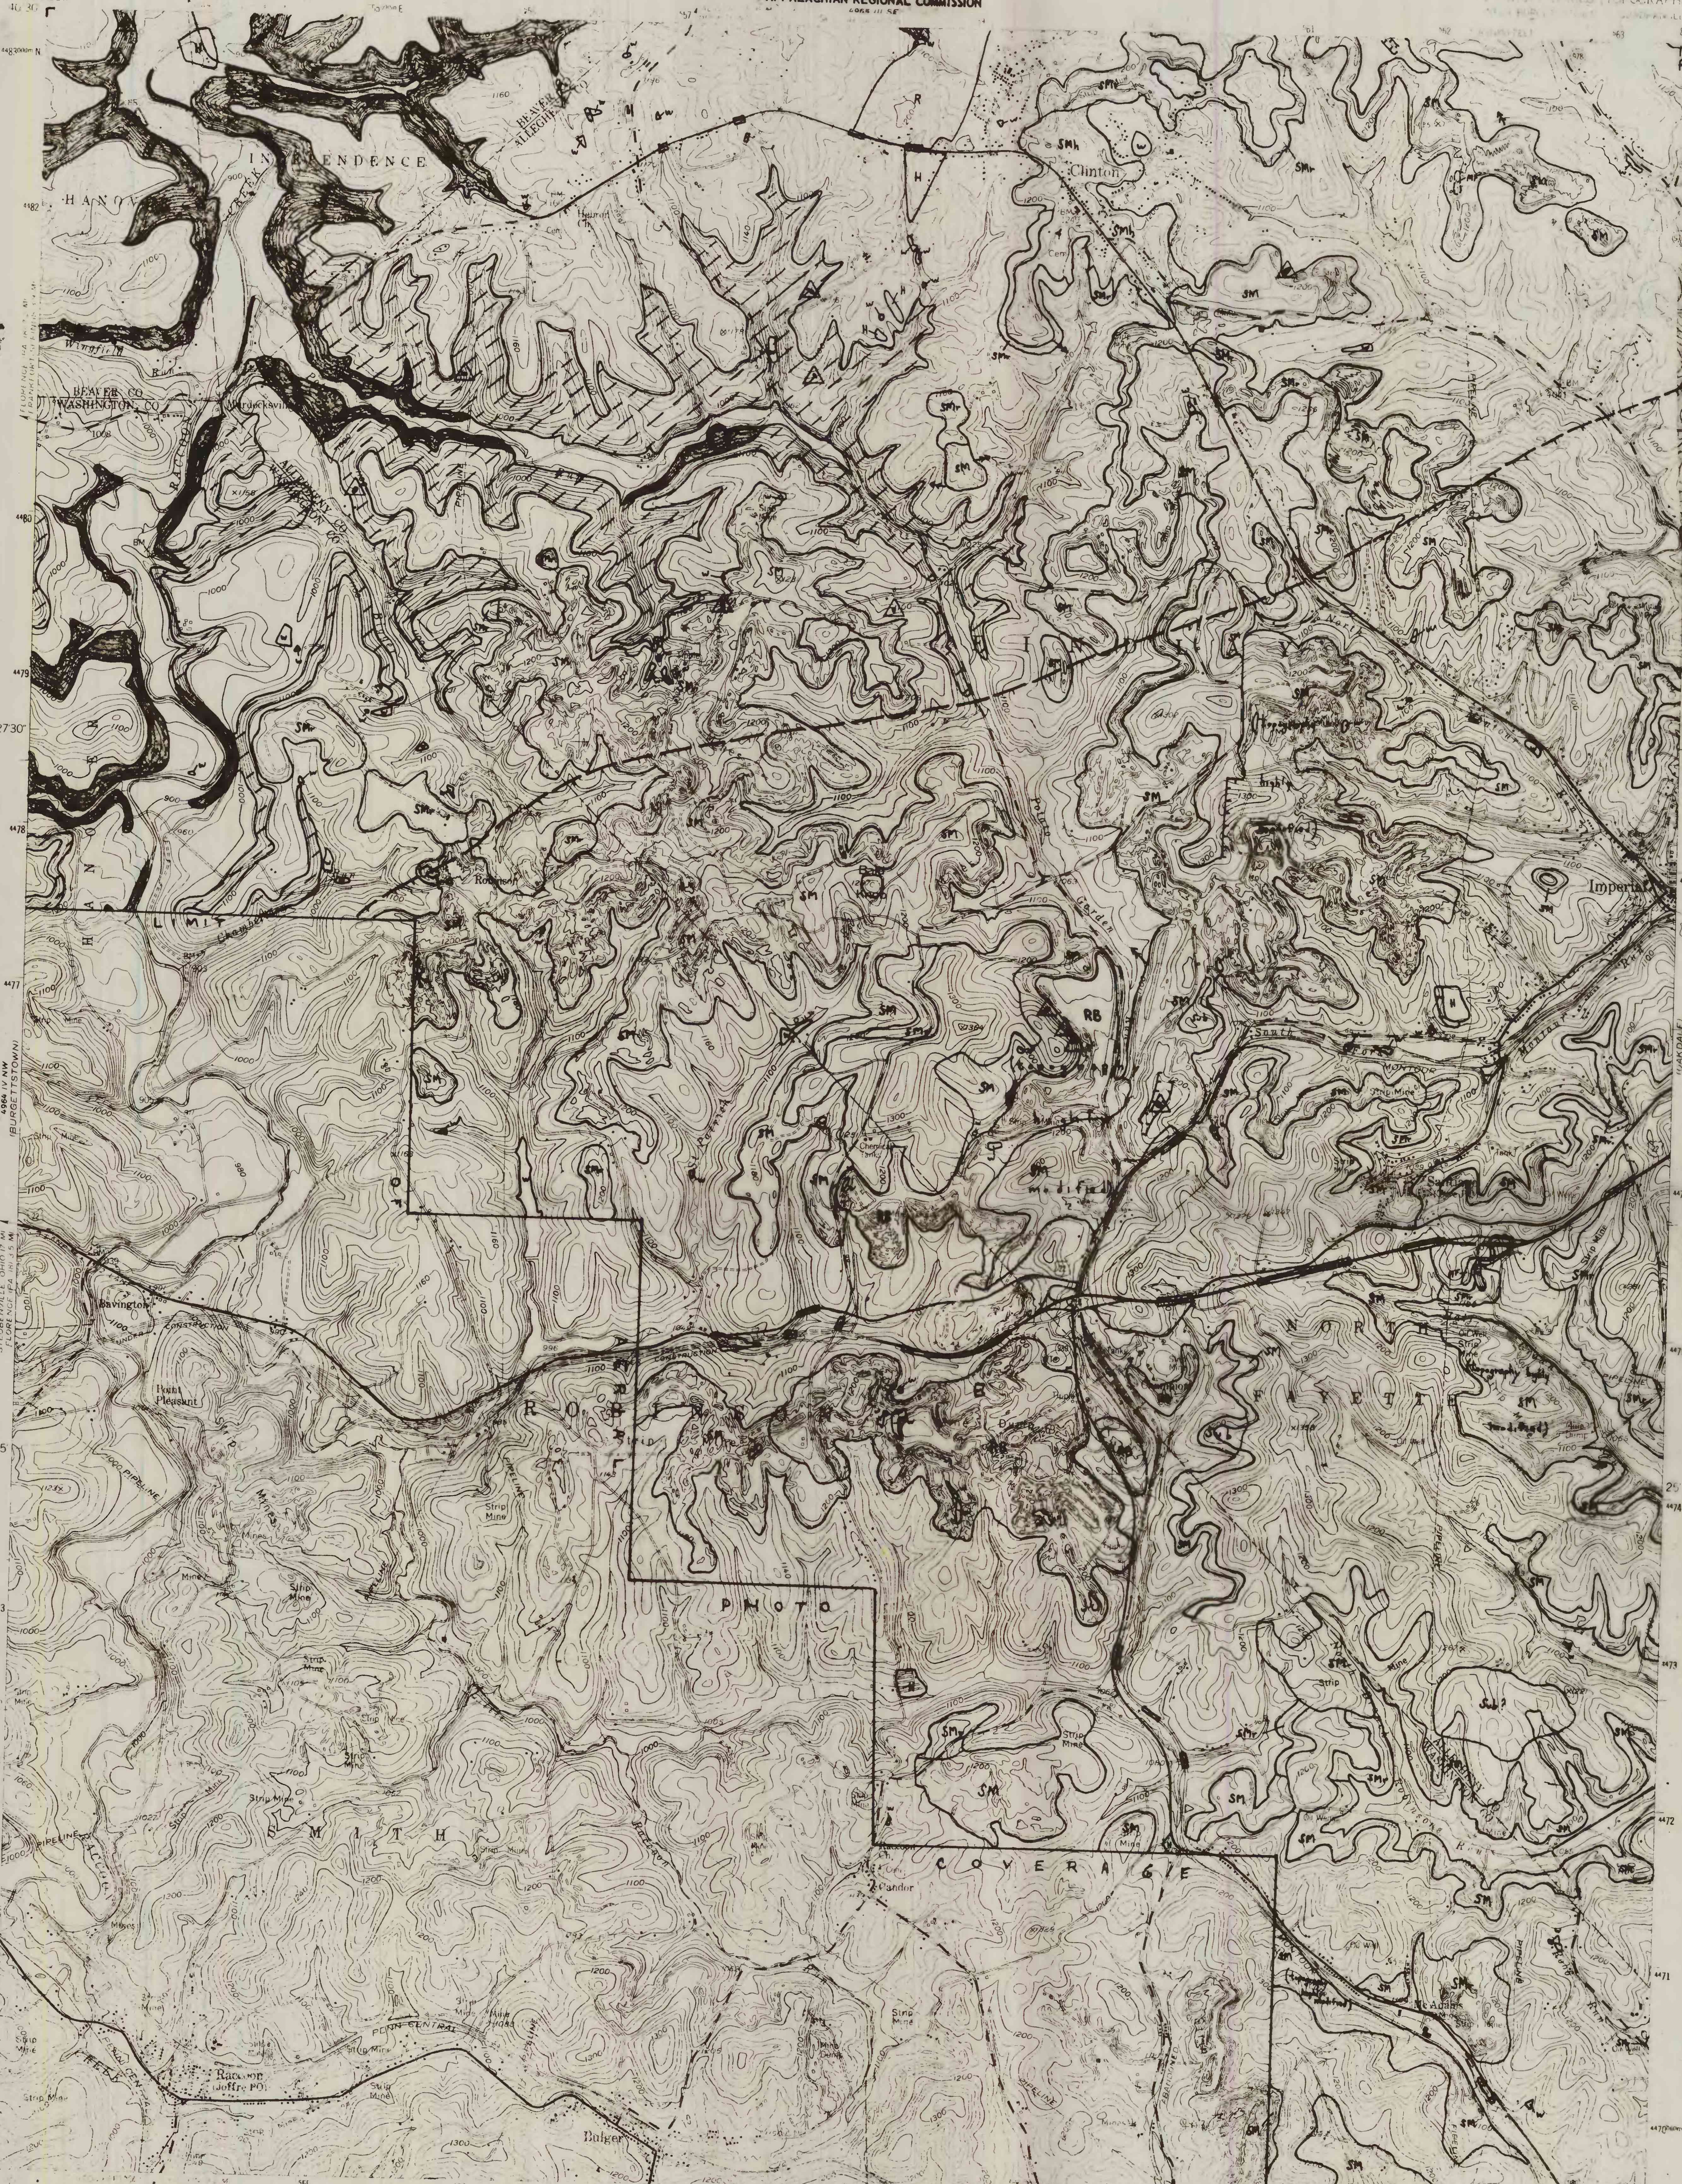
Map based on 1973 aerial photographs,  
field reconnaissance, 1973-74; soil  
surveys by U.S. Dept. Agriculture Soil  
Conservation Service, and existing geologic  
data. This map has not been  
edited or reviewed for conformity with  
Geological Survey standards and nomenclature.
