1 Landslide susceptibility and land modified by man map of
2 part of the Clinton 7-1/2-minute quadrangle,
3 Allegheny County and vicinity, Pennsylvania
4 By J. S. Pomeroy

22 U. S. Geological Survey
23 OPEN FILE MAP 74-234
24 This map is preliminary and has
25 not been edited for conformity
 with Geological Survey standards
 or nomenclature.

FACTORS AFFECTING LANDSLIDE SUSCEPTIBILITY

(to accompany U.S. Geological Survey open-file
landslide-susceptibility maps of Allegheny County)

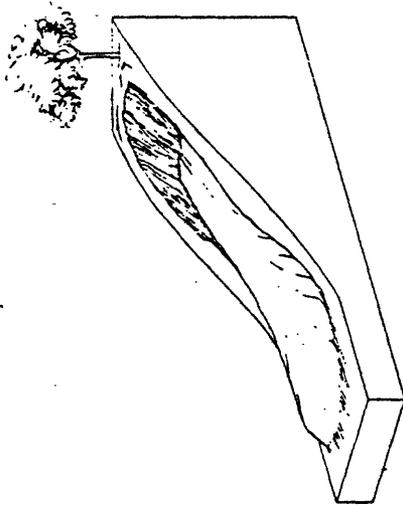
Earthflow: colluvial materials that move downslope in a manner similar to a viscous fluid.

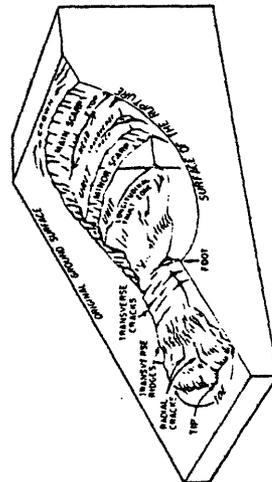
Nomenclature of parts of a landslide (from Ectel, 1958):

Credits:--This text is abstracted with minor changes from Briggs (1974). The following illustrations are adapted with minor modifications from Nilsen (1972), Eckel (1958), and from the pioneering text by Sharpe (1938). They illustrate nomenclature of landslides, types of landslides found in Allegheny County, and features of creep, which is a widespread feature of Allegheny County slopes.
