U.S. Geological Survey
OPEN FILE MAP 74-277
This map is preliminary and has
not been edited for conformity
with Geological Survey standards
or nomenclature.

**LANDSLIDE SUSCEPTIBILITY MAP OF PART OF THE DONORA 7 1/2' QUADRANGLE,
ALLEGHENY COUNTY AND VICINITY, PENNSYLVANIA**

by
William E. Davies

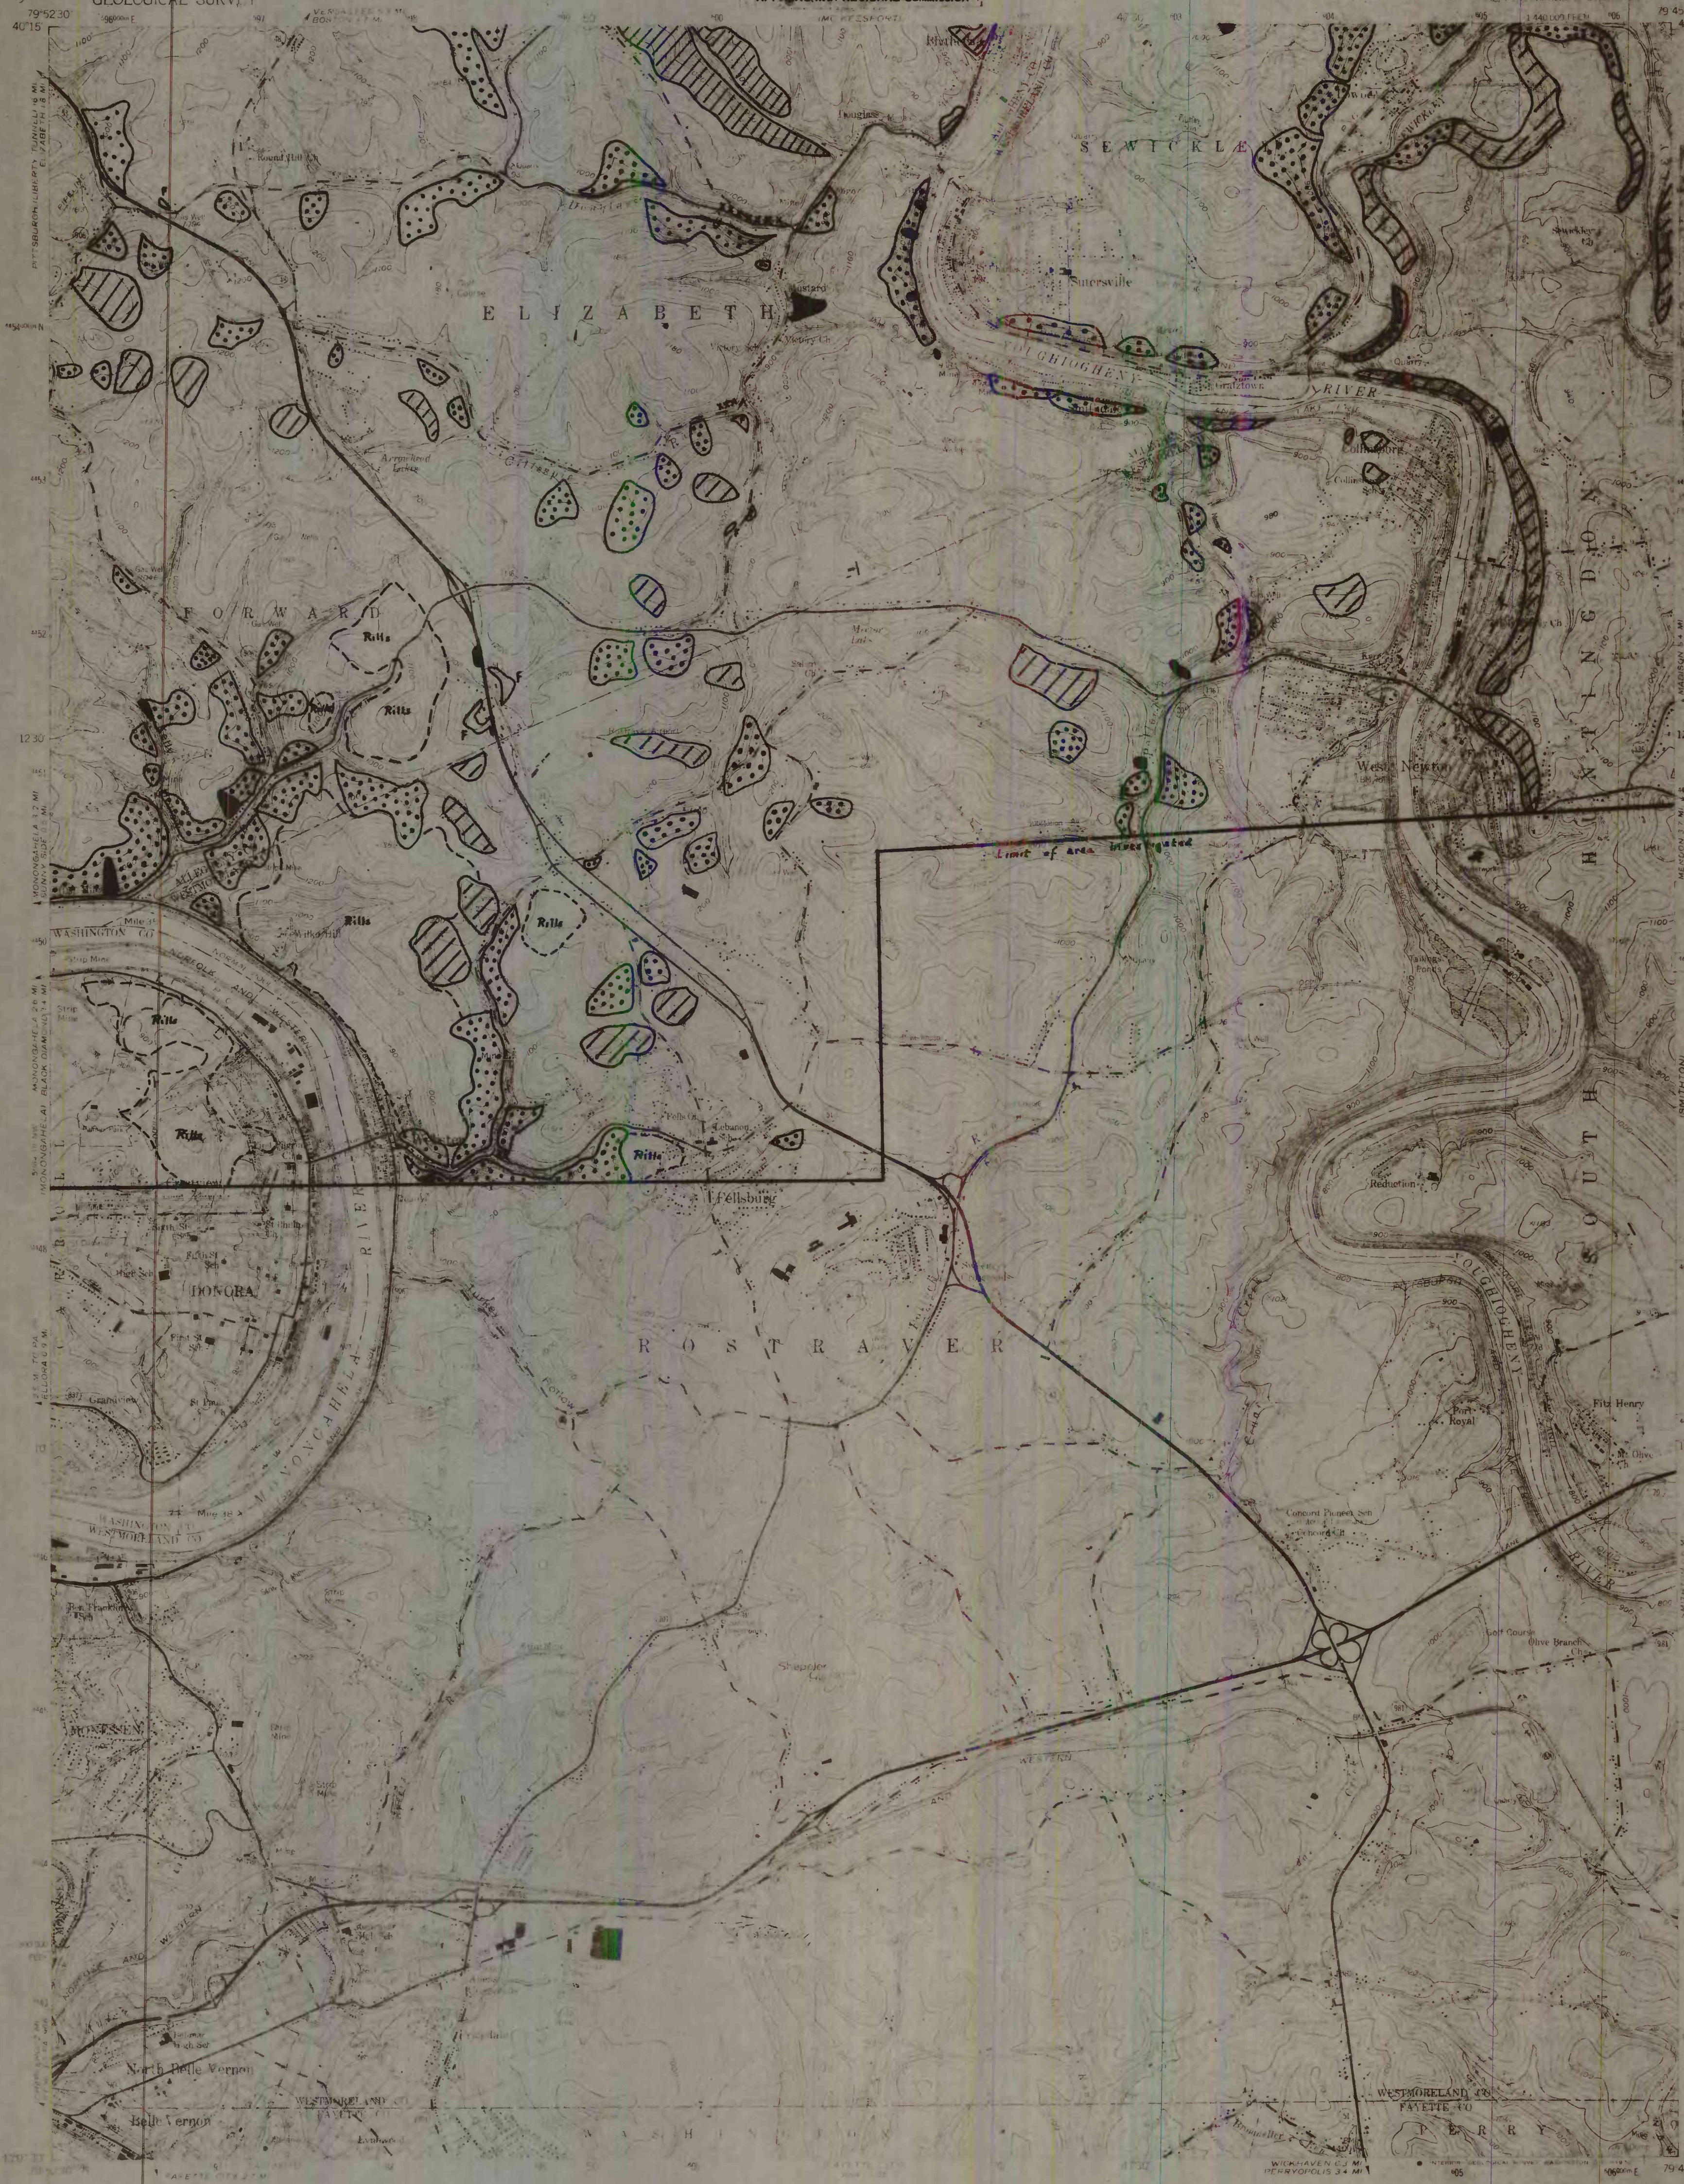
RECENT LANDSLIDES
Distinctly earth slumps and earth flows; historic landslides or those characterized by earth scars. Small landslides enclosed by triangles.

PREHISTORIC LANDSLIDES
Distinctly earth slumps and earth flows; historic landslides or those characterized by earth scars. Small landslides enclosed by triangles.

SLOPES WITH CONSPICUOUS SOIL CREEP
Clayey soils, generally less than 5 ft. thick, commonly underlain by weathered shale; characterized by shallow, slow but distinct, downslope movement that can be easily accelerated by overloading from fills or structures.

RELATIVELY STABLE GROUND
Most slopes have little or no susceptibility to landsliding unless intensively modified by man; slight soil creep common on undisturbed slope.

STEEP SLOPES SUSCEPTIBLE TO ROCKFALL
Dip-slip, thick-bedded sandstone and limestone, 1 to over 10 ft. thick; sub-surface flaky sandy shale and weathered shale; highly fractured and locally undercut by weathering of shale; in steep natural and cut slopes and cliffs, 15 to over 150 ft. high.

MAN-MADE FILL
Heterogeneous soil and rock material; variable susceptibility to slope failure depending on nature of materials, foundation conditions, design and construction. Fills in older urban areas mapped only where associated with recent landslides. Fills too small to be shown by letter "F".

AREA OF RILLS
Numerous rills or gullies in rounded hills of highly erodible sandstone and siltstone. The eroding sandstone most exposed, rapidly leading to small slides. Rills are more numerous on west side of hills.

Map based on 1973 aerial photographs,
field reconnaissance, 1973-74; soil
surveys by U.S. Dept. Agriculture Soil
Conservation Service, and existing geo-
logic data. This map has not been
edited or reviewed for conformity with
Geological Survey standards and nomenclature.
