U.S. Geological Survey
OPEN FILE MAP 74-278
This map is preliminary and has
not been edited for conformity
with Geological Survey standards
or nomenclature.

**LANDSLIDE SUSCEPTIBILITY MAP OF PART OF THE FREEPORT 7 1/2' QUADRANGLE,
ALLEGHENY COUNTY AND VICINITY, PENNSYLVANIA**

by
William E. Davies

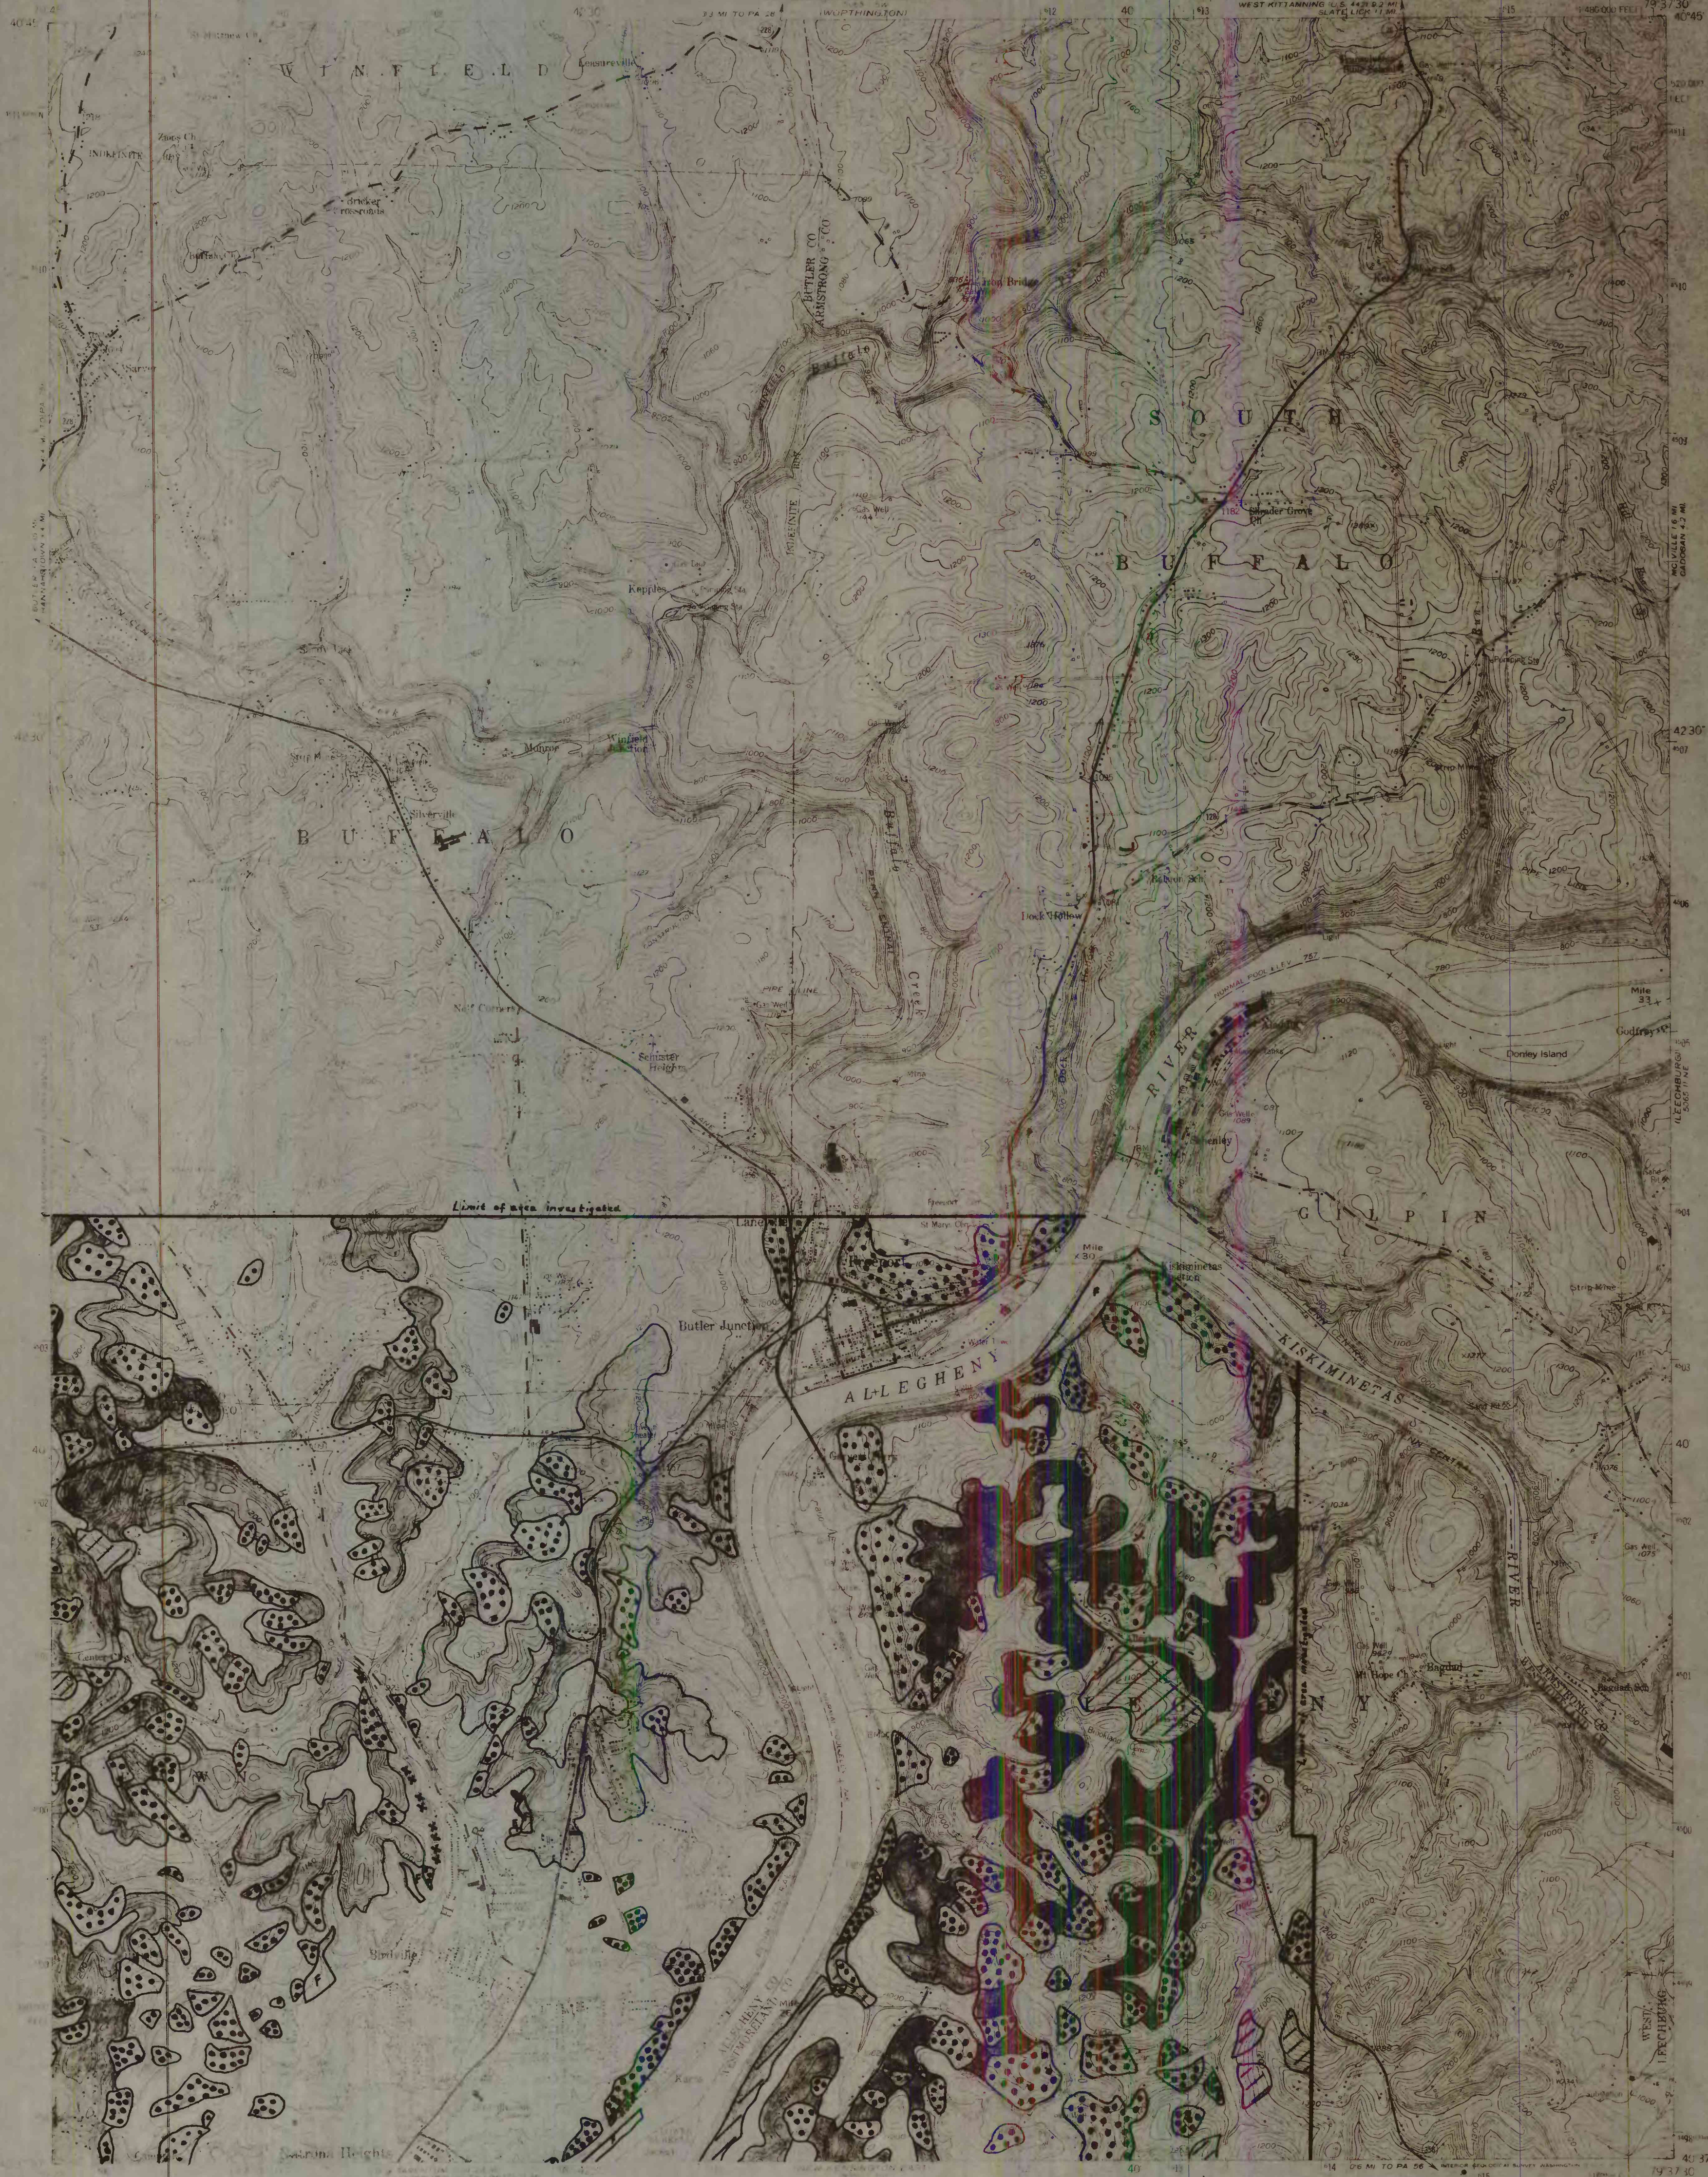
RECENT LANDSLIDES
Dominantly earth slumps and earth flows characteristically recorded or characterized by fresh scars. Small landslides enclosed by triangles.

PREHISTORIC LANDSLIDES
Dominantly earth slumps and earth flows characterized by hummocky topography, relatively stable in nature, but can be reactivated by excavation, loading and changes in ground and surface water conditions. Includes some probable recent landslides not covered by records examined.

SLOPES WITH CONSPICUOUS SOIL CREEP
Clayey soils, generally less than 5 ft. thick, commonly underlain by weathered shale; characterized by shallow, slow but distinct, downslope movement that can be greatly accelerated by overloading from fills or structures.

OUTCROP AREA OF THICK "RED BEDS" AND ASSOCIATED ROCKS
Rock weathers rapidly on exposure; weathered rock and related soil commonly result in soil creep and landslides; cuts and fills in "red beds" generally not stable.

RELATIVELY STABLE GROUND
Most slopes have little susceptibility to landsliding unless adversely modified by man; slight soil creep common on undisturbed slopes.

STEEP SLOPES SUSCEPTIBLE TO ROCKFALL
Dominantly thick-bedded sandstone and limestone, 1 to over 10 ft. thick; sub-ordinate flapsy sandy shale and interbedded shale; highly fractured and locally undercut by weathering of shale; in steep natural and cut slopes and cliffs, 15 to over 100 ft. high.

MAN-MADE FILL
Heterogeneous soil and rock material; variable susceptibility to slope failure depending on nature of materials, foundation conditions, design and construction. Fills in older urbanized areas mapped only where associated with recent landslides. Fills too small to be shown by pattern identified by letter "F".

Map based on 1973 aerial photographs,
field reconnaissance, 1973-74; soil
surveys by U.S. Dept. Agriculture Soil
Conservation Service, and existing geo-
logic data. This map has not been
edited or reviewed for conformity with
Geological Survey standards and nomen-
clature.
Initial data from 319th Engineer
Battalion (Hydrology) U.S. Army
Corps, 1973-74.
