U.S. Geological Survey
OPEN FILE MAP 74-282
This map is preliminary and has
not been edited for conformity
with Geological Survey standards
or nomenclature.

LANDSLIDE SUSCEPTIBILITY MAP OF PART OF THE MURRYSVILLE 7 1/2' QUADRANGLE,
ALLEGHENY COUNTY AND VICINITY, PENNSYLVANIA

by
William E. Davies

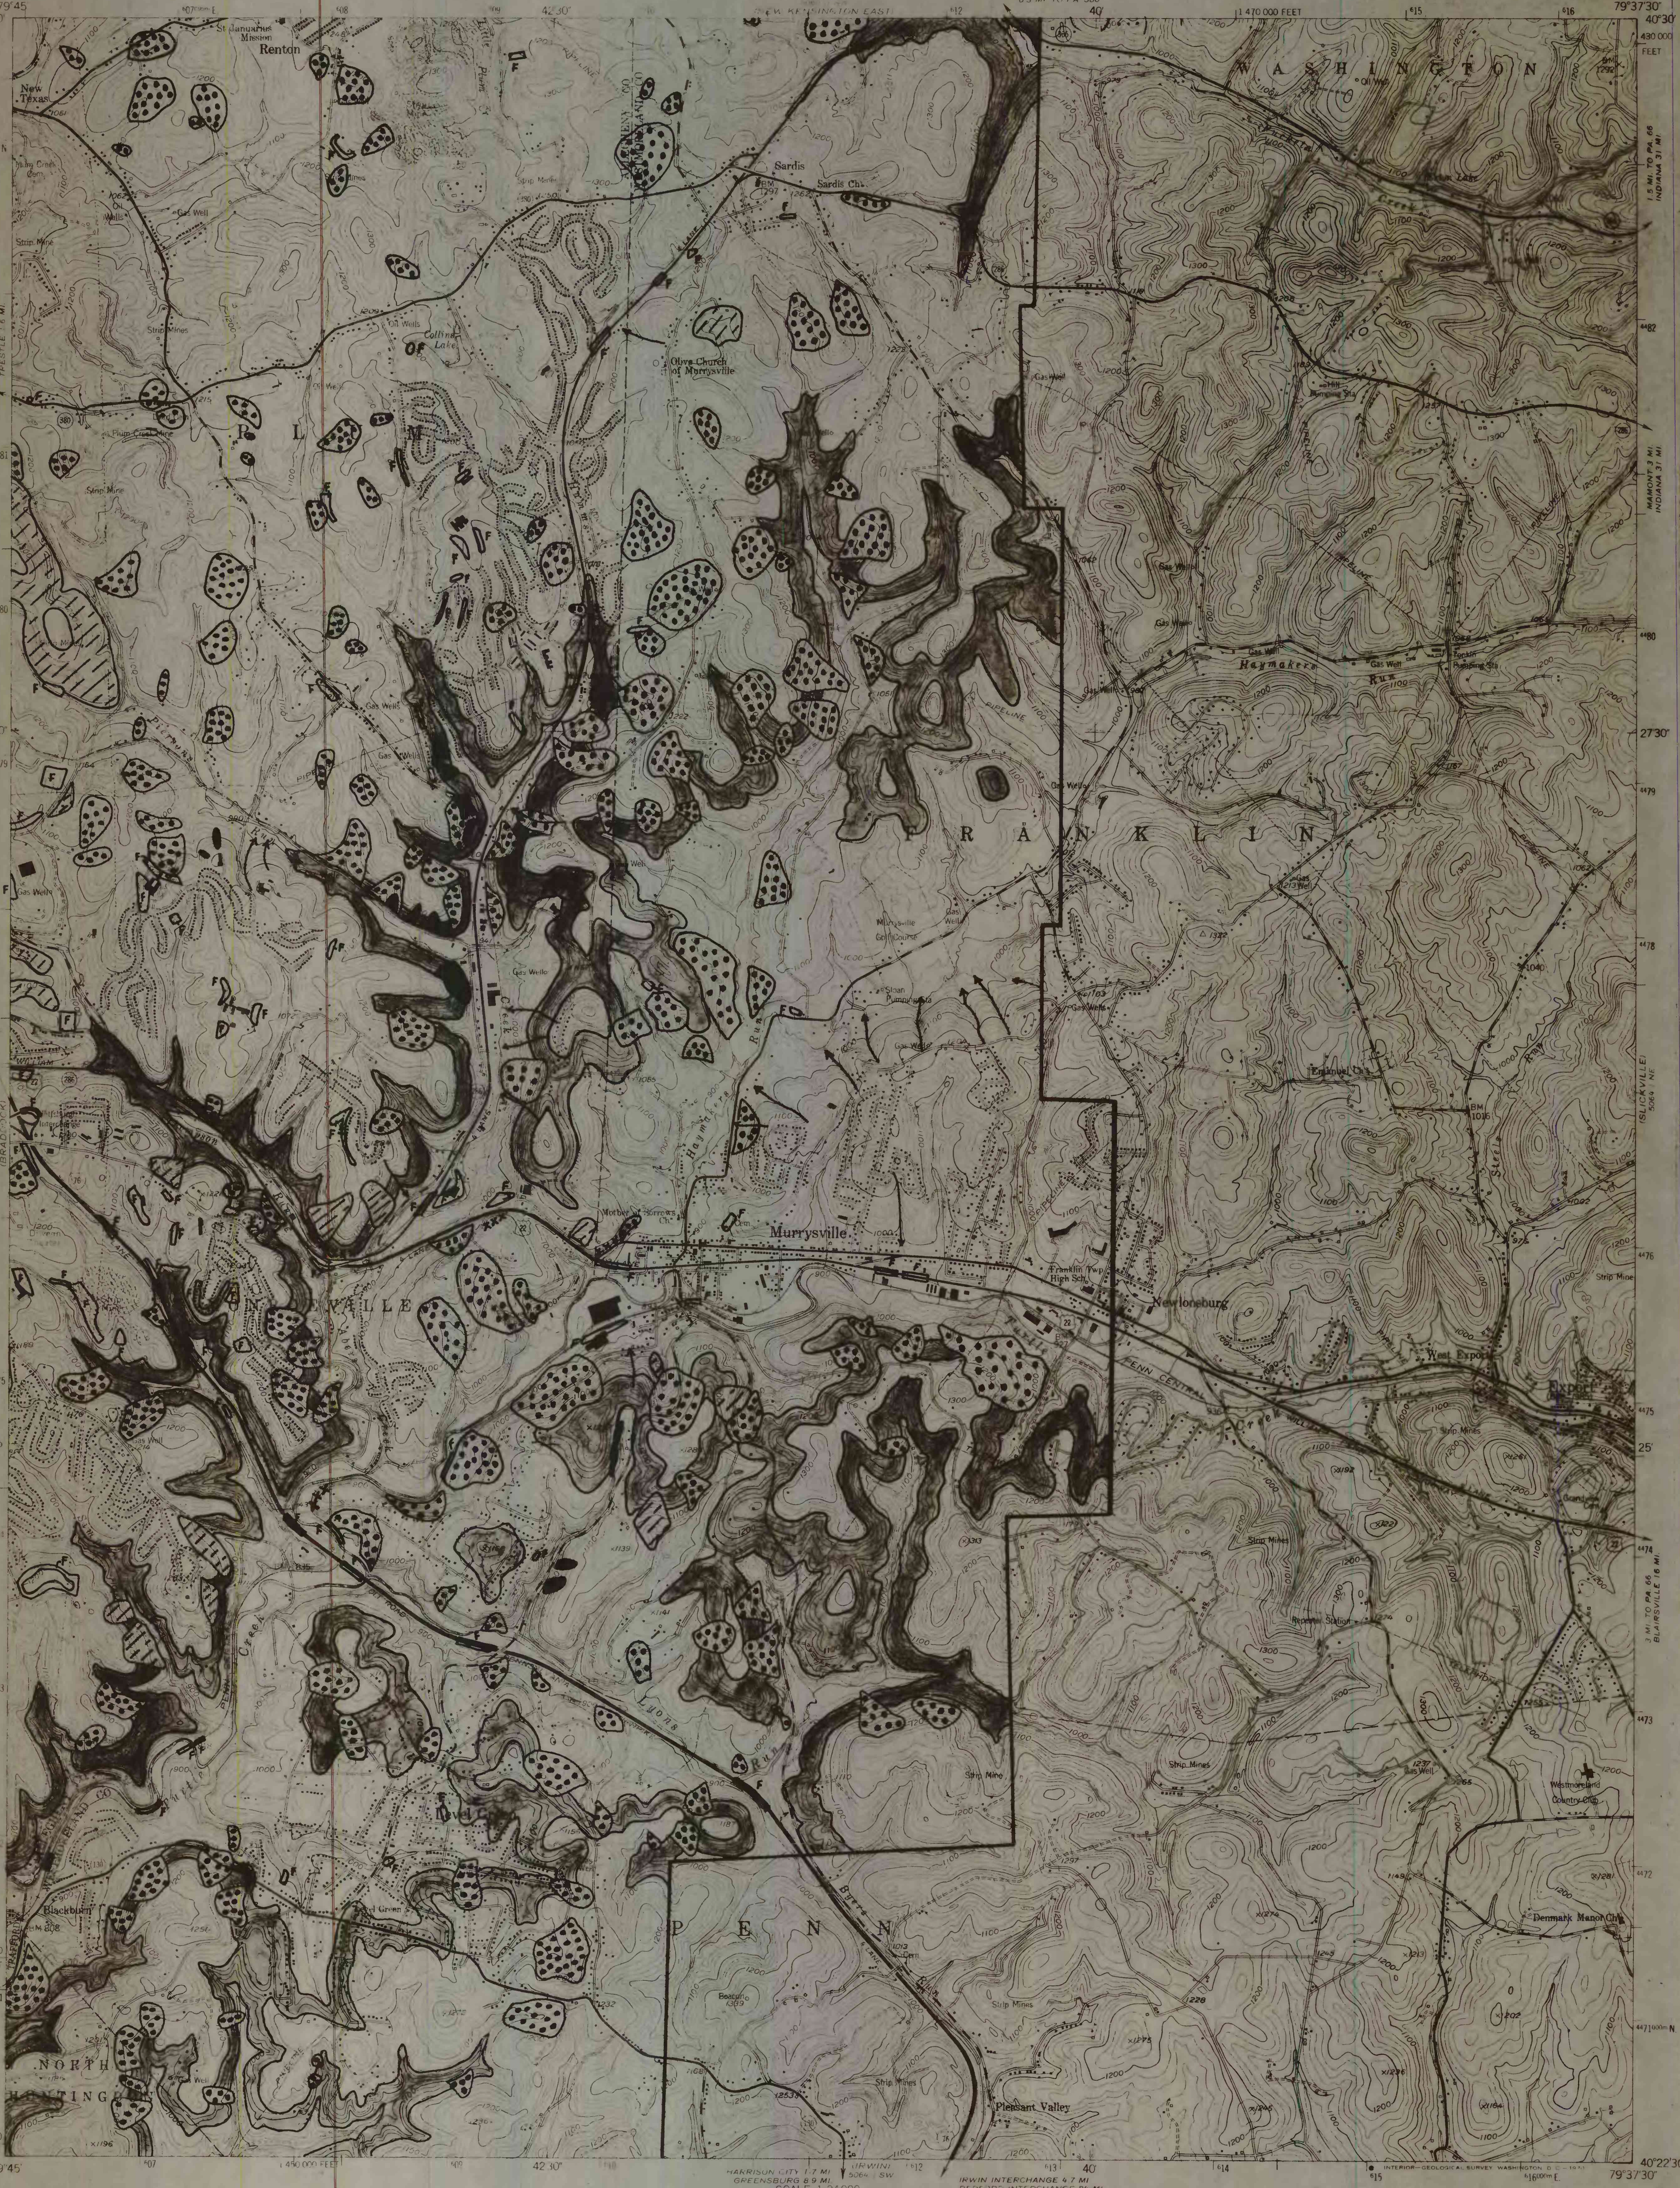
RECENT LANDSLIDES
Dominantly earth slumps
and earth flows, typically
recorded or charac-
terized by fresh scars.
Small landslides enclosed
by triangles.

DEBRIS SLIDES
Slides in steep narrow val-
leys, primarily rock, soil
and vegetation debris.

PREHISTORIC LANDSLIDES
Dominantly earth slumps
and earth flows charac-
terized by hummocky topog-
raphy and slump benches,
relatively stable in natural
state but can be reactiv-
ated by saturation, loading
and changes in ground and
surface water conditions.
Includes some probable re-
cent landslides not covered
by records examined.

**SLOPES WITH CONSPICUOUS
SOIL CREEP**
Clayey soils, generally
less than 5 ft. thick, com-
monly underlain by
weathered shale; charac-
terized by shallow, slow-
but distinct, downslope
movement that can be
greatly accelerated by
overloading from fills or
structures.

**OUTCROP AREA OF
THICK "RED BEDS" AND
ASSOCIATED ROCKS**
Rock weathers rapidly on
exposure; weathered rock
and related soil commonly
result in soil creep and
landslides; cuts and fills
in "red beds" generally
not stable.

RELATIVELY STABLE GROUND
Most slopes have little sus-
ceptibility to landsliding
unless extensively modified
by man; slight soil creep
common on undisturbed
slopes.

**STEEP SLOPES
SUSCEPTIBLE TO ROCKFALL**
Dominantly thick-bedded
sandstone and limestone,
1 to over 10 ft. thick, sub-
ordinate flaggy sandy shale
and interbedded shale;
highly fractured and locally
undercut by weathering of
shale; in steep natural and
cut slopes and cliffs, 15 to
over 150 ft. high.

MAN-MADE FILL
Heterogeneous soil and rock
material; variable suscep-
tibility to slope failure de-
pending on nature of ma-
terials, foundation condi-
tions, design and construc-
tion. Fills in older urban-
ized areas mapped only
where associated with re-
cent landslides. Fills too
small to be shown by let-
ter "F".

Map based on 1973 aerial photographs,
field reconnaissance, 1973-74; soil
surveys by U.S. Dept. Agriculture Soil
Conservation Service, and existing geo-
logic data. This map has not been
edited or reviewed for conformity with
Geological Survey standards and no-
menclature.
