Fig. 13. Location and alignment of trenches and location of wells in Burial Ground 6, as of June 1974 (from Oak Ridge National Laboratory Engineering Drawing No. C-10822-FA-006-D)

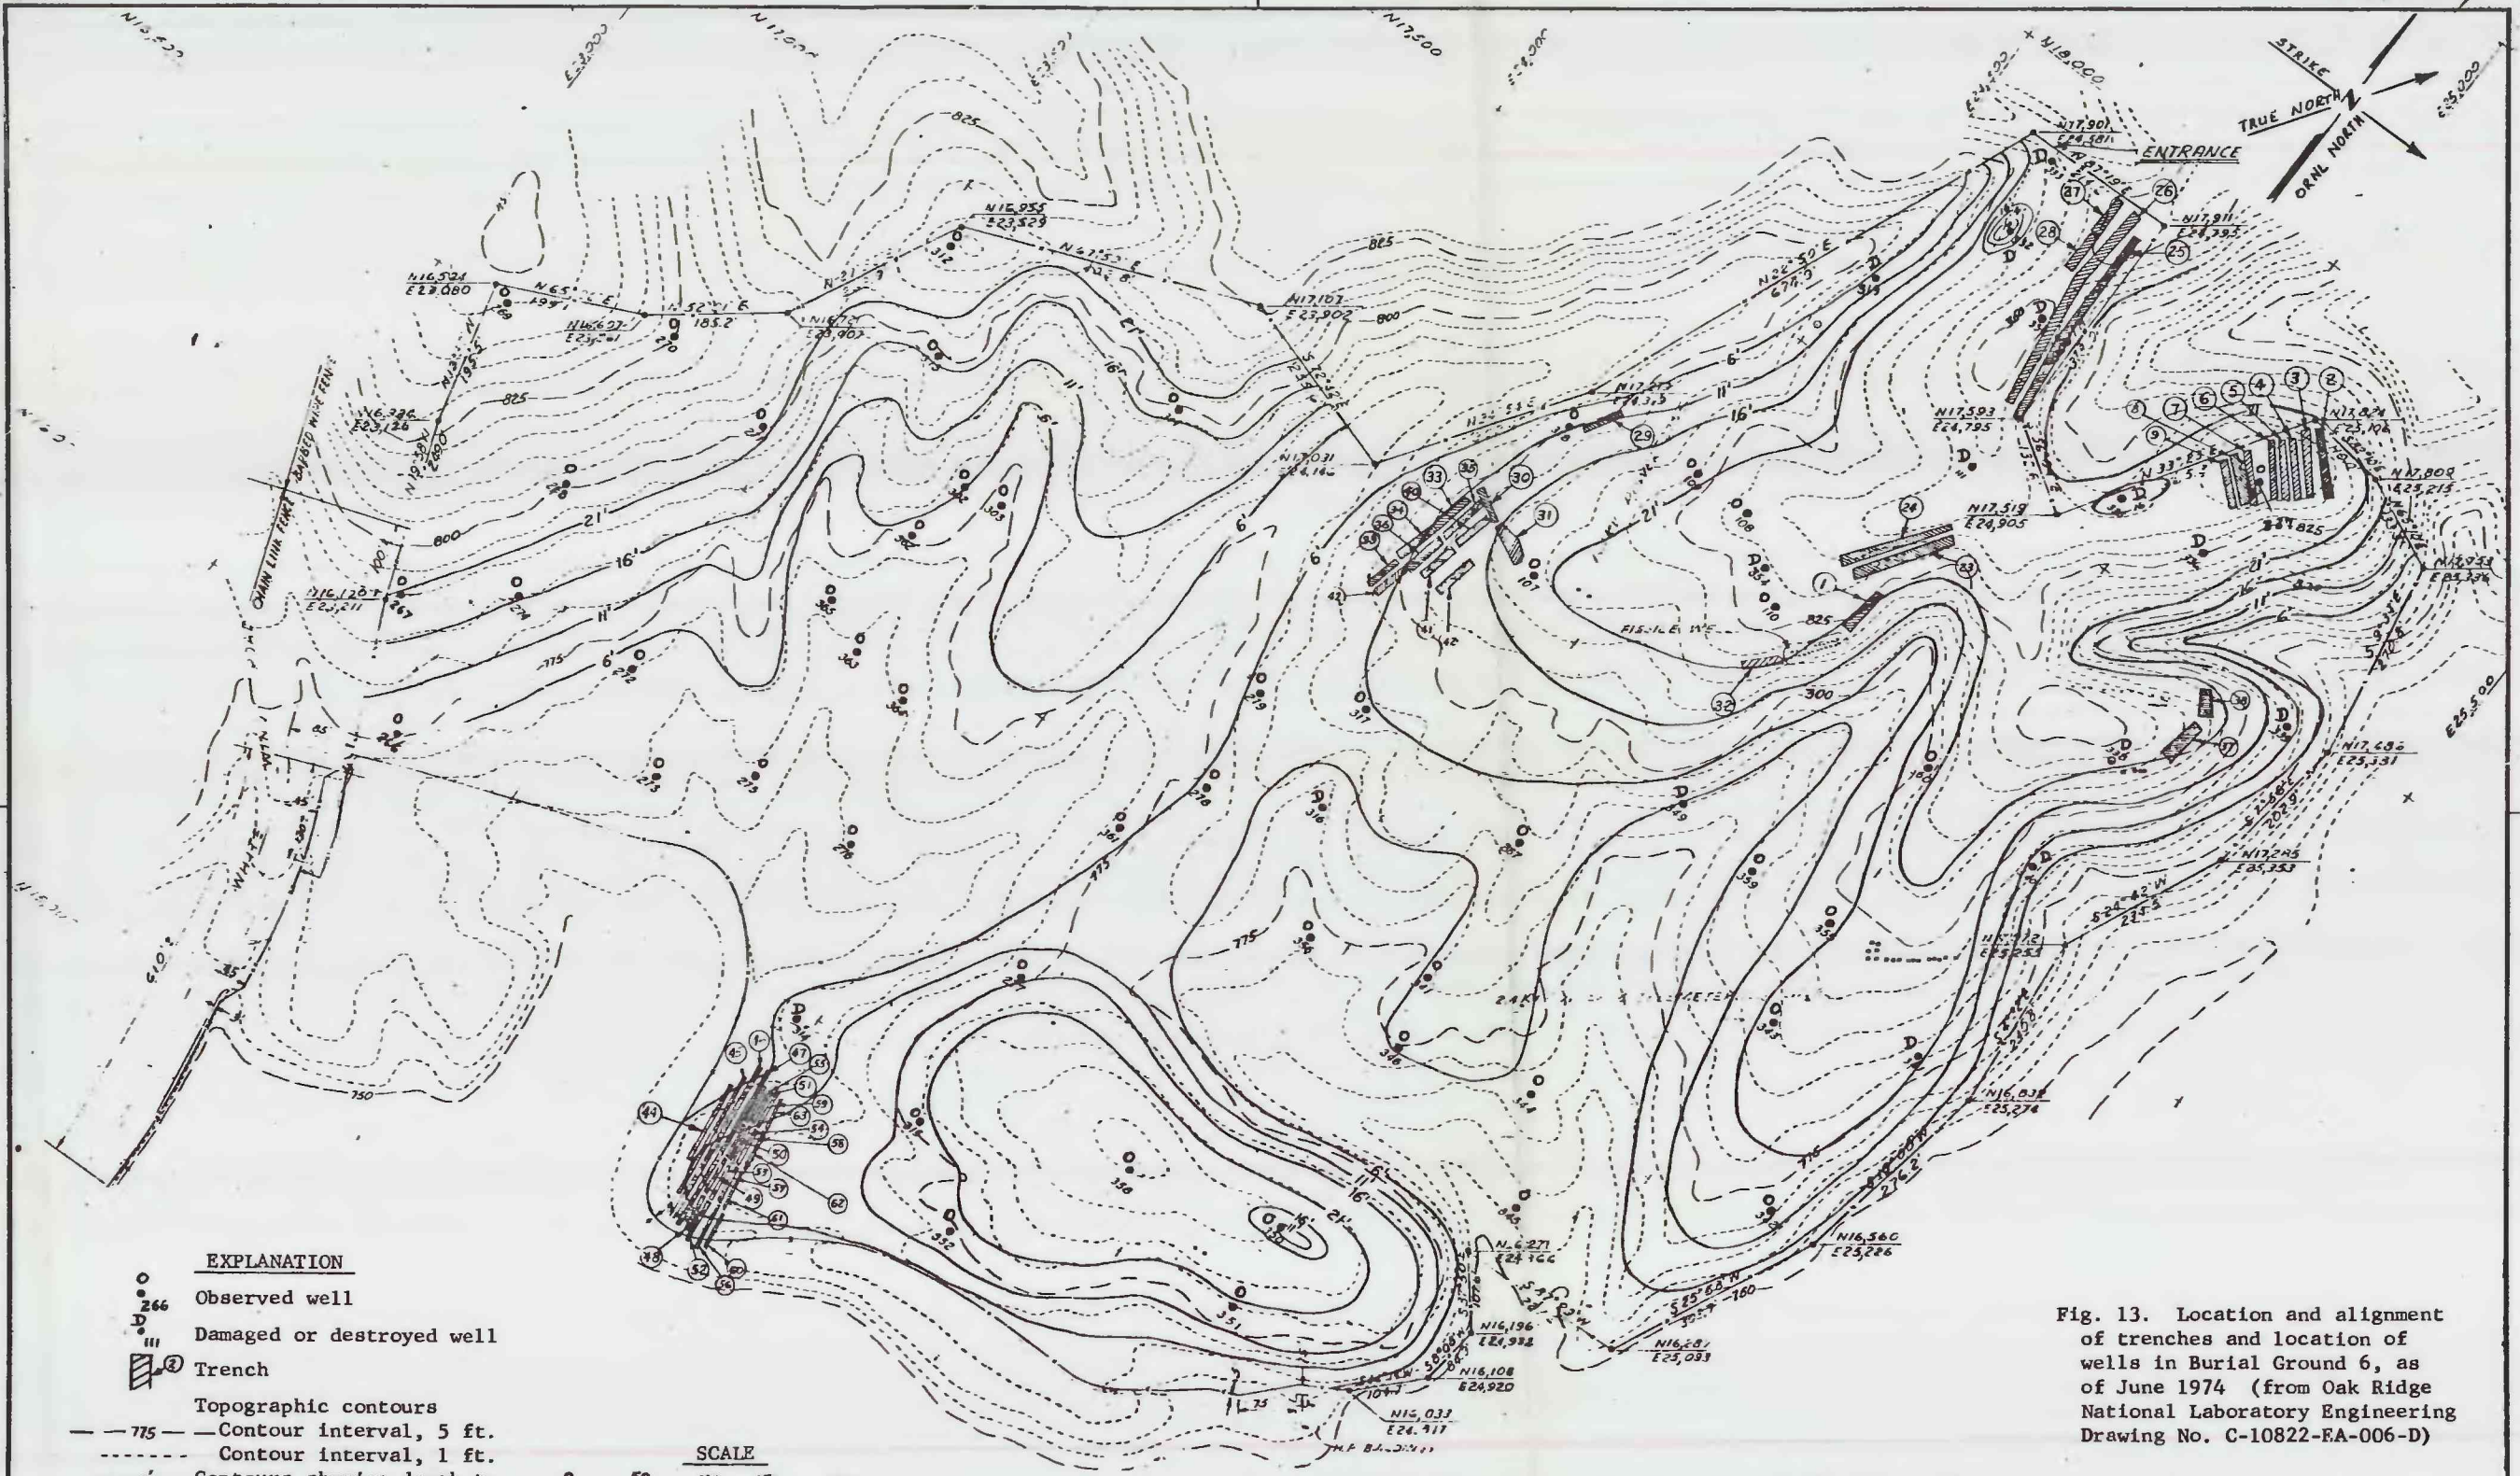
- 266 Observed well
- III Damaged or destroyed well
- ▨ Trench
- Topographic contours
- - - 775 - - - Contour interval, 5 ft.
- - - - - Contour interval, 1 ft.
- - - II - - - Contours showing depth to water, April 22, 1965
