MAP SHOWING DEPTH TO WATER TABLE, SEPTEMBER 1976, AND AREA INUNDATED BY THE JUNE 1975 FLOOD, HELENA VALLEY, LEWIS AND CLARK COUNTY, MONTANA

BY K. R. WILKE AND M. V. JOHNSON
1978

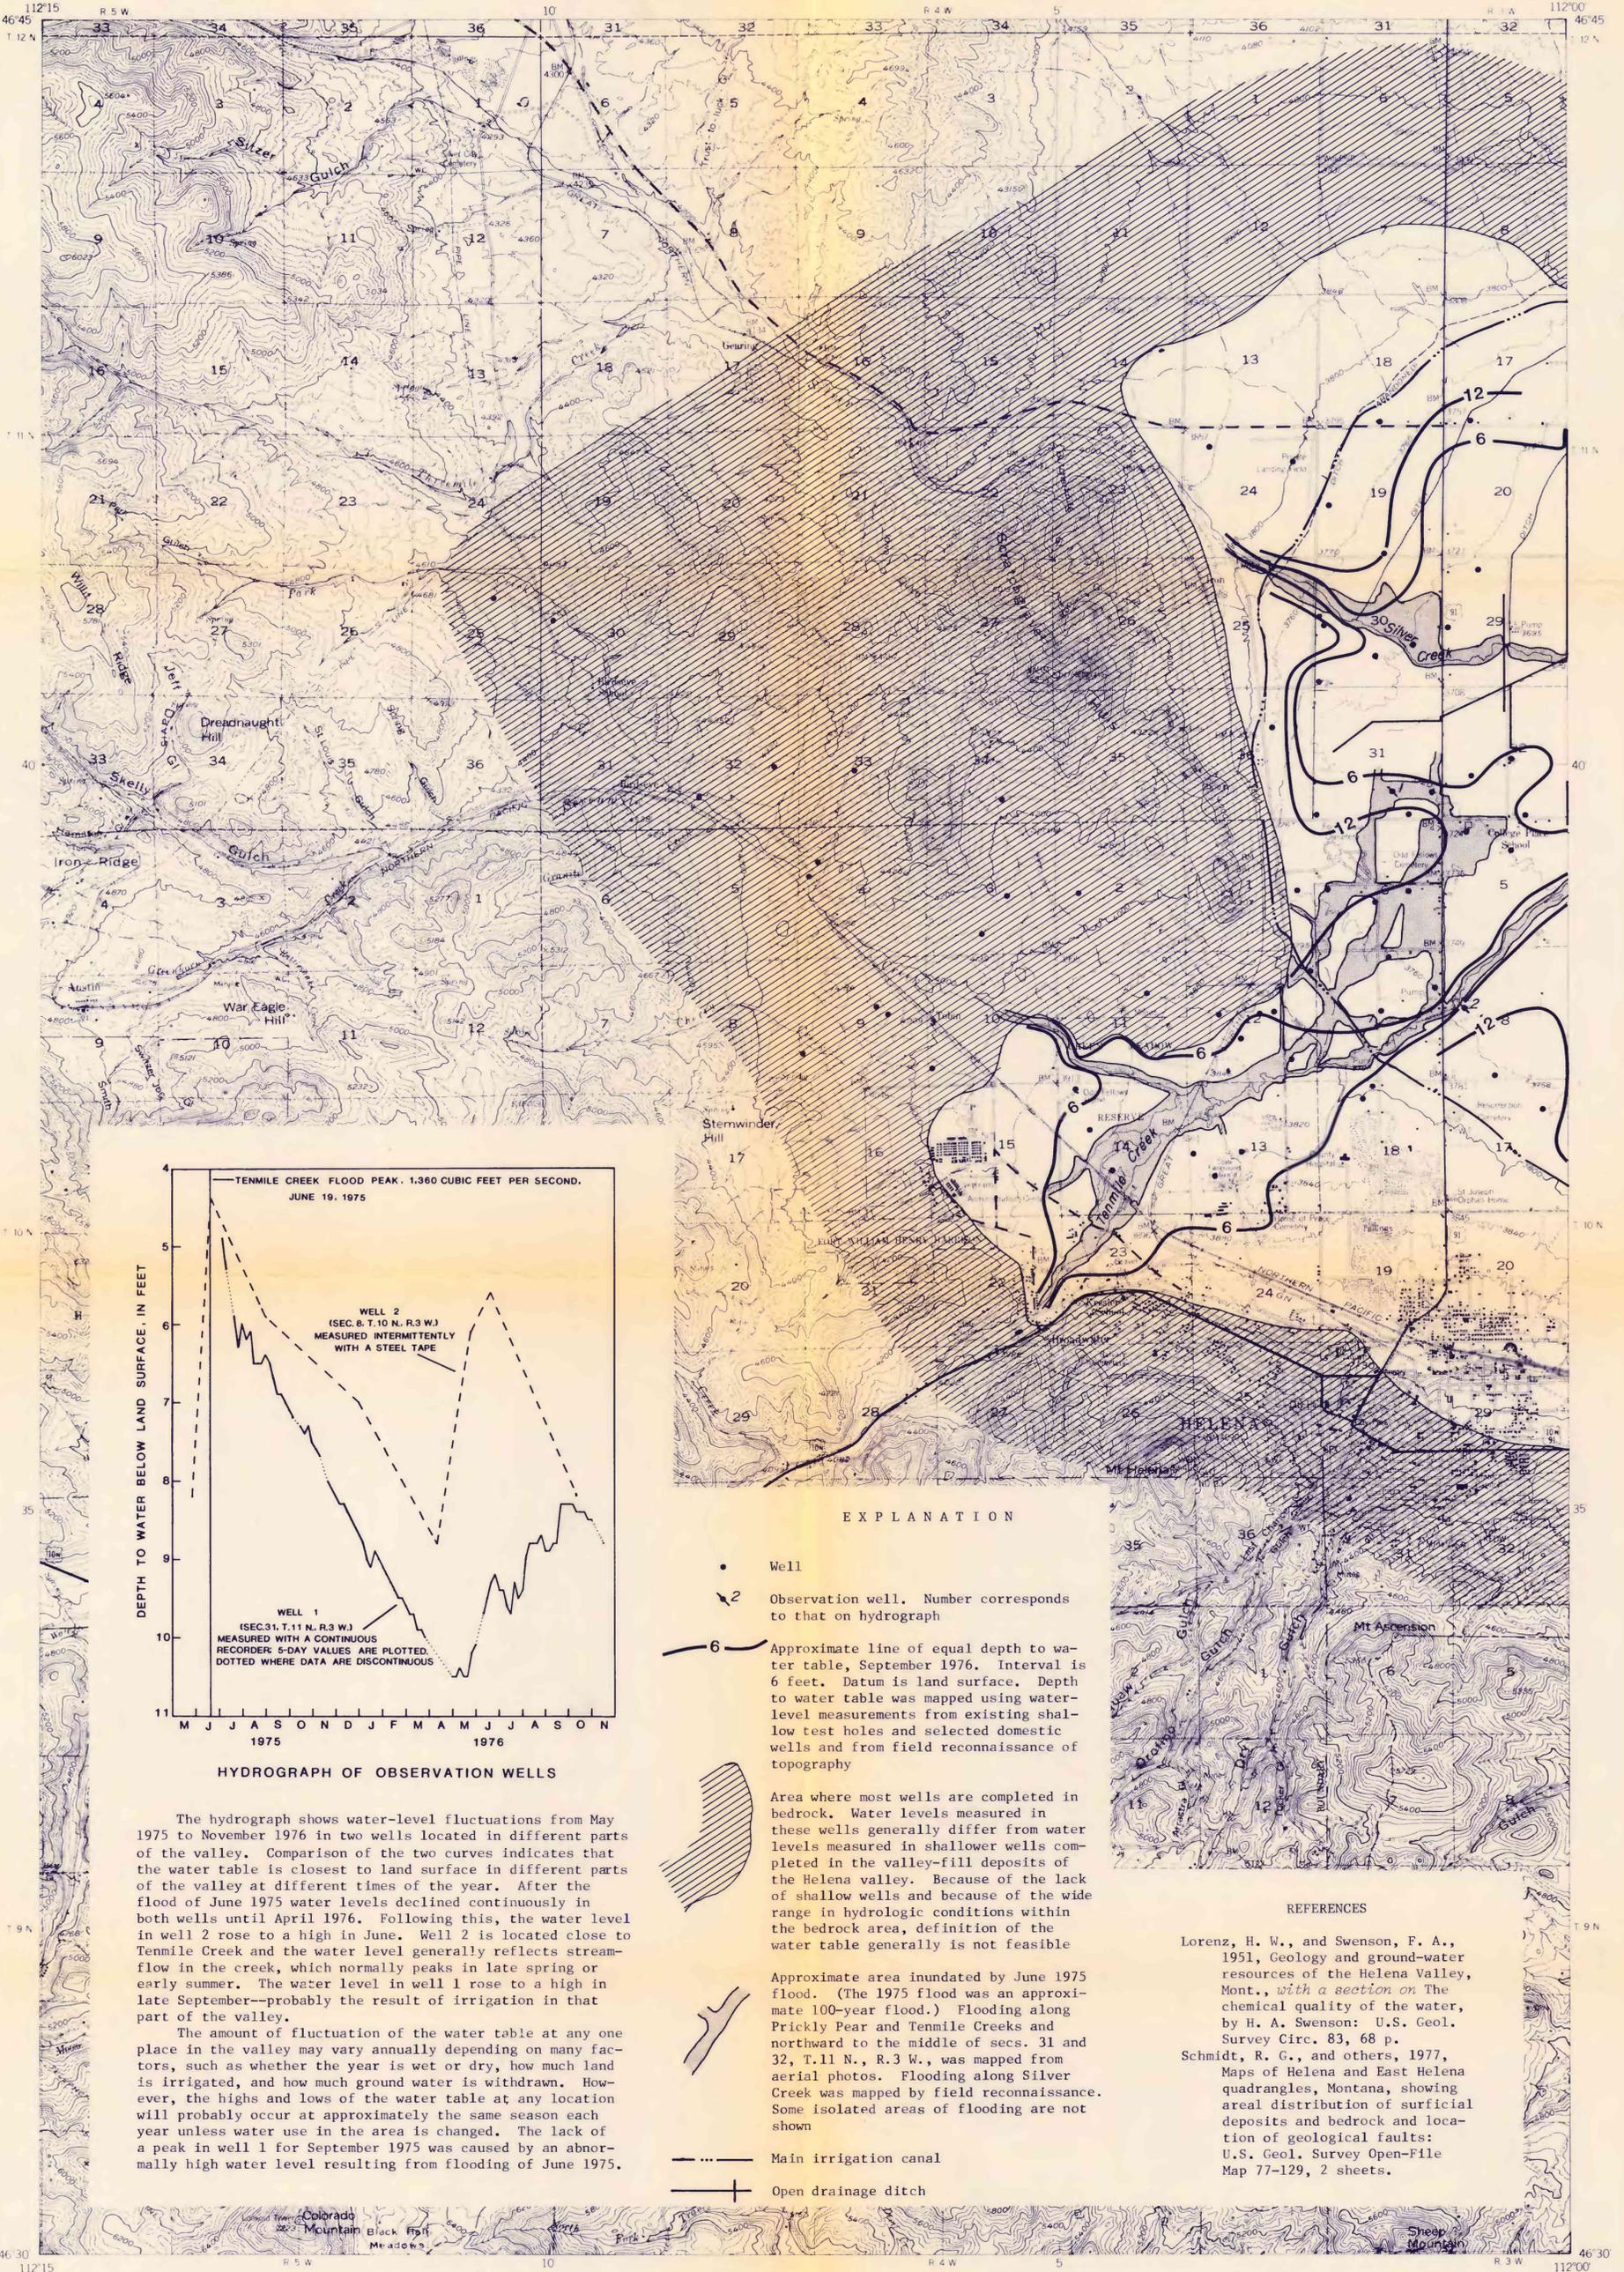
- EXPLANATION
- Well
 - 2 Observation well. Number corresponds to that on hydrograph
 - 6 — Approximate line of equal depth to water table, September 1976. Interval is 6 feet. Datum is land surface. Depth to water table was mapped using water-level measurements from existing shallow test holes and selected domestic wells and from field reconnaissance of topography

- [Hatched Area] Area where most wells are completed in bedrock. Water levels measured in these wells generally differ from water levels measured in shallower wells completed in the valley-fill deposits of the Helena valley. Because of the lack of shallow wells and because of the wide range in hydrologic conditions within the bedrock area, definition of the water table generally is not feasible

- [Shaded Area] Approximate area inundated by June 1975 flood. (The 1975 flood was an approximate 100-year flood.) Flooding along Prickly Pear and Tenmile Creeks and northward to the middle of secs. 31 and 32, T. 11 N., R. 3 W., was mapped from aerial photos. Flooding along Silver Creek was mapped by field reconnaissance. Some isolated areas of flooding are not shown

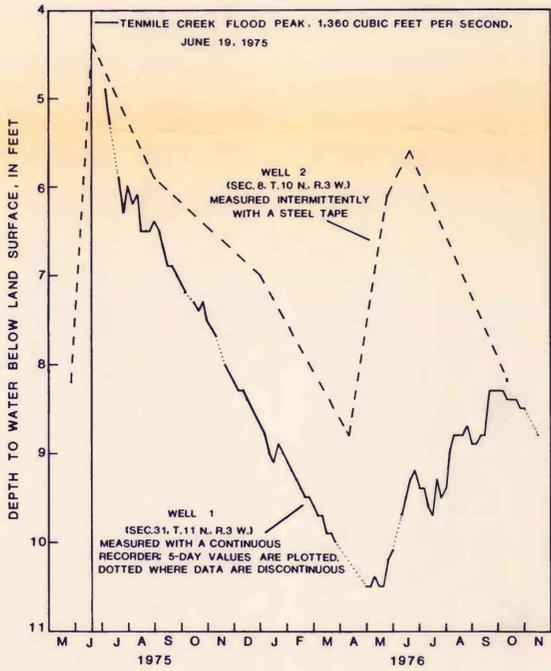
The hydrograph shows water-level fluctuations from May 1975 to November 1976 in two wells located in different parts of the valley. Comparison of the two curves indicates that the water table is closest to land surface in different parts of the valley at different times of the year. After the flood of June 1975 water levels declined continuously in both wells until April 1976. Following this, the water level in well 2 rose to a high in June. Well 2 is located close to Tenmile Creek and the water level generally reflects streamflow in the creek, which normally peaks in late spring or early summer. The water level in well 1 rose to a high in late September—probably the result of irrigation in that part of the valley.

The amount of fluctuation of the water table at any one place in the valley may vary annually depending on many factors, such as whether the year is wet or dry, how much land is irrigated, and how much ground water is withdrawn. However, the highs and lows of the water table at any location will probably occur at approximately the same season each year unless water use in the area is changed. The lack of a peak in well 1 for September 1975 was caused by an abnormally high water level resulting from flooding of June 1975.
