(200)
R290
wo.78-412

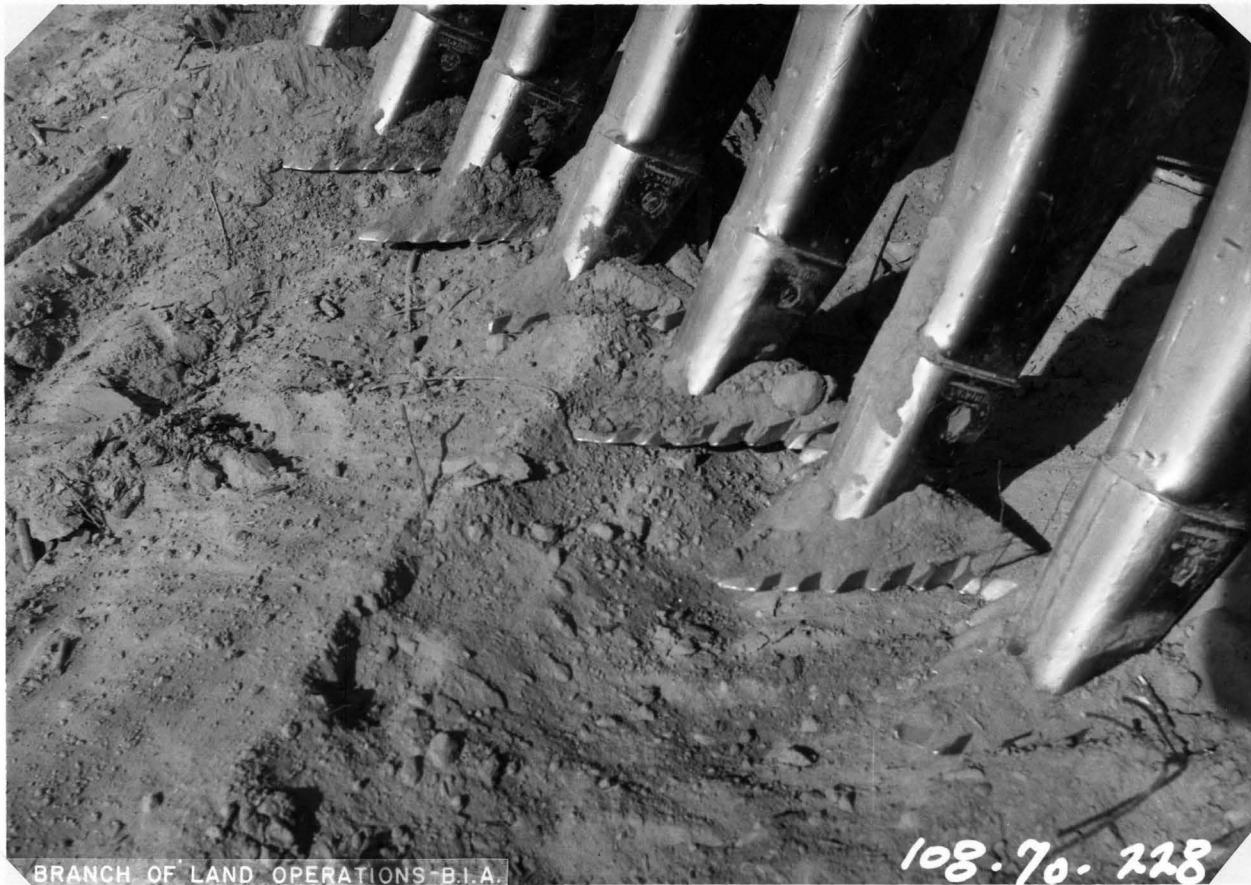
Figure 8.--Brush rake equipped with serrated points for eliminating dense saltcedar seedlings. Photograph furnished by U.S. Bureau of Indian Affairs, San Carlos, Arizona.
