STATE OF OHIO

BETHESDA QUADRANGLE

no.78-1057 Bethesda, OH no. A-8 c.1

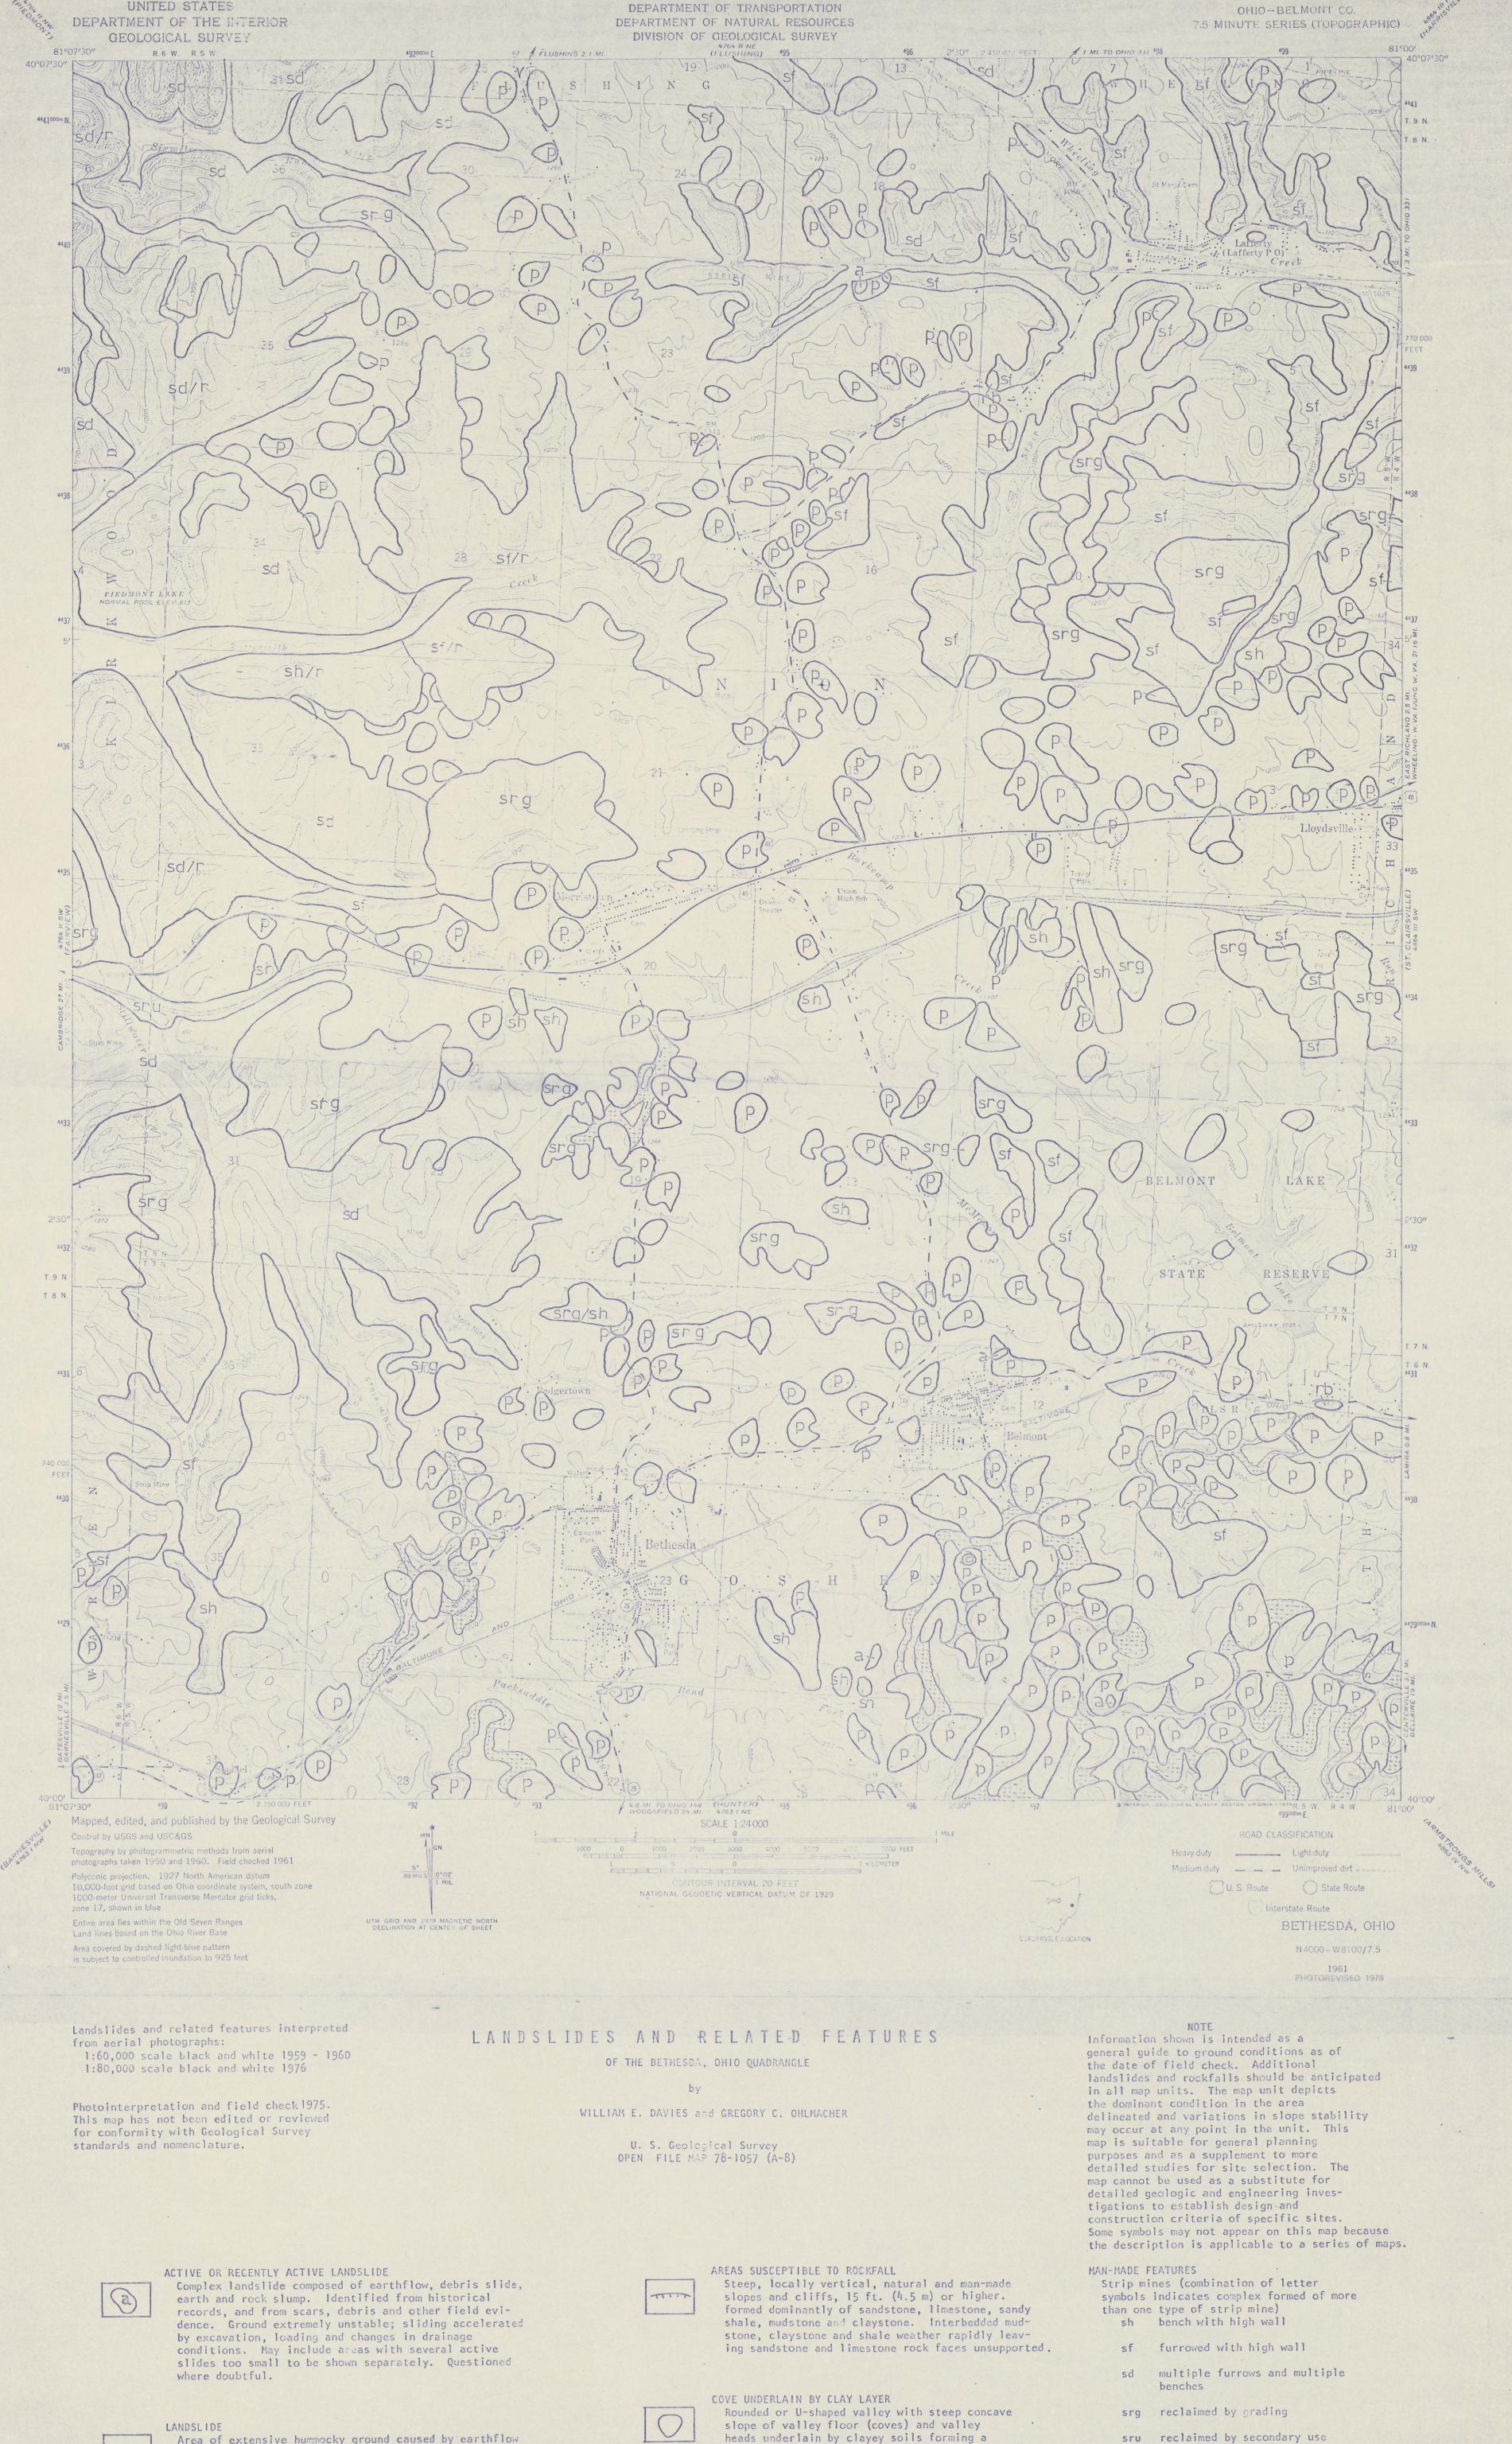
Area of extensive hummocky ground caused by earthflow and earth and rock slump. Lacks clear evidence of active sliding. Relatively stable in natural, undisturbed state, generally not affected by small structures properly sited in areas away from the edge of the toe; can be reactivated by extensive, rapid excavation, loading, and changes in ground water and surface water conditions. Area of old landslide probably includes recent ones not identified from field evidence or otherwide documented. Upslope boundary of landslide generally defined by modified scarp, but downslope (toe) may be gradational and not well defined. Questioned where doubtful.

Valley wall along major streams with slope as steep as 40° (85%); stony, clayey silt soil up to 50 ft. (15 m) thick; commonly buttressed by a terrace or bench at the toe of the slope; very susceptible to sliding by cutting of toe area, removal of terrace or bench, and overloading; landslide commonly activated without apparent cause.

AREAS SUSCEPTIBLE TO DEBRIS FLOWS AND DEBRIS AVALANCHES Primarily shallow, narrow ravines and chutes with accumulation of stony colluvium generally 10 ft. (3 m) or less in thickness; susceptible to rapid movement during intense rainfall. Most ravines designated show evidence of former debris flows and avalanches. Symbol - designates historical debris flow or debris avalanche.

coherent layer generally 8 ft. (2.5 m) or less in thickness. Zone of water commonly at the base of the clay layer is under 2 to 8 ft. (0.6 -2.5 m) artesian head. Clay soil is underlain by claystone and shale. Clay slab moves as a coherent mass up to 1 ft. (0.3 m) per year; very susceptible to more rapid sliding when overloaded by fill or structure and by excavations that break the continuity of slope. Recent soil slips (earth flows) as much as 40,000 square feet (3,700 square meters) in size are common.

SOIL AND ROCK SUSCEPTIBLE TO LANDSLIDING Soil and rock similar to that involved in landslides elsewhere in map area; primarily areas underlain by claystone, mudstone and shale associated with other rock types. Rock weathers rapidly on exposure forming clayey soil highly susceptible to sliding.

AREAS LEAST PRONE TO LANDSLIDES Map areas in which no patterns or symbols are shown; primarily valley floors, ridge tops and
