LANDSLIDES AND RELATED FEATURES

OF THE ST. CLAIRSVILLE, OHIO QUADRANGLE

U. S. Geological Survey
OPEN FILE MAP 78-1057 (A-9)

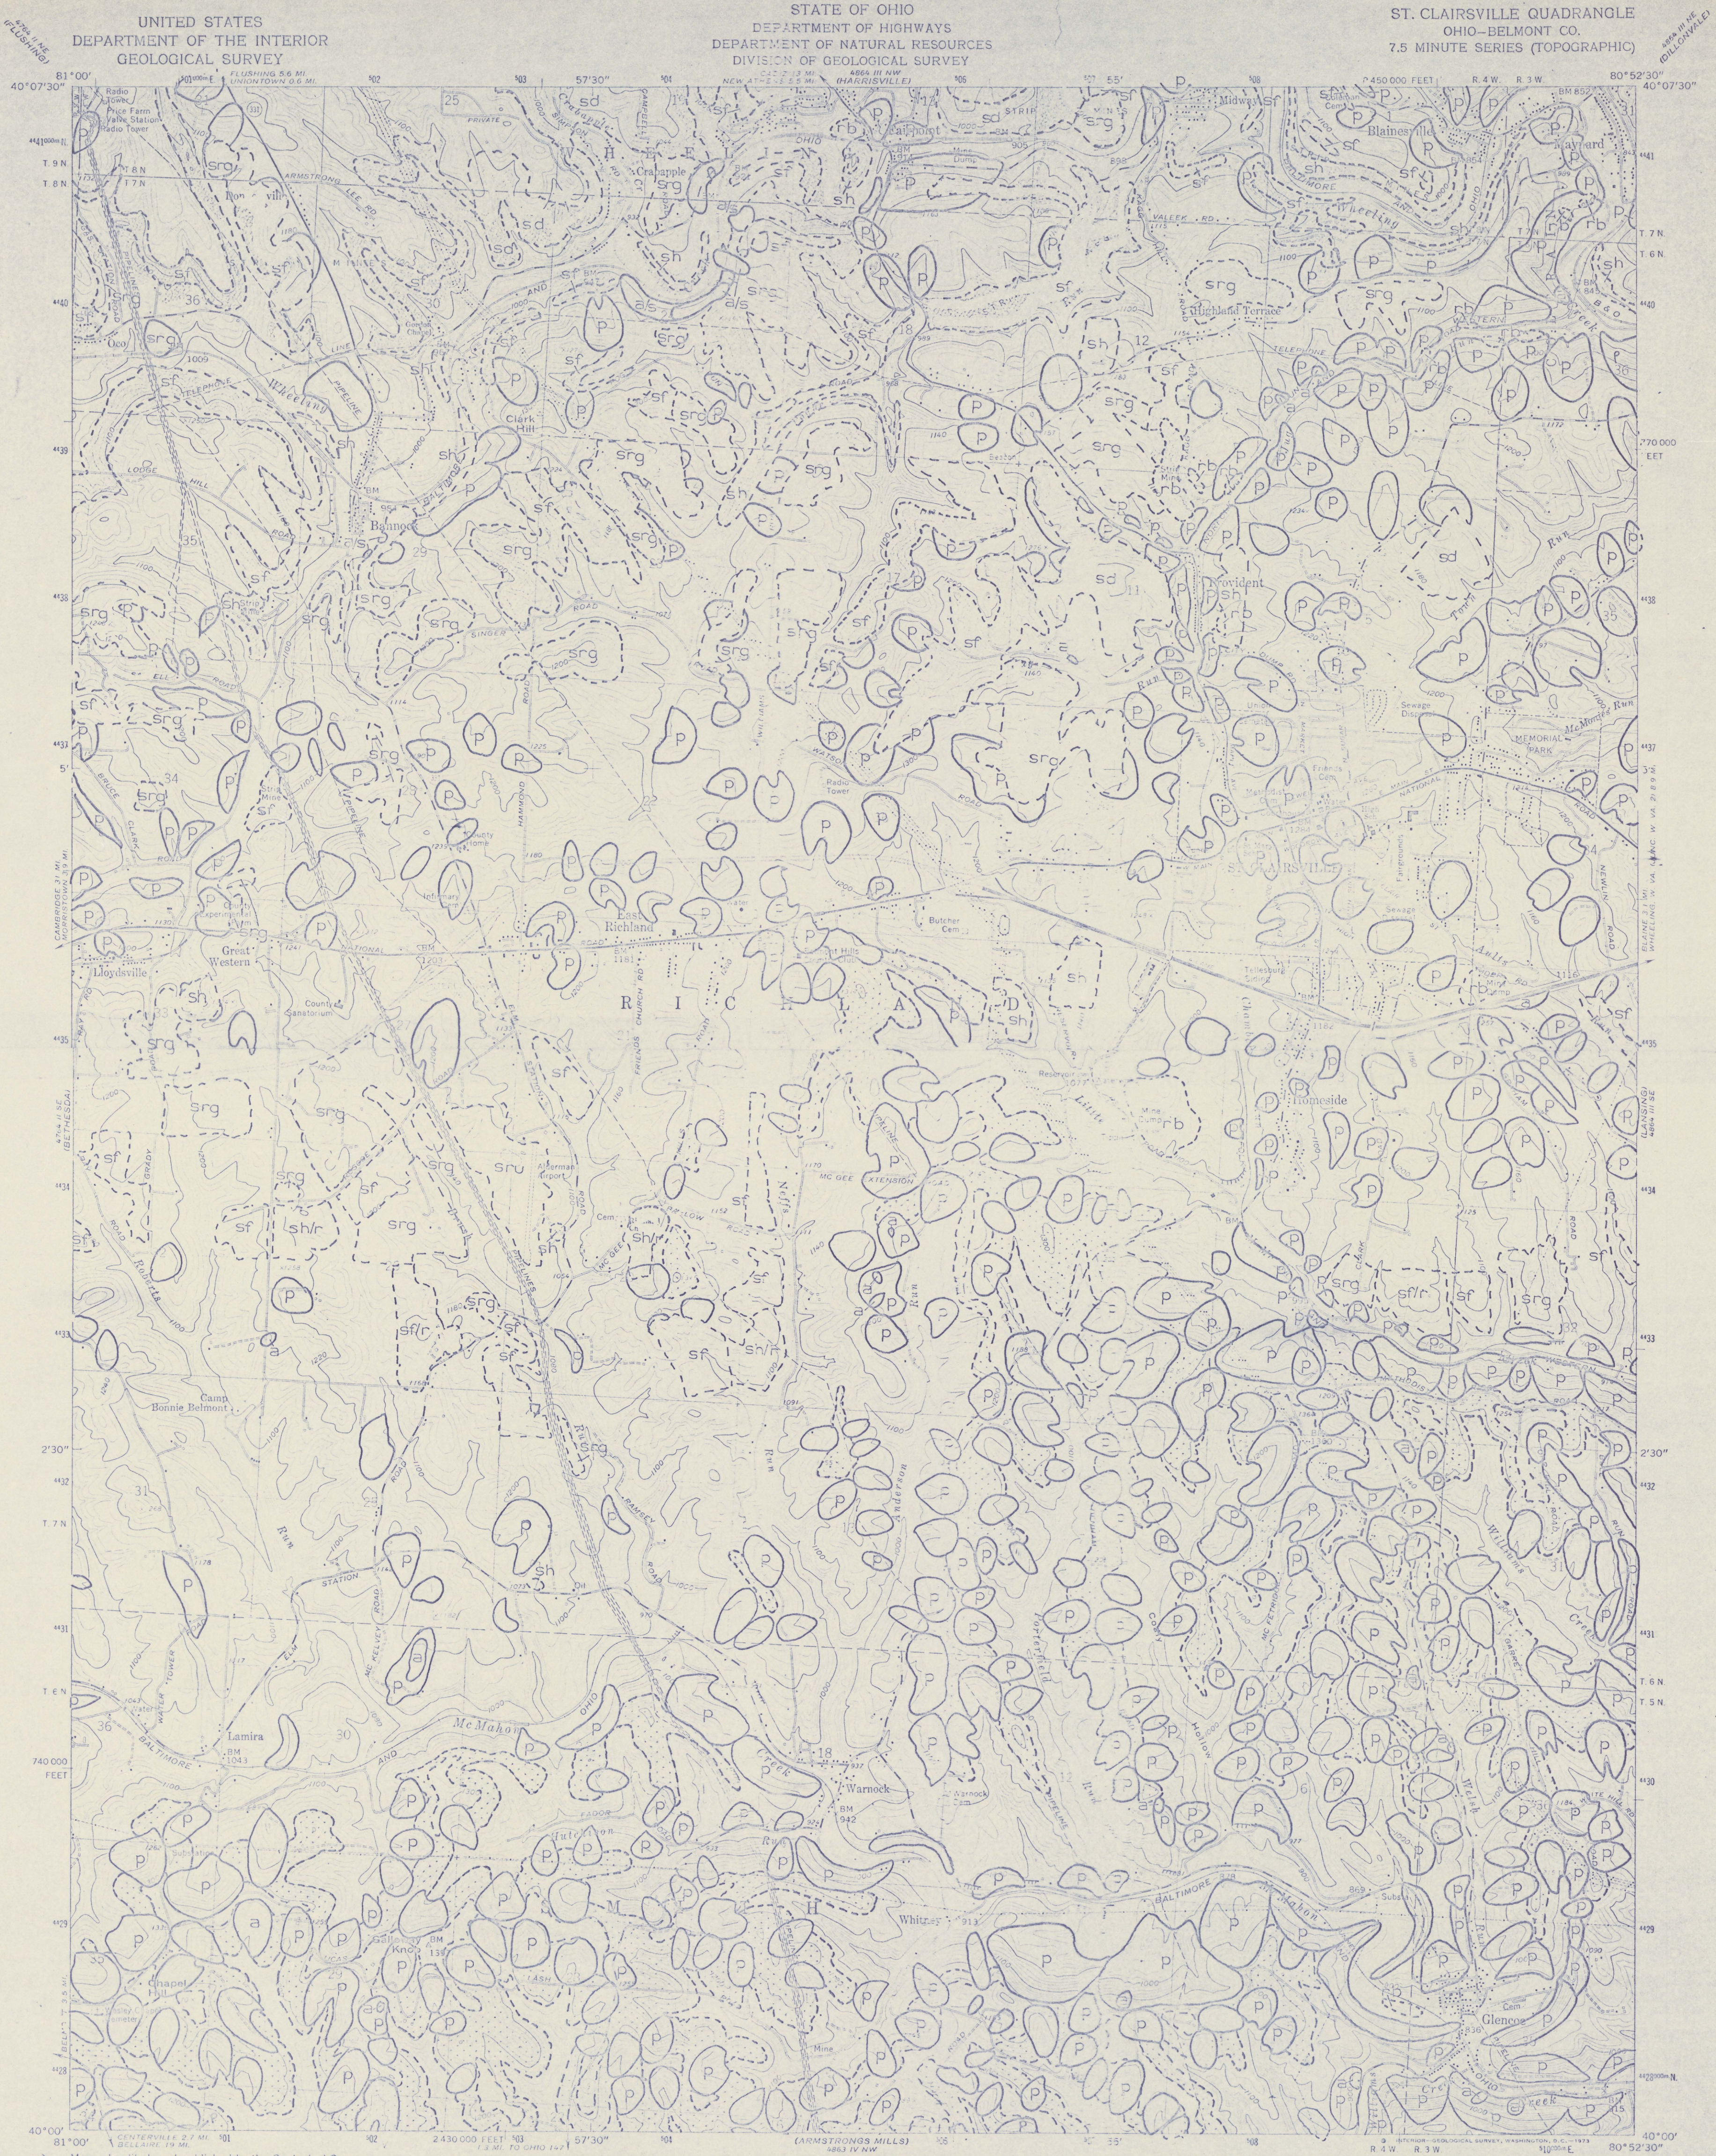
Landslides and related features interpreted
from aerial photographs:
1:60,000 scale black and white 1959 - 1960
1:80,000 scale black and white 1976

Photointerpretation and field check 1975.
This map has not been edited or reviewed
for conformity with Geological Survey
standards and nomenclature.

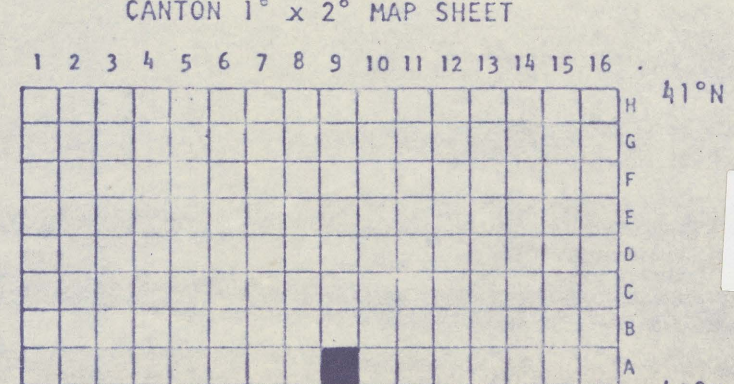
The first five digits of the open file number designate the
specific 1:250,000 scale map sheet of which this quadrangle
is a part. The last two digits designate the position of the
quadrangle in a subdivision of the 1:250,000 scale map based
on rows and tiers shown in the diagram to the right. The
location of this quadrangle is shown by the black square.
