BALTIC, OHIO
NW 4 NEWCOMERTOWN 15 QUADRANGLE
N4022 5—W8137 5/7 5

LANDSLIDES AND RELATED FEATURES

OF THE BALTIC, OHIO QUADRANGLE
by
WILLIAM E. DAVIES and GREGORY C. OHLMACHER
1978
U. S. Geological Survey
OPEN FILE MAP 78-1057 (D-3)

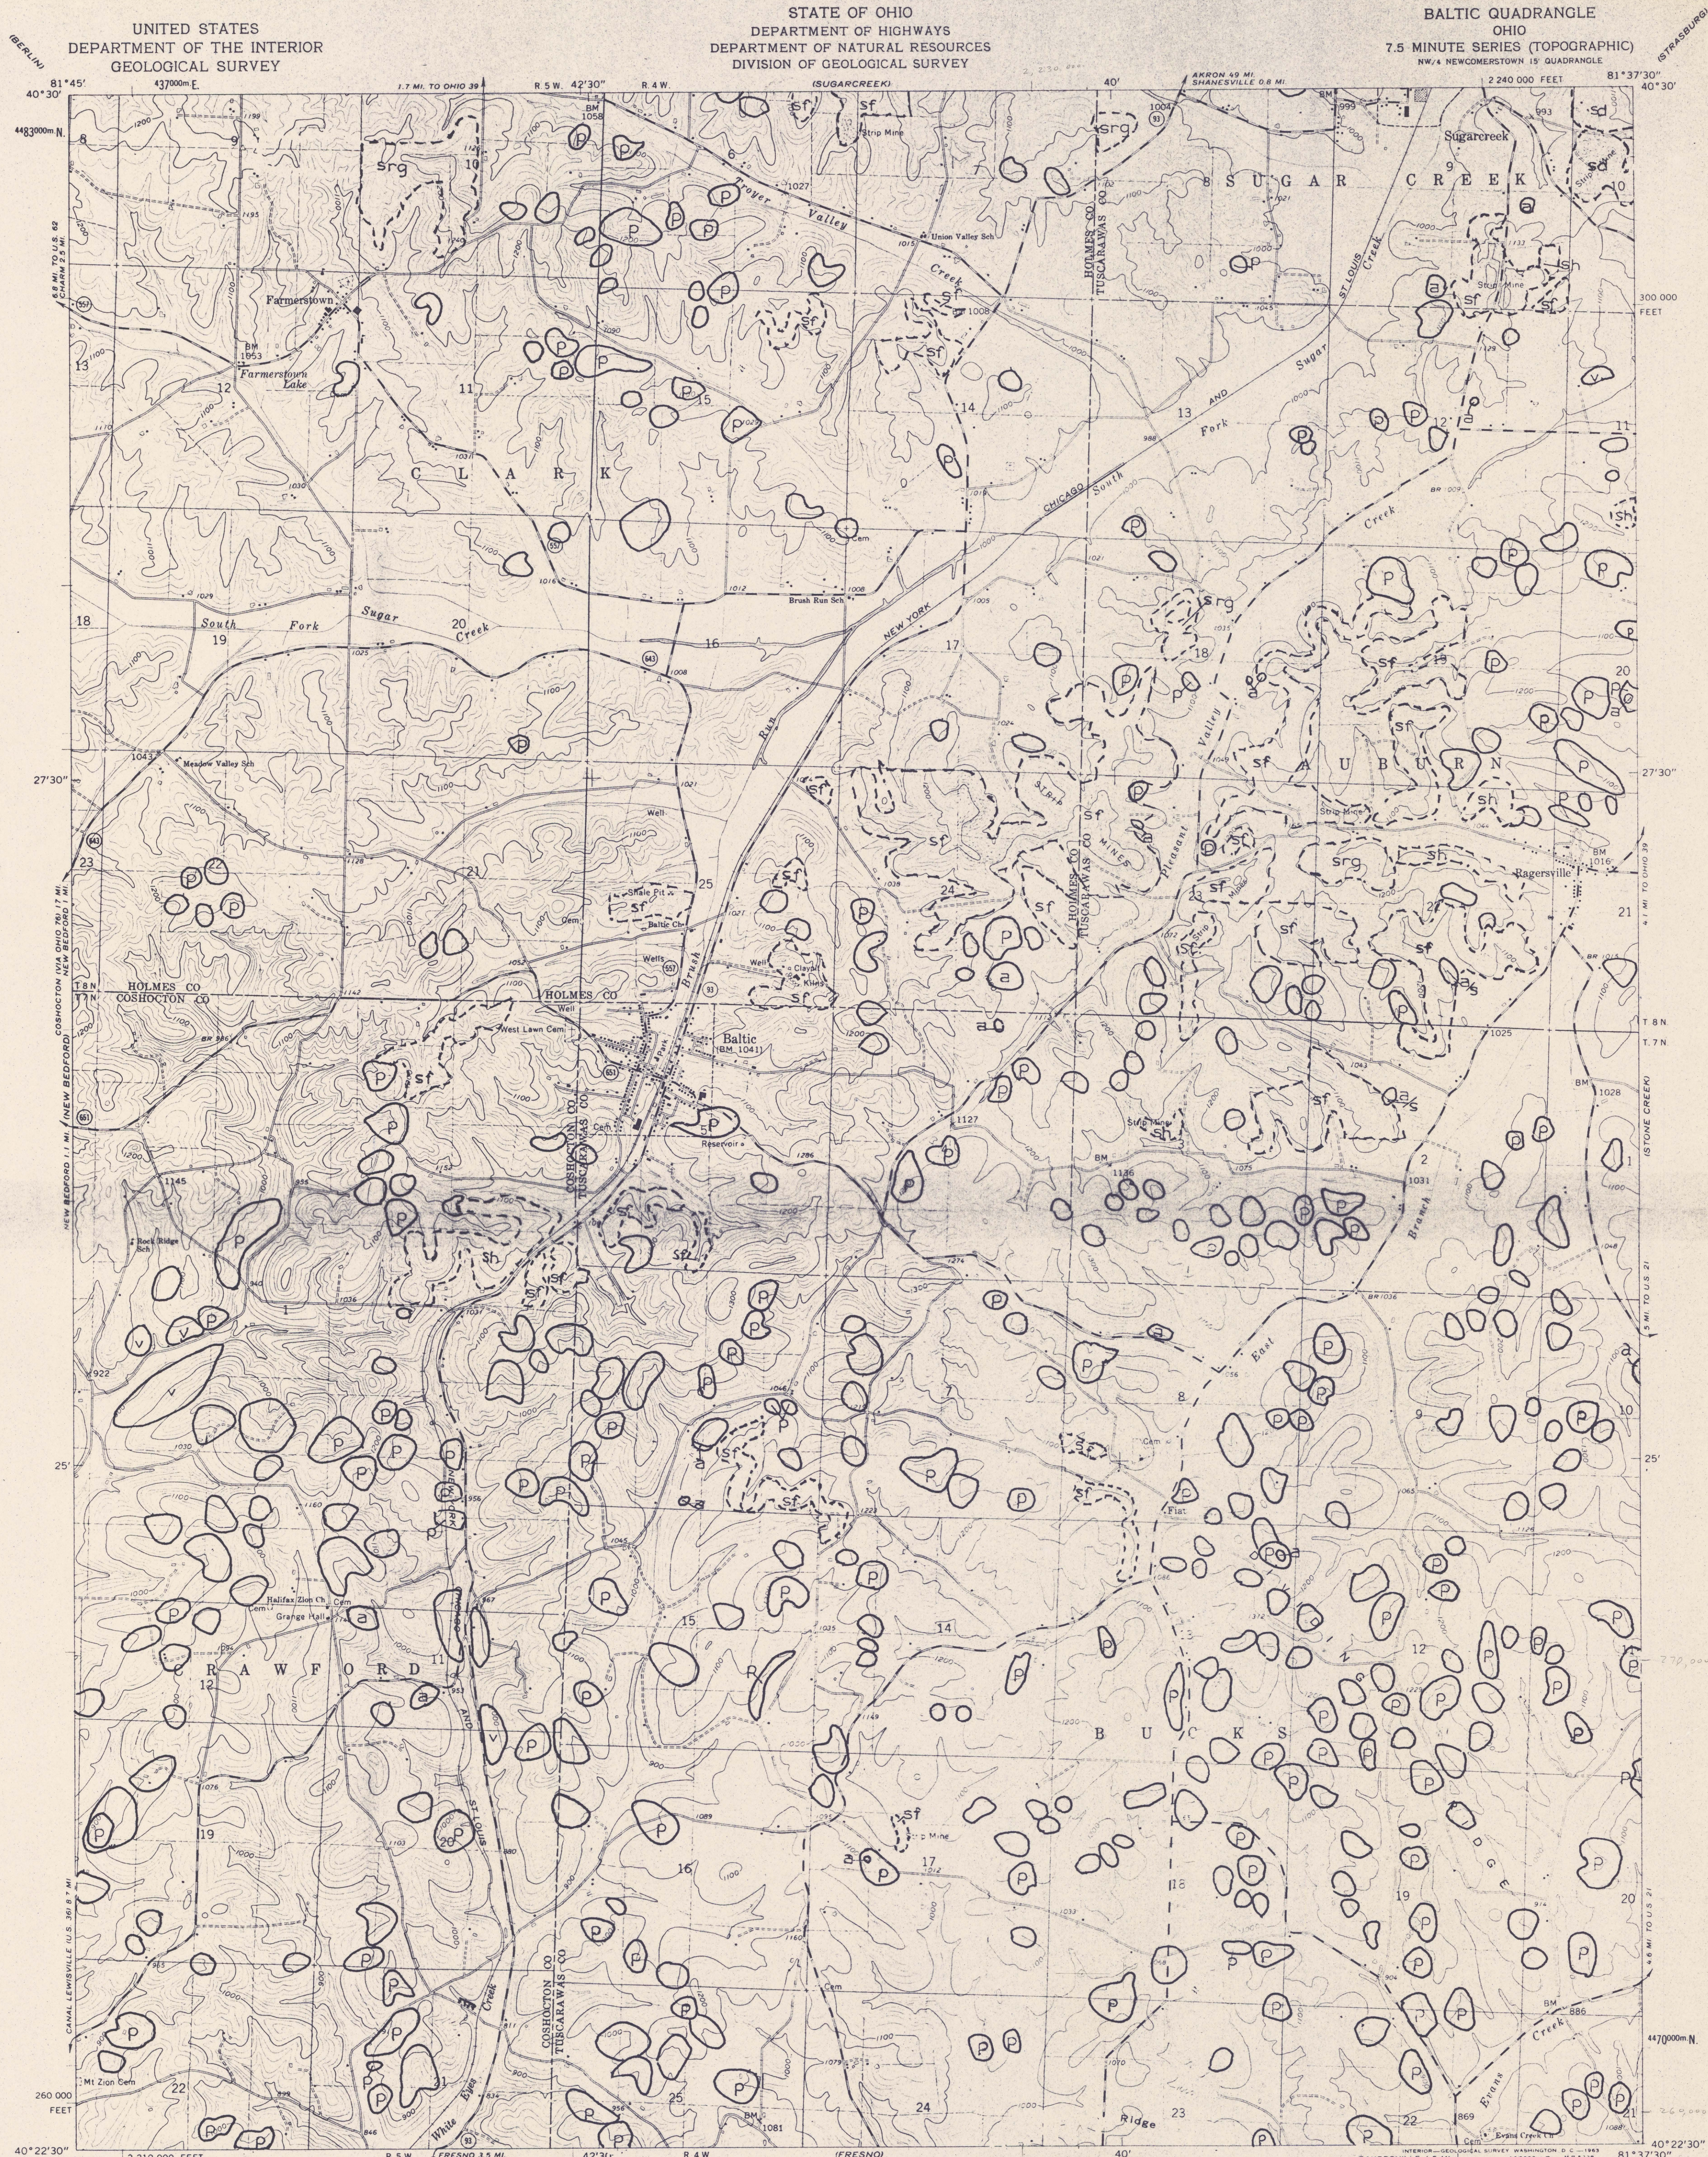
Landslides and related features interpreted from aerial photographs:
1:40,000 scale black and white 1973
1:60,000 scale black and white 1959
1:80,000 scale black and white 1976
Photointerpretation and field check 1976.
This map has not been edited or reviewed for conformity with Geological Survey standards and nomenclature.

NOTE
Information shown is intended as a general guide to ground conditions as of the date of field check. Additional landslides and rockfalls should be anticipated in all map units. The map unit depicts the dominant condition in the area delineated and variations in slope stability may occur at any point in the unit. This map is suitable for general planning purposes and as a supplement to more detailed studies for site selection. The map cannot be used as a substitute for detailed geologic and engineering investigations to establish design and construction criteria of specific sites. Some symbols may not appear on this map because the description is applicable to a series of maps.

- ACTIVE OR RECENTLY ACTIVE LANDSLIDE**
Complex landslide composed of earthflow, debris slide, earth and rock slump. Identified from historical records, and from scars, debris and other field evidence. Ground extremely unstable; sliding accelerated by excavation, loading and changes in drainage conditions. May include areas with several active slides too small to be shown separately. Questioned where doubtful.

- LANDSLIDE**
Area of extensive hummocky ground caused by earthflow and earth and rock slump. Lacks clear evidence of active sliding. Relatively stable in natural, undisturbed state, generally not affected by small structures properly sited in areas away from the edge of the toe; can be reactivated by extensive, rapid excavation, loading, and changes in ground water and surface water conditions. Area of old landslide probably includes recent ones not identified from field evidence or otherwise documented. Upslope boundary of landslide generally defined by modified scarp, but downslope (toe) may be gradational and not well defined. Questioned where doubtful.

- COLLUVIAL SLOPE**
Valley wall along major streams with slope as steep as 40° (85%); stony, clayey silt soil up to 50 ft. (15 m) thick; commonly buttressed by a terrace or bench at the toe of the slope; very susceptible to sliding by cutting of toe area, removal of terrace or bench, and overloading; landslide commonly activated without apparent cause.

- AREAS SUSCEPTIBLE TO DEBRIS FLOWS AND DEBRIS AVALANCHES**
Primarily shallow, narrow ravines and chutes with accumulation of stony colluvium generally 10 ft. (3 m) or less in thickness; susceptible to rapid movement during intense rainfall. Most ravines designated show evidence of former debris flows and avalanches. Symbol - - designates historical debris flow or debris avalanche.

- AREAS SUSCEPTIBLE TO ROCKFALL**
Steep, locally vertical, natural and man-made slopes and cliffs, 15 ft. (4.5 m) or higher. Formed dominantly of sandstone, limestone, sandy shale, mudstone and claystone. Interbedded mudstone, claystone and shale weather rapidly leaving sandstone and limestone rock faces unsupported.

- COVE UNDERLAIN BY CLAY LAYER**
Rounded or U-shaped valley with steep concave slope of valley floor (coves) and valley heads underlain by clayey soils forming a coherent layer generally 8 ft. (2.5 m) or less in thickness. Zone of water commonly at the base of the clay layer is under 2 to 8 ft. (0.6 - 2.5 m) artesian head. Clay soil is underlain by claystone and shale. Clay slab moves as a coherent mass up to 1 ft. (0.3 m) per year; very susceptible to more rapid sliding when overloaded by fill or structure and by excavations that break the continuity of slope. Recent soil slips (earth flows) as much as 40,000 square feet (3,700 square meters) in size are common.

- SOIL AND ROCK SUSCEPTIBLE TO LANDSLIDING**
Soil and rock similar to that involved in landslides elsewhere in map area; primarily areas underlain by claystone, mudstone and shale associated with other rock types. Rock weathers rapidly on exposure forming clayey soil highly susceptible to sliding.

- AREAS LEAST PRONE TO LANDSLIDES**
Map areas in which no patterns or symbols are shown; primarily valley floors, ridge tops and broad benches; modification by excavation and fill may lead to local landslides.

- MAN-MADE FEATURES**
Strip mines (combination of letter symbols indicates complex formed of more than one type of strip mine)
sh bench with high wall
sf furrowed with high wall
sd multiple furrows and multiple benches
srg reclaimed by grading
sru reclaimed by secondary use
sh/r regraded in part, high wall remains
Coal refuse banks
r identified on aerial photographs; not classified in field check
rb not burnt nor on fire
rbu burnt
rbd burning
rbs sludge
Quarries
q quarry site
qub spoil bank, quarry waste
Gravel pits
g site of gravel pit
Slides in man-made features
a/f earth flow in fill
a/s earth flow in strip castings
a/r earth flow in coal refuse
