STANDARDVILLE QUADRANGLE  
UTAH-CARBON CO.  
7.5 MINUTE SERIES (TOPOGRAPHIC)

OPEN-FILE REPORT 79-147

COAL RESOURCE OCCURRENCE MAP OF THE STANDARDVILLE QUADRANGLE,  
CARBON COUNTY UTAH,

PLATE 25  
OVERBURDEN ISOPACH MAP  
OF THE  
SPRING CANYON SUB 3 COAL BED

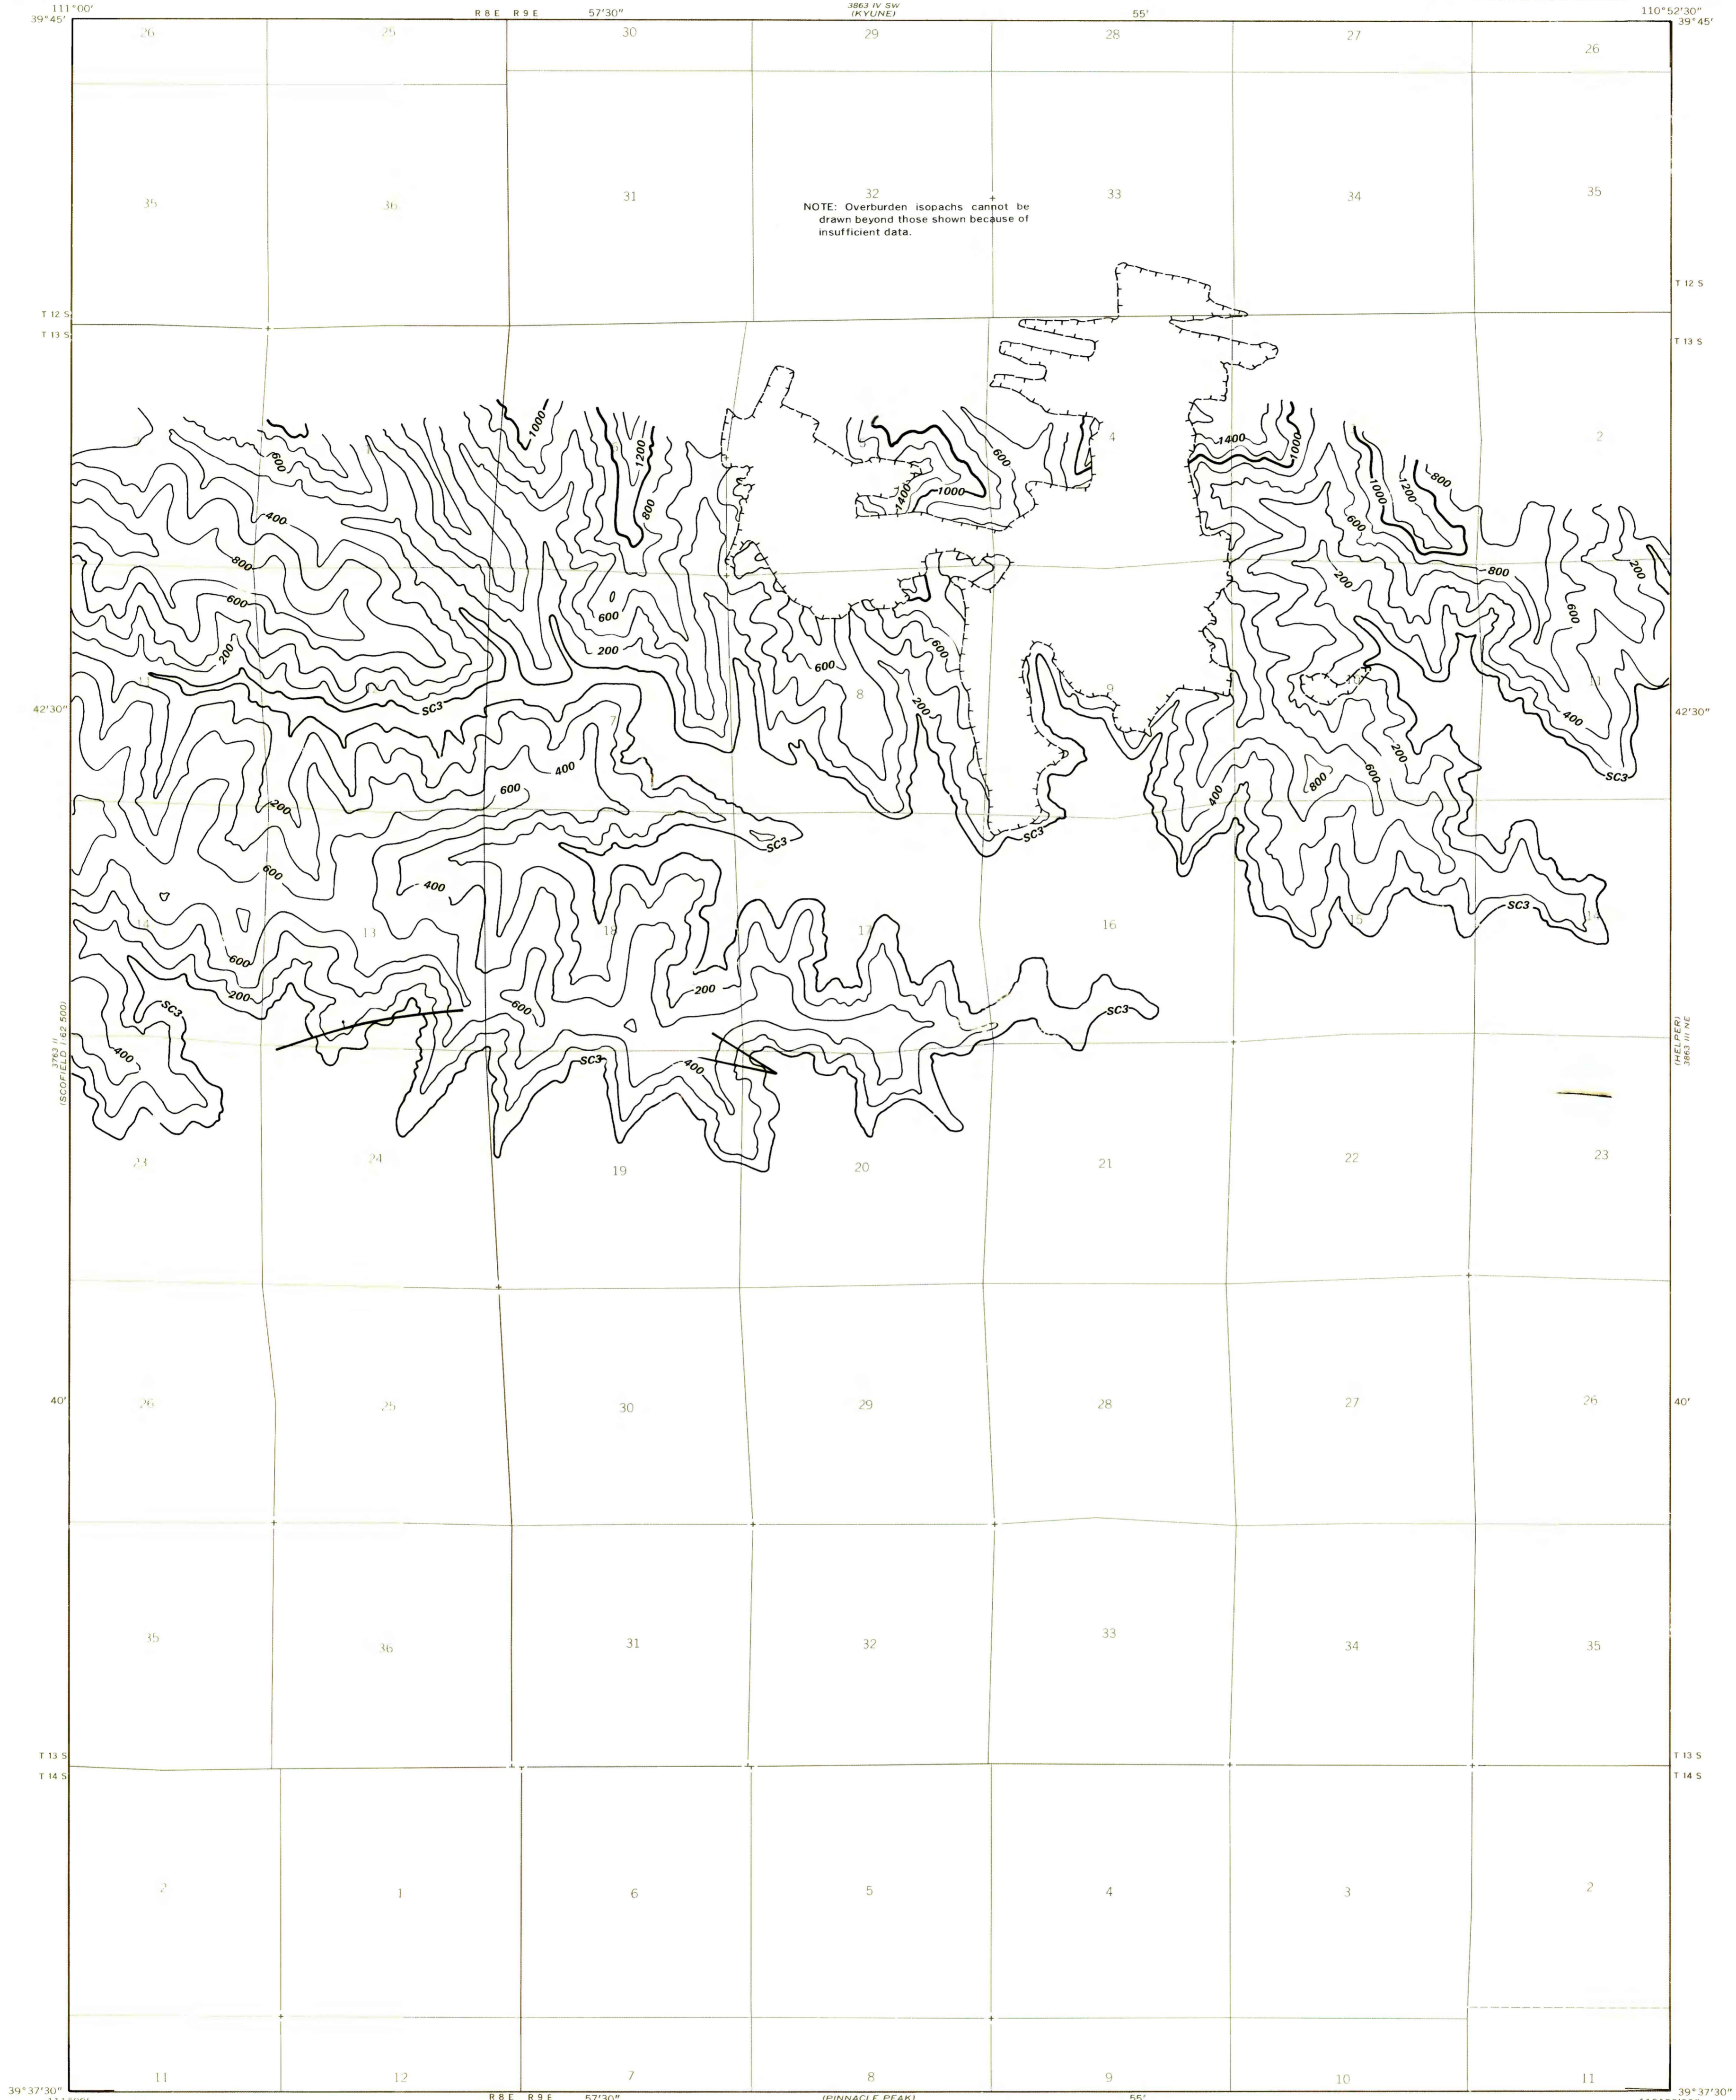
OVERBURDEN ISOPACHS - Showing thickness of overburden, in feet, from the surface to top of the Spring Canyon Sub 3 coal bed. Isopach interval 200 feet (61.0 m).

TRACE OF COAL BED OUTCROP - Showing symbol of name of coal bed.

FAULT - Bar and ball on downthrown side where direction of movement is known.

UNDERGROUND COAL MINE - Hachures point to mined-out area. Dashed where approximately located.
