Late Diagenetic Indicators of Buried Oil and Gas: II,
Direct Detection Experiment at Cement and Garza Oil Fields, Oklahoma and Texas,
using enhanced LANDSAT I and II Images

Terrence J. Donovan, Patricia A. Termain, and Mitchell E. Henry

Open-File Report 79-243
1979

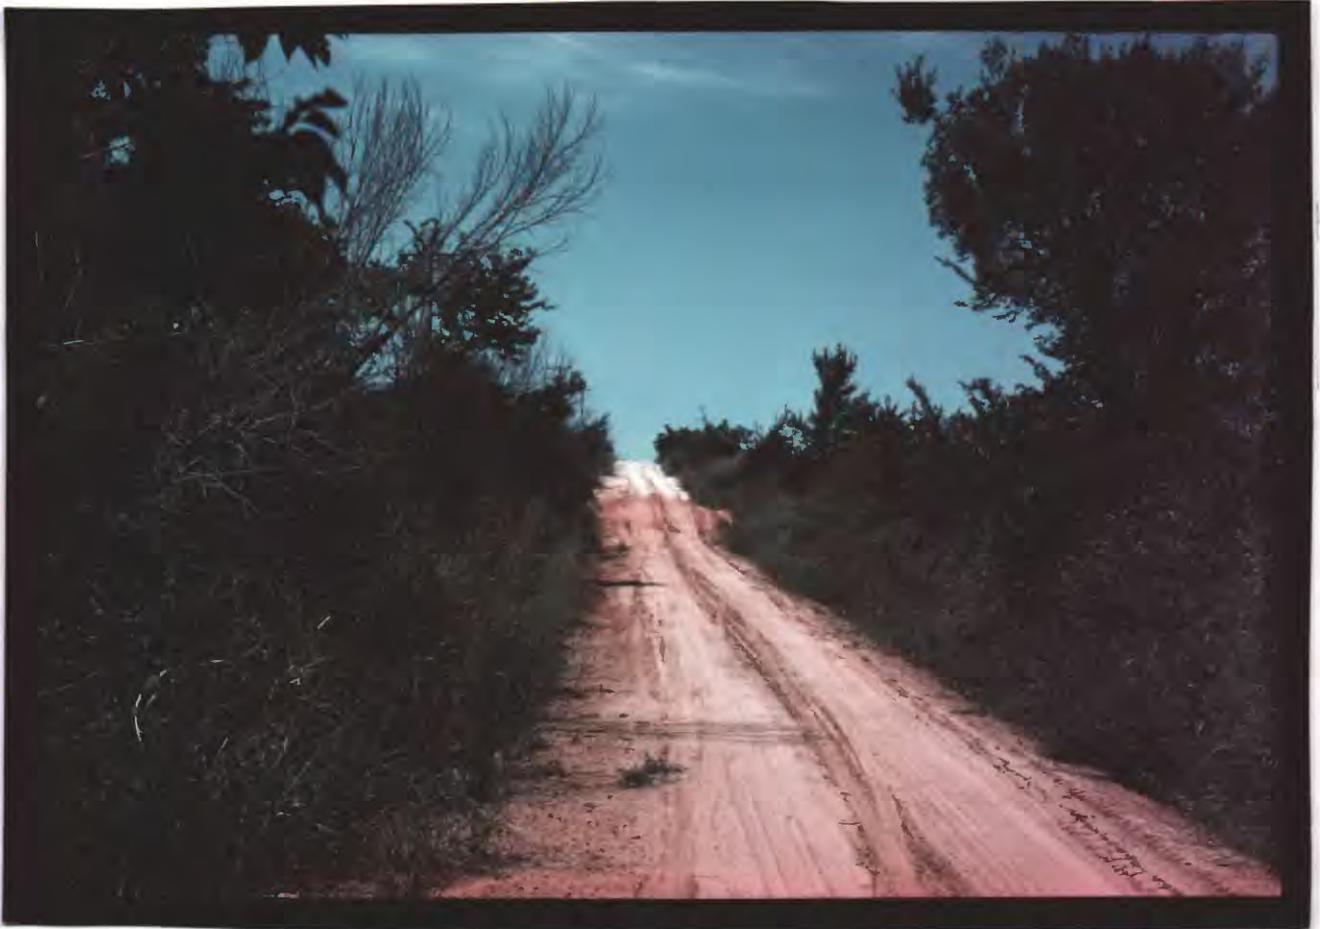
Figure 3. Color change in Rush Springs Sandstone in east-west section line road. View is to the west, diagonally up the eastern plunge of the Cement anticline.

Figure 3 is an example of the remarkable color change evident in a section line road crossing the eastern plunge of the Cement anticline. Figure 4 is an aerial view of the color contact in a road on the southeastern flank of the structure. The color contact along the southern flank of the field is shown in figure 5 and figure 6 is an aerial view of the same contact viewed from the opposite direction. Figure 7 shows the contact in a road cut on the north flank of the structure. These photographs clearly demonstrate the limited areal extent of the exposures at Cement. In figure 8 bleached sandstone grades upward into limonitic stained sandstone which in turn is overlain by vegetated but poorly developed red-brown soil. This sequence is not common at Cement. Presumably, the limonitic stain develops as a result of the upward (capillary?) movement and subsequent precipitation of iron oxides in an oxidizing environment. The soil cover and limonite stain restrict detection of the bleached rock from vertical look-angles; the limonite stained zones themselves are areally too limited for LANDSAT's resolution although under more ideal conditions they can be separated from other materials (Rowan and others). Ground and aerial photographs of carbonate-cemented sandstone buttes of the Keechi Hills are shown in figures 9 and 10. Several kinds of geochemical anomalies occur at Cement; examples of trace metal (Mn) variations in the carbonate cement and the overlying soil are shown in figures 11 and 12.

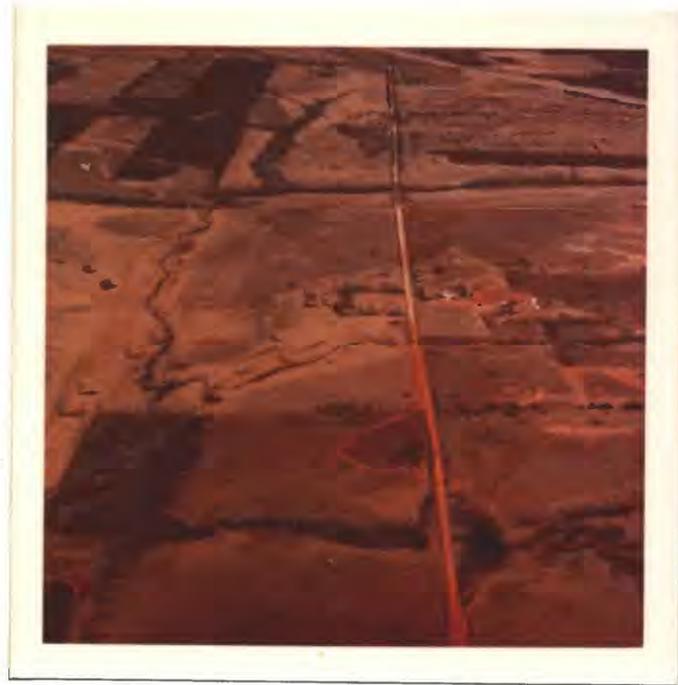
Figure 4. Low oblique aerial photograph of color change in Rush Springs Sandstone along southern flank of Cement anticline in east-west section line road. The Cement structure strikes diagonally across the photograph from lower left to upper right. View is to the east.

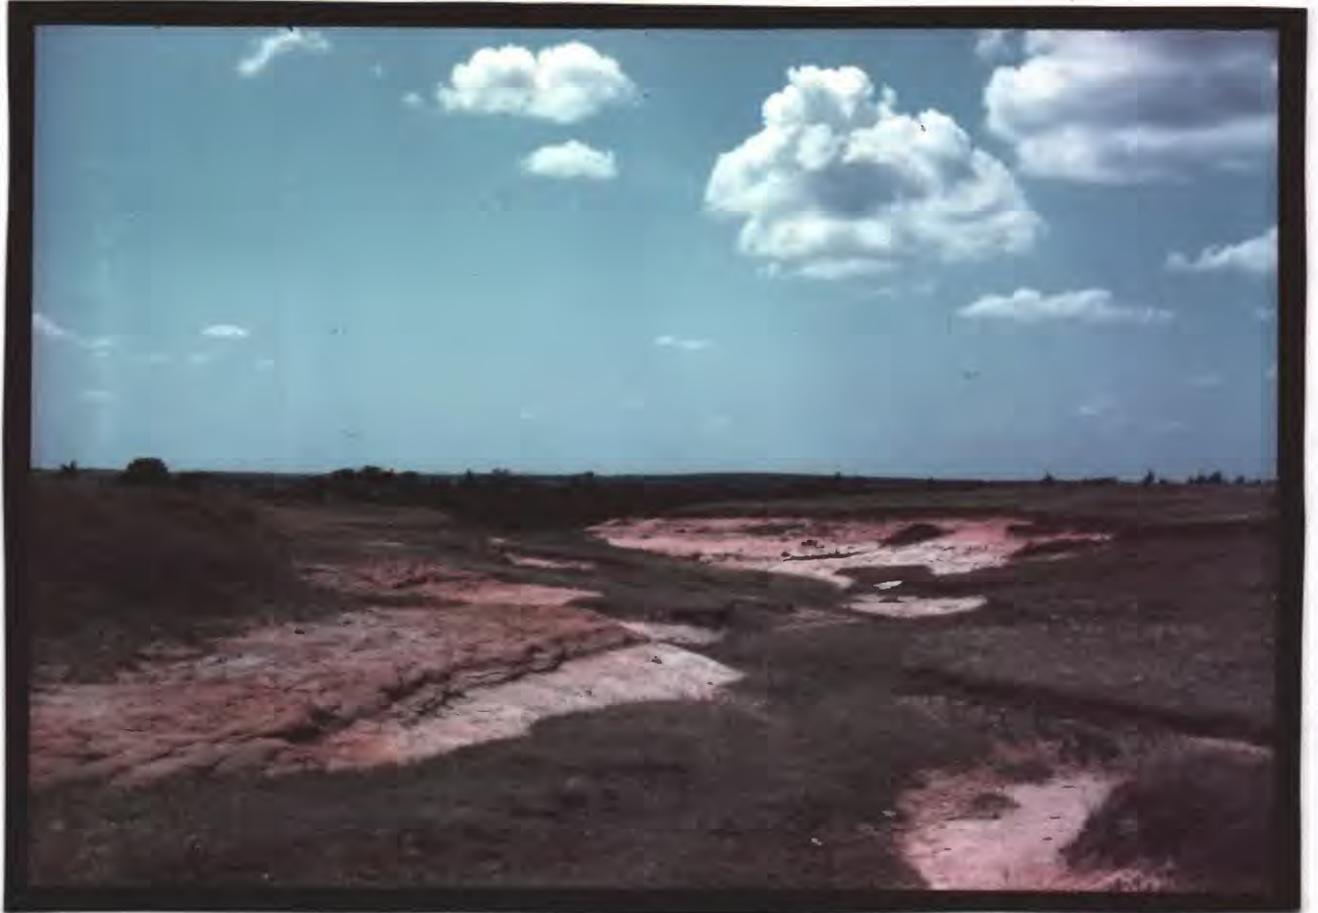
Figure 5. Contact between unaltered and altered (bleached) Rush Springs Sandstone in drainage channel along south flank of the Cement anticline. View is to the west.

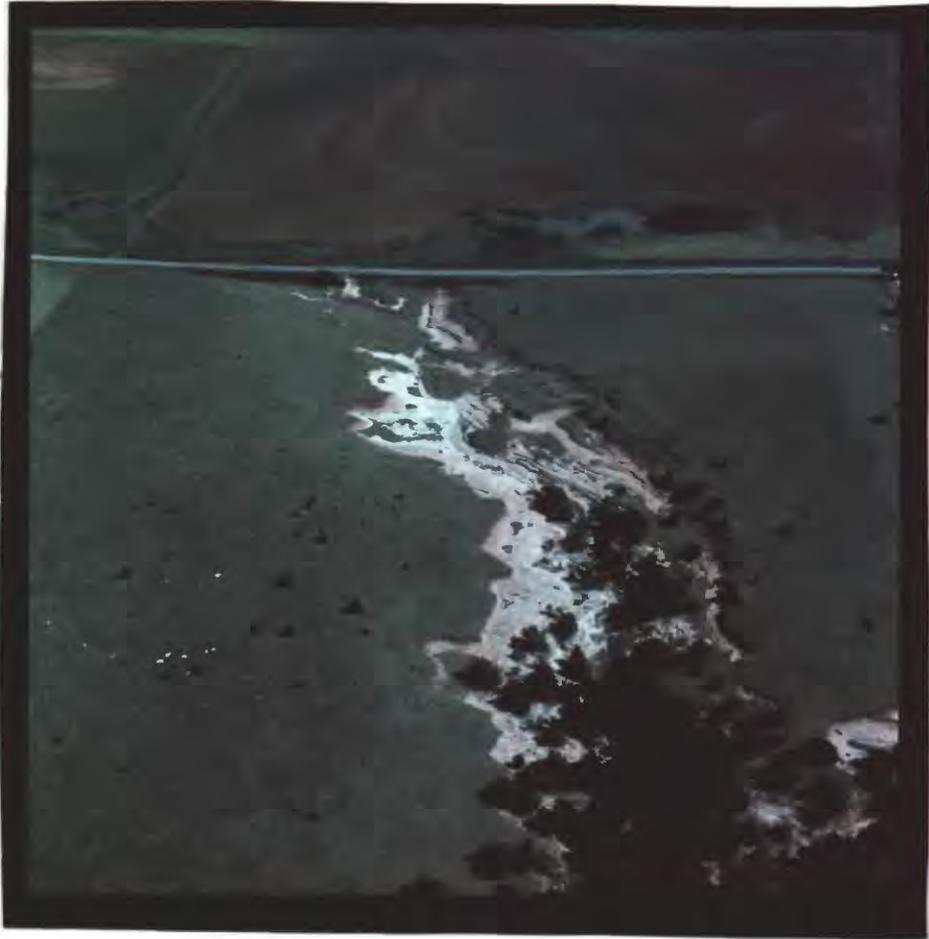
Figure 6. Low oblique aerial photograph of the contact between unaltered and altered Rush Springs Sandstone shown in figure 5. View is to the east and the color contact can be seen along the south channel wall in the far to middle distance where it disappears beneath cultivated soil-cover.

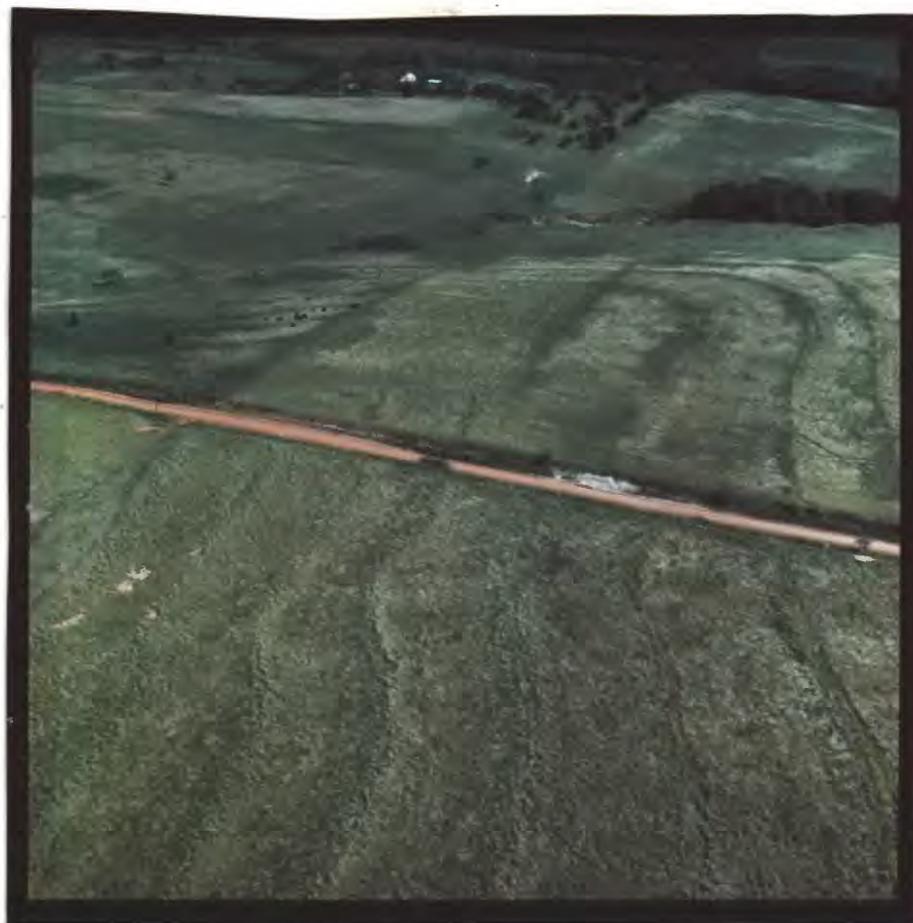
Figure 7. Low oblique aerial photograph of the color contact in Rush Springs Sandstone in road cut along north-south section line road. View is to the northeast and the crest to the Cement structure is to the right.

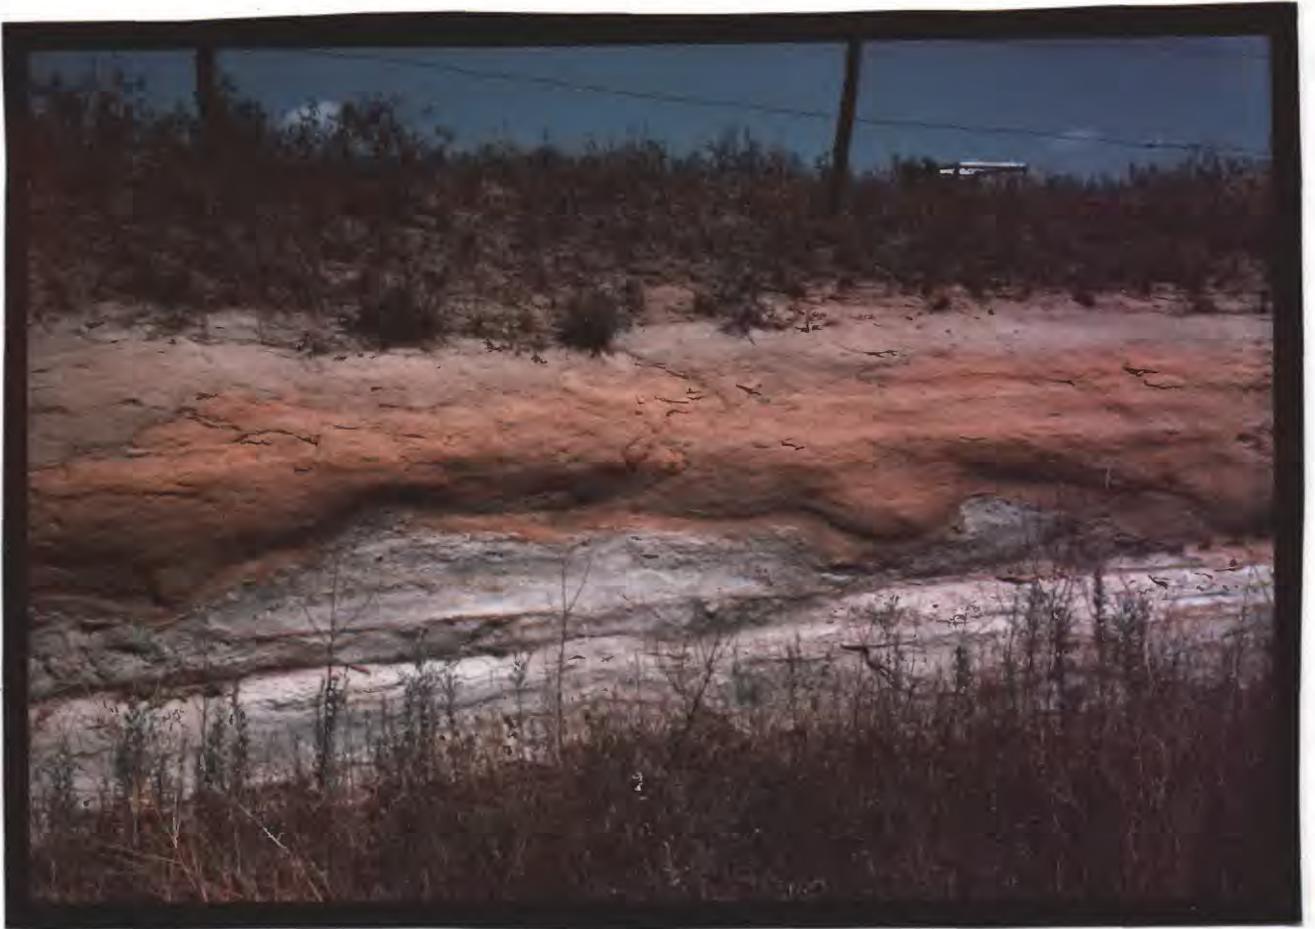
Figure 8. Bleached Rush Springs Sandstone abruptly grading upward to limonitic-stained sandstone in road cut near the crest of the Cement anticline.

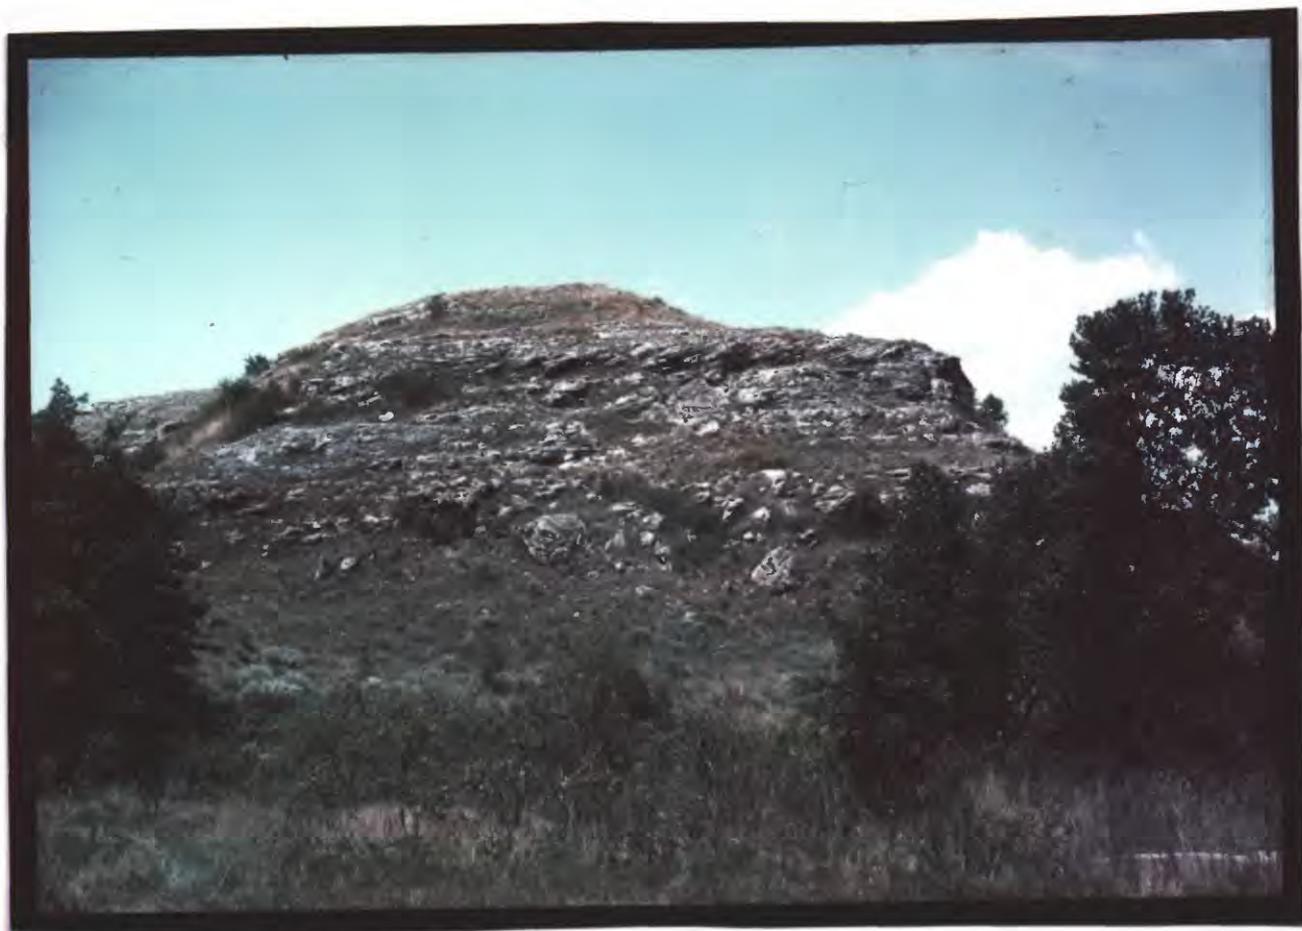
Figure 9. Carbonate impregnated, erosion resistant Rush Springs Sandstone butte of the Keechi Hills, East Cement.

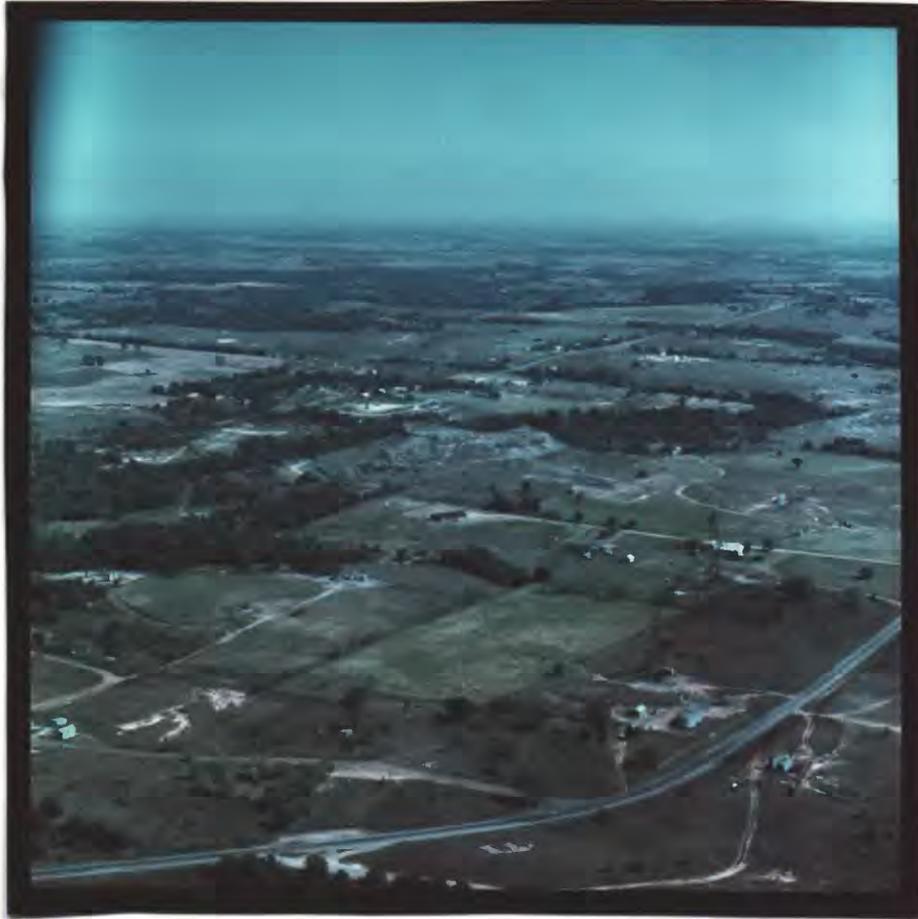
Figure 10. High oblique aerial photograph of part of Keechi Hills, East Cement. View is to the northeast.

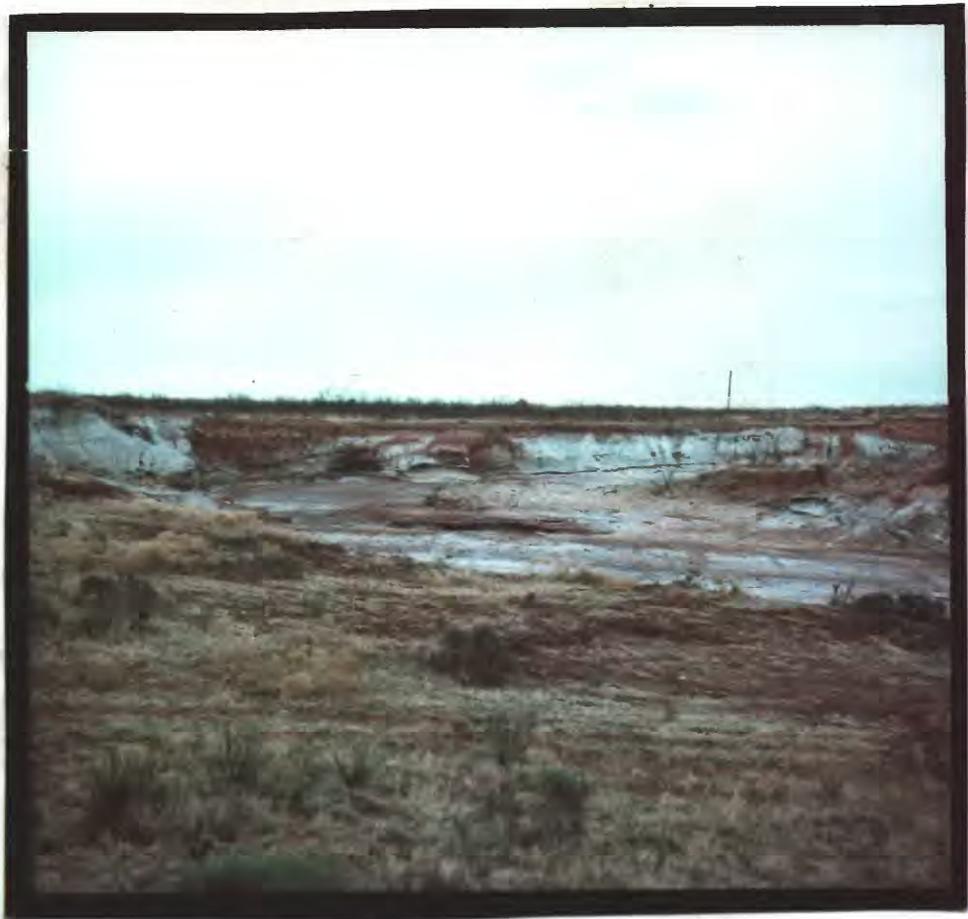
Figure 14. Bleached Triassic Sandstone in drainage channel, Garza oil field, Texas.

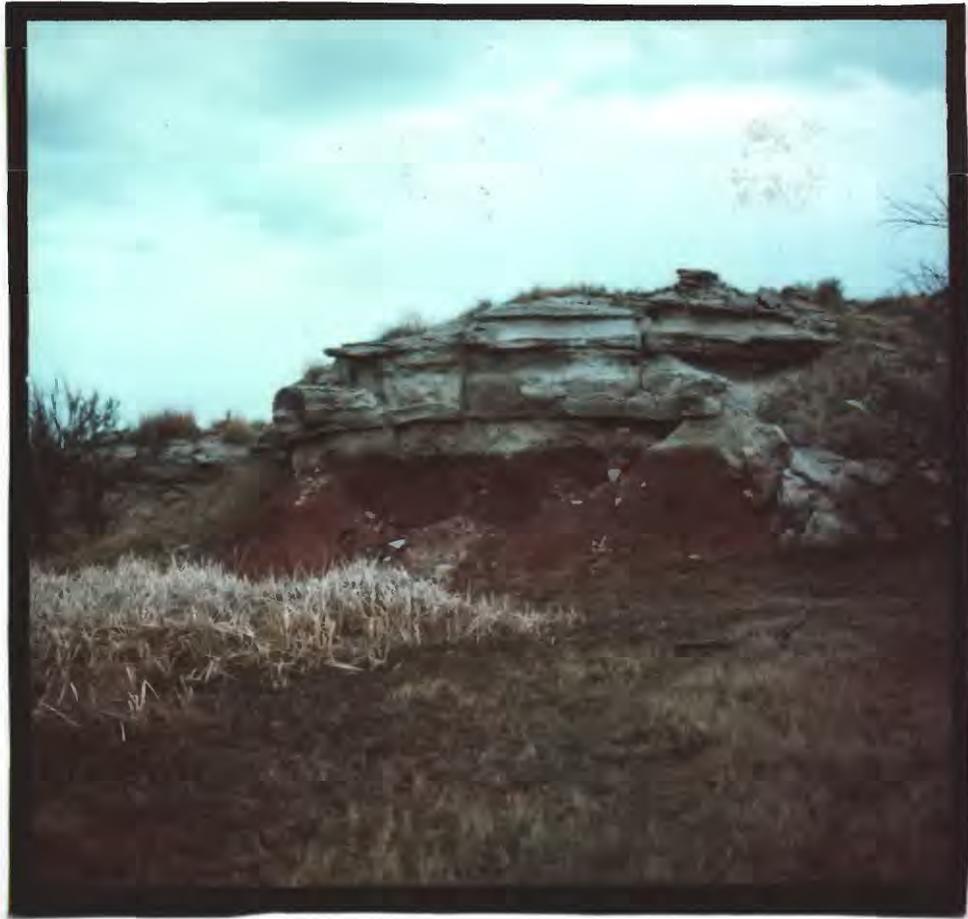
Figure 17. Bleached Triassic fine-grained sandstone caprock and bleaching in proximal 0.3 m of underlying shale, Garza oil field, Texas.

Although the oil field and surface anomaly are considerably smaller and less significant than Cement, the cultural overprint is less dense and the soil, alluvium, and vegetation cover are comparatively thin. The discolored areas (in Triassic red beds) are less-well distributed areally and they are narrowly stratibound in thin sandstone units (figs. 14 and 15). Although we have no detailed documentation, we suggest (Donovan and Dalziel, 1977) that seeping fluids may have effused vertically along joints and fractures (fig. 16) and then spread laterally along permeable sandstones. A thin zone of red shale immediately underlying the bleached sandstones is also bleached presumably owing to proximity to reducing agents carried in the overlying permeability channels (fig. 17).

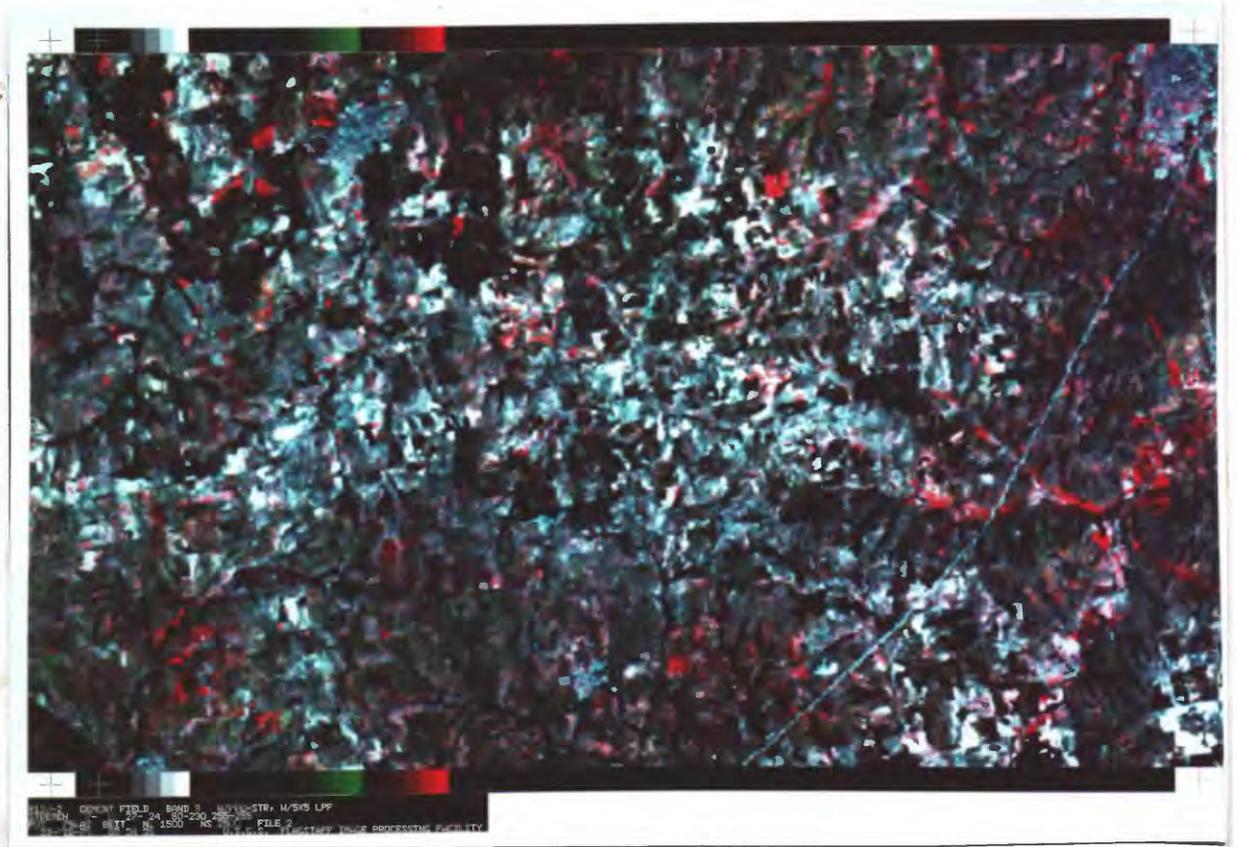
Figure 20. Sine stretched, magnified and filtered color composite image of LANDSAT bands 4, 5, and 7, Cement area, Oklahoma.

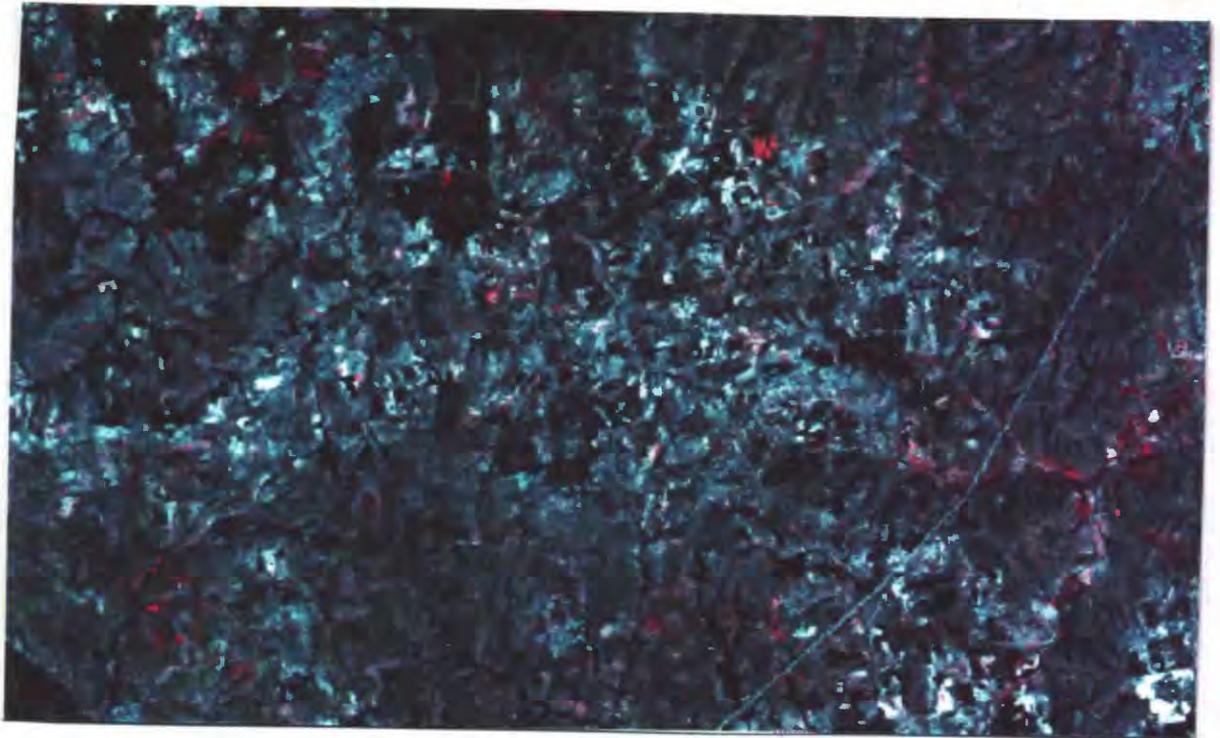
Figure 24. False color LANDSAT composite image, Cement area, Oklahoma.

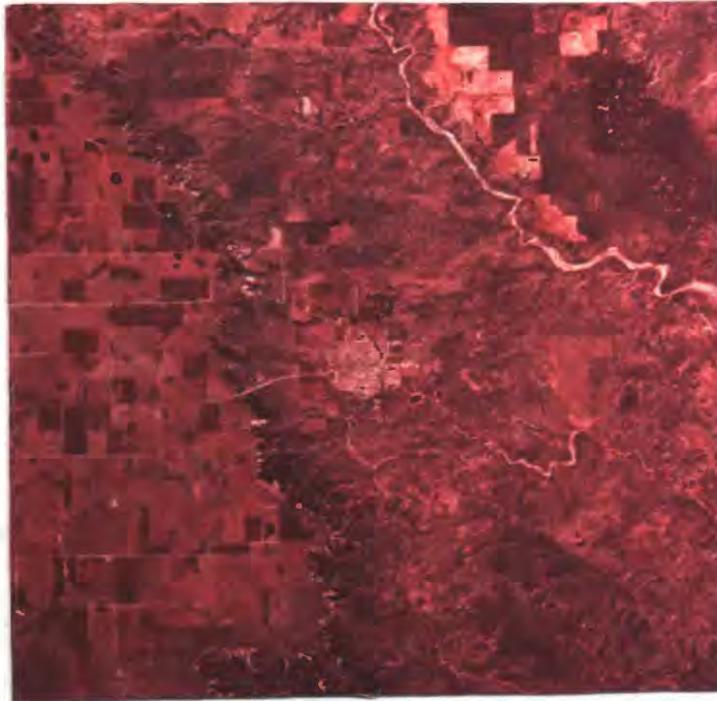
Figure 29. Portion of SKYLAB S190B photograph of the Garza area, centered on the town of Post. Scale: approximately 1:250,000. When enlarged to a scale of approximately 1:62,500 individual outcrops can be mapped.

At Garza, areas of alteration could easily be detected in an enhanced false color LANDSAT image by a biased interpreter and could also be mapped with a modest degree of reliability using SKYLAB and aerial photographs.
