UNITED STATES DEPARTMENT OF THE INTERIOR  
GEOLOGICAL SURVEY

CORE DESCRIPTIONS AND PRELIMINARY OBSERVATIONS OF  
VIBRACORES FROM THE ALASKAN BEAUFORT SEA SHELF

OPEN-FILE REPORT 79-351

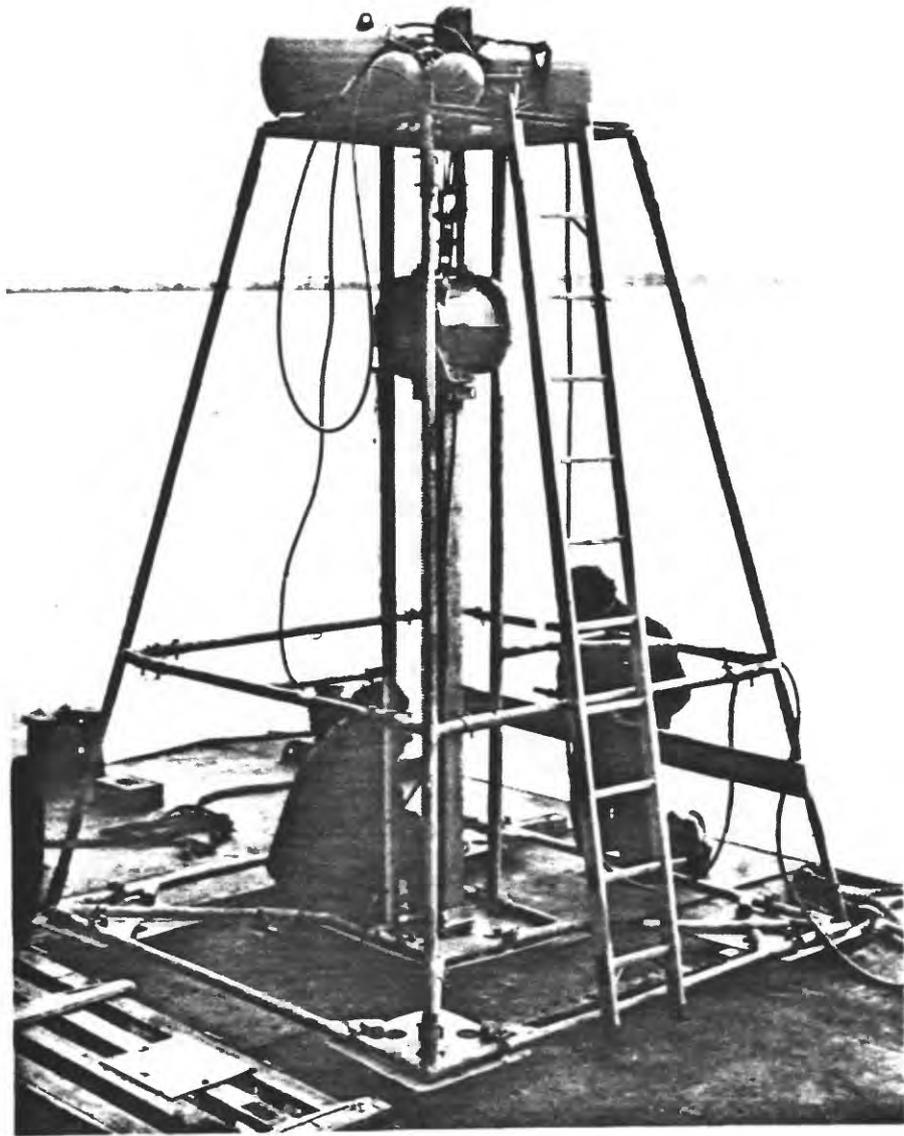
Figure 1. Vibrocorer used in this study. The overall height of the corer is 3 meters. The cylindrical housing atop a square core houses the vibrator barrel, which is guided into the sediment by the T rails on either end of the cylinder. The two cylindrical housings on the top of the corer contain the winch for withdrawing the core barrel and control electronics.

The samples described in this report were obtained using a vibratory corer. Vibrations are generated from the forces created when a pair of electrically driven, counter-rotating, eccentric weights in the core head drives a hammer against an anvil. The hammer impact from the downstroke is repeated 2,840 times per minute transmitting 700 kp of force at each stroke through the driving head to the 2-meter core barrel. The repetitive blows and the weight of the driving head force the barrel into the sediment. The vibrating head and core barrel are guided into the sediment by a bottom-resting quadruped frame with vertical rails. This same frame supports penetration and inclination measuring devices and a winch which withdraws the core barrel from the sea bed after sampling. The configuration and dimensions of the corer are shown in Figure 1.

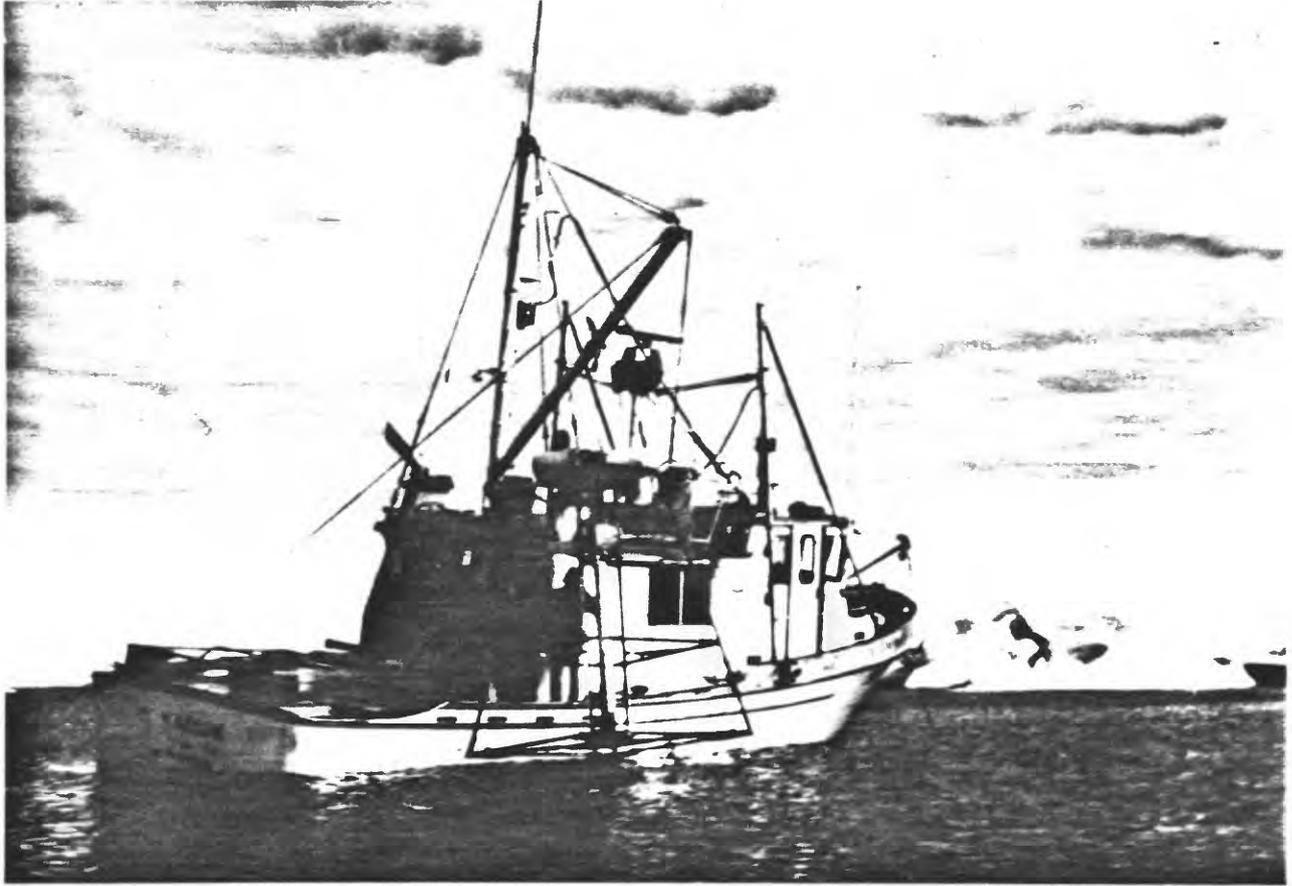
Figure 2. The U.S. Geological Survey's research vessel KARLUK anchored, ready to lower the vibrocorer to the sea floor.

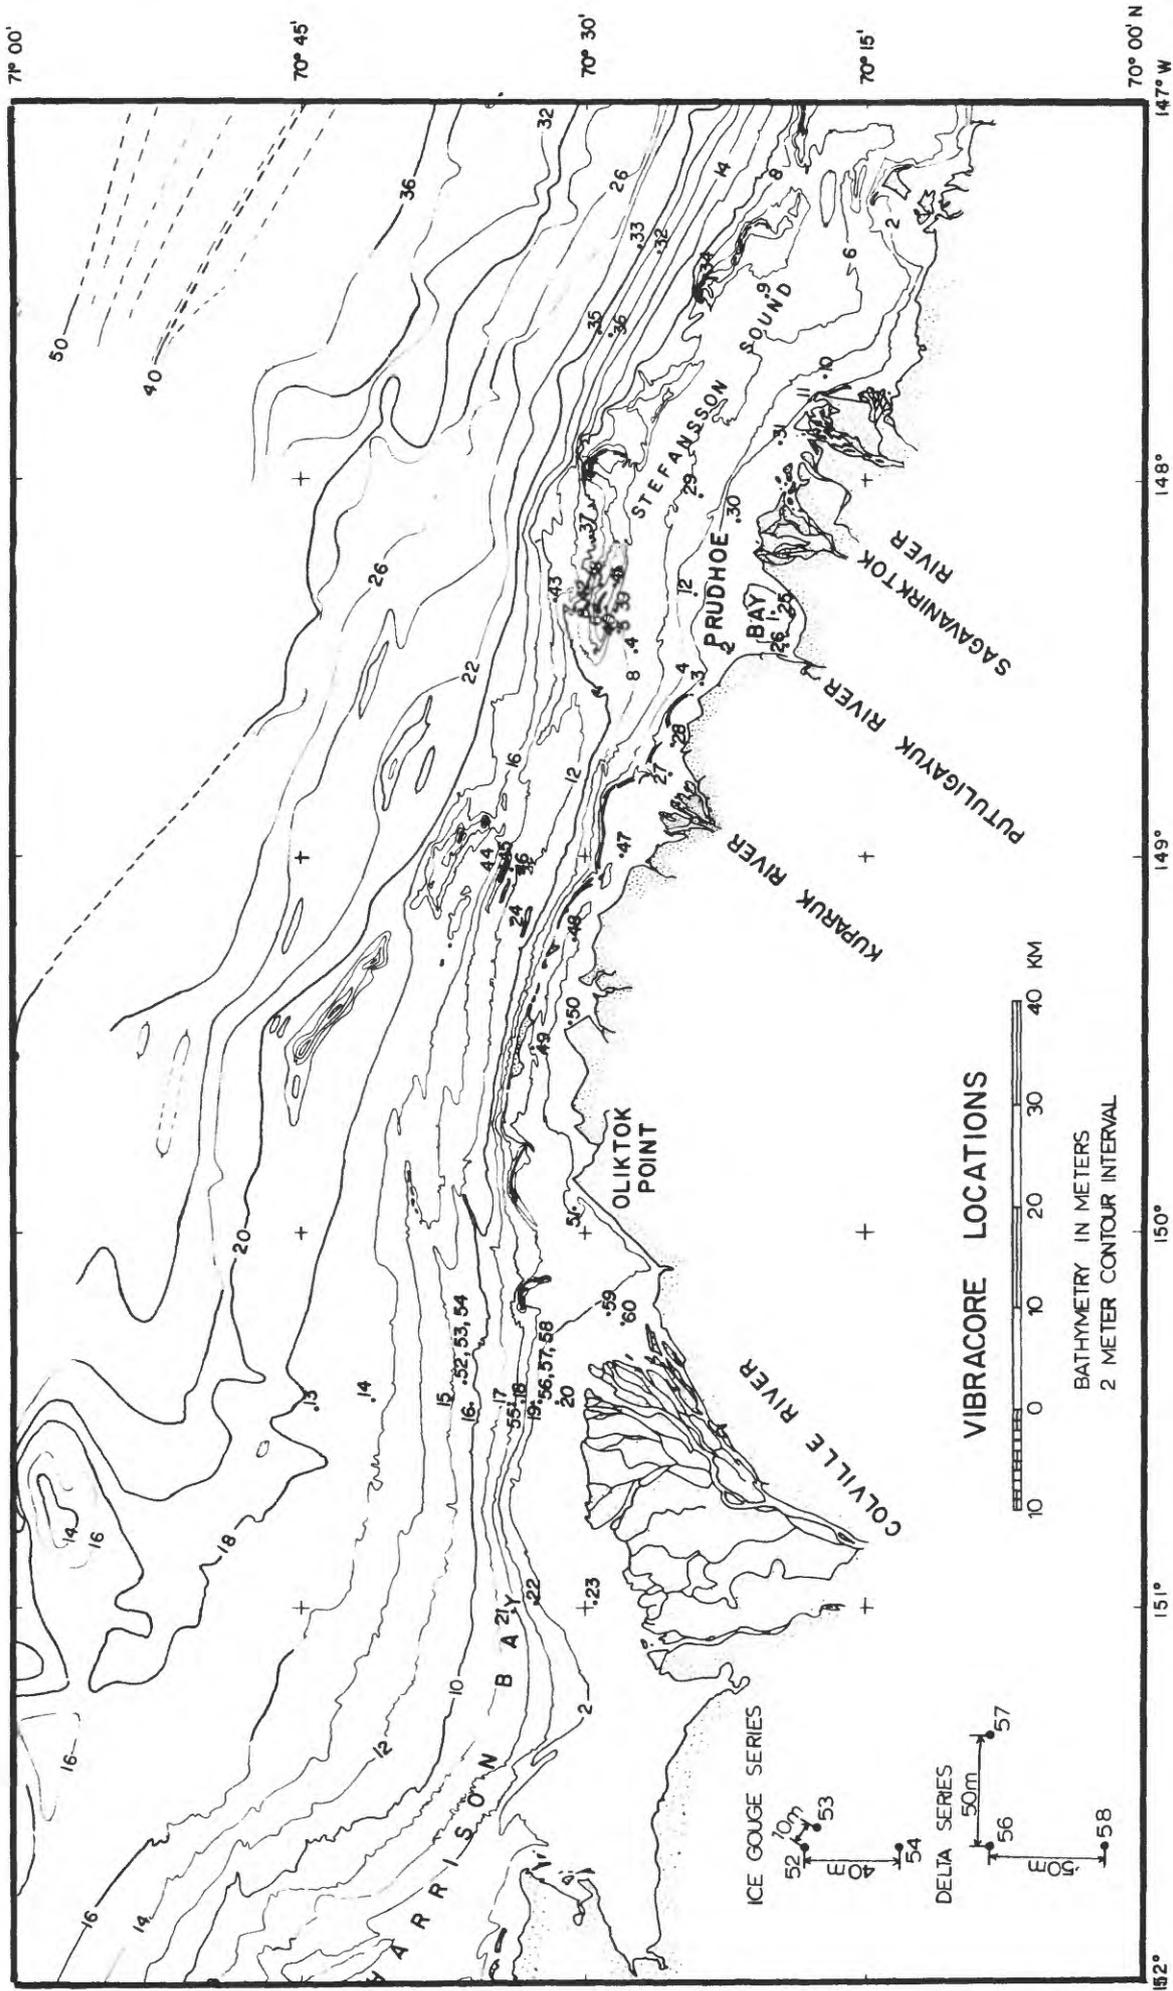
Figure 3. Bathymetry map showing the location of vibrocores taken in 1976 and 1977. Note the location of the "2-m bench" of the Colville and Sagavanirktok Rivers, the location of the cores seaward of the Colville delta in ice gouge terrain and the location of core in the vicinity of the barrier island directly north of Prudhoe Bay.

The coring procedure at each sample site in both 1976 and 1977 was essentially the same. The vessel used for this sampling, the Geological Survey's R/V KARLUK, was anchored from the bow at each site, corer was lowered over the starboard quarter, as shown in Figure 2. After the core frame had settled to the sea floor, the vibrators were operated for 3-minute increments alternating with 20-minute cooling intervals, until either full penetration was indicated or further penetration was unlikely. Vibrating times ranged from less than 3 minutes to a maximum of 10 minutes. In 1976, incremental times and penetration depths were recorded for determining the rate of penetration. The implications of varied penetration rates observed at each coring site are discussed in a report by Reimnitz and others (1977). Several sedimentary environments were chosen for the sampling program including bays, lagoons, ice gouge terrain, delta front platforms, shoals, and islands, as shown in Figure 3.

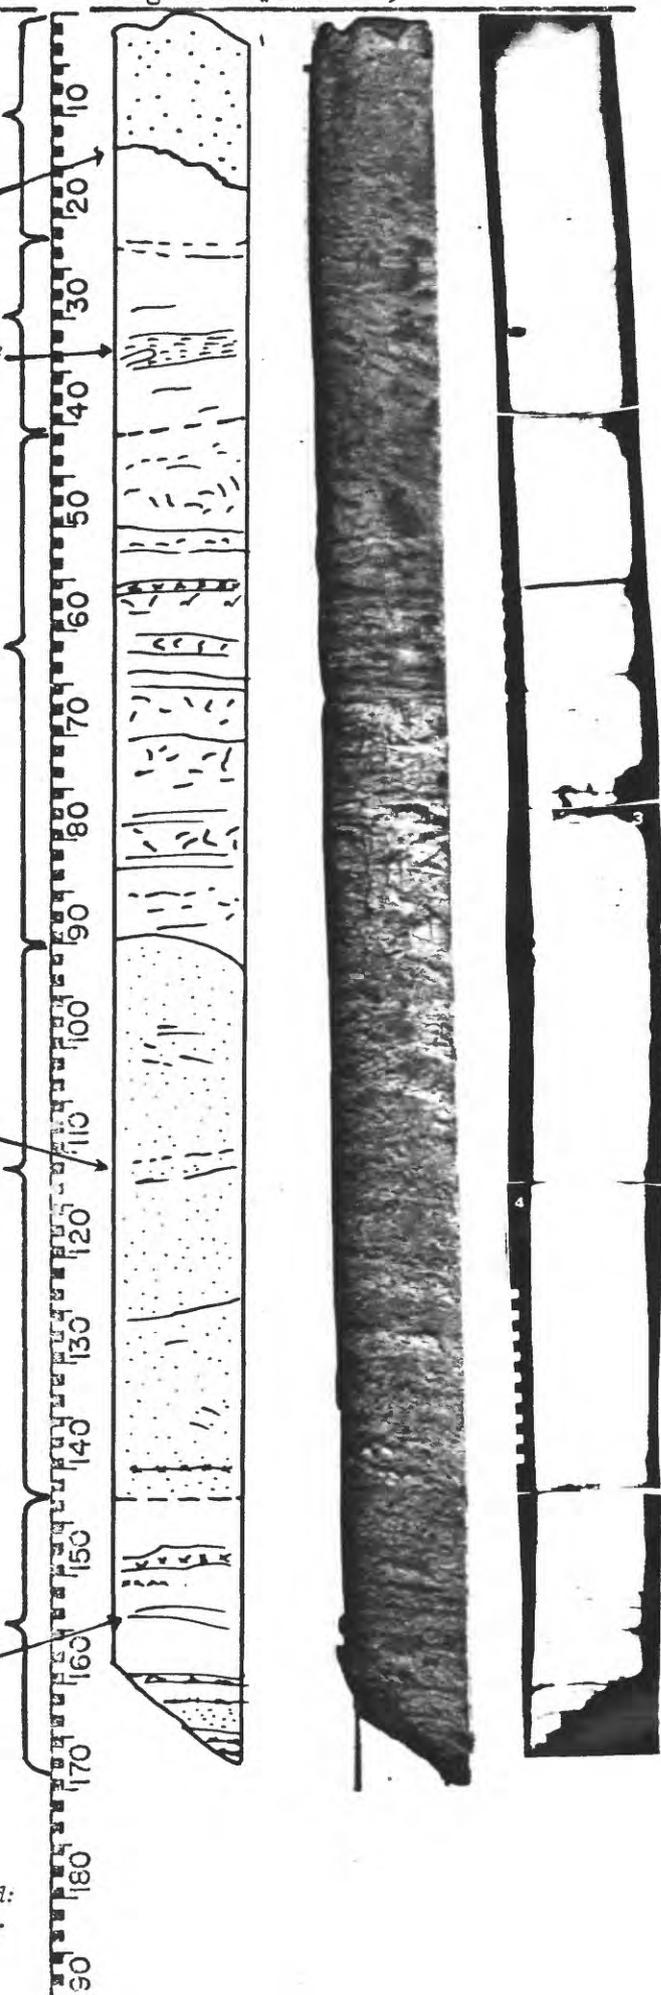
Core V-9 Depth 6.5 m 70°20.1'N, 147°31.1'W Remarks: Stefansson Sound south of Narwhal Island

Central cut - no shells observed  
 Generally dark, reduced sandy mud with  
 small olive oxidized zones at surface  
 and below 32 cm.
