Landslides and related features interpreted from aerial photographs:
1:20,000 scale (black and white) 1972
1:80,000 scale (black and white) 1977

Photointerpretation and field check 1979
This map has not been edited or reviewed for conformity with Geological Survey standards and nomenclature.

LANDSLIDES AND RELATED FEATURES
OF THE NEW HOME, GA. - ALA. - TENN. QUADRANGLE
by ROGER E. THOMAS
U.S. Geological Survey
OPEN FILE MAP 79-944 (H-4)

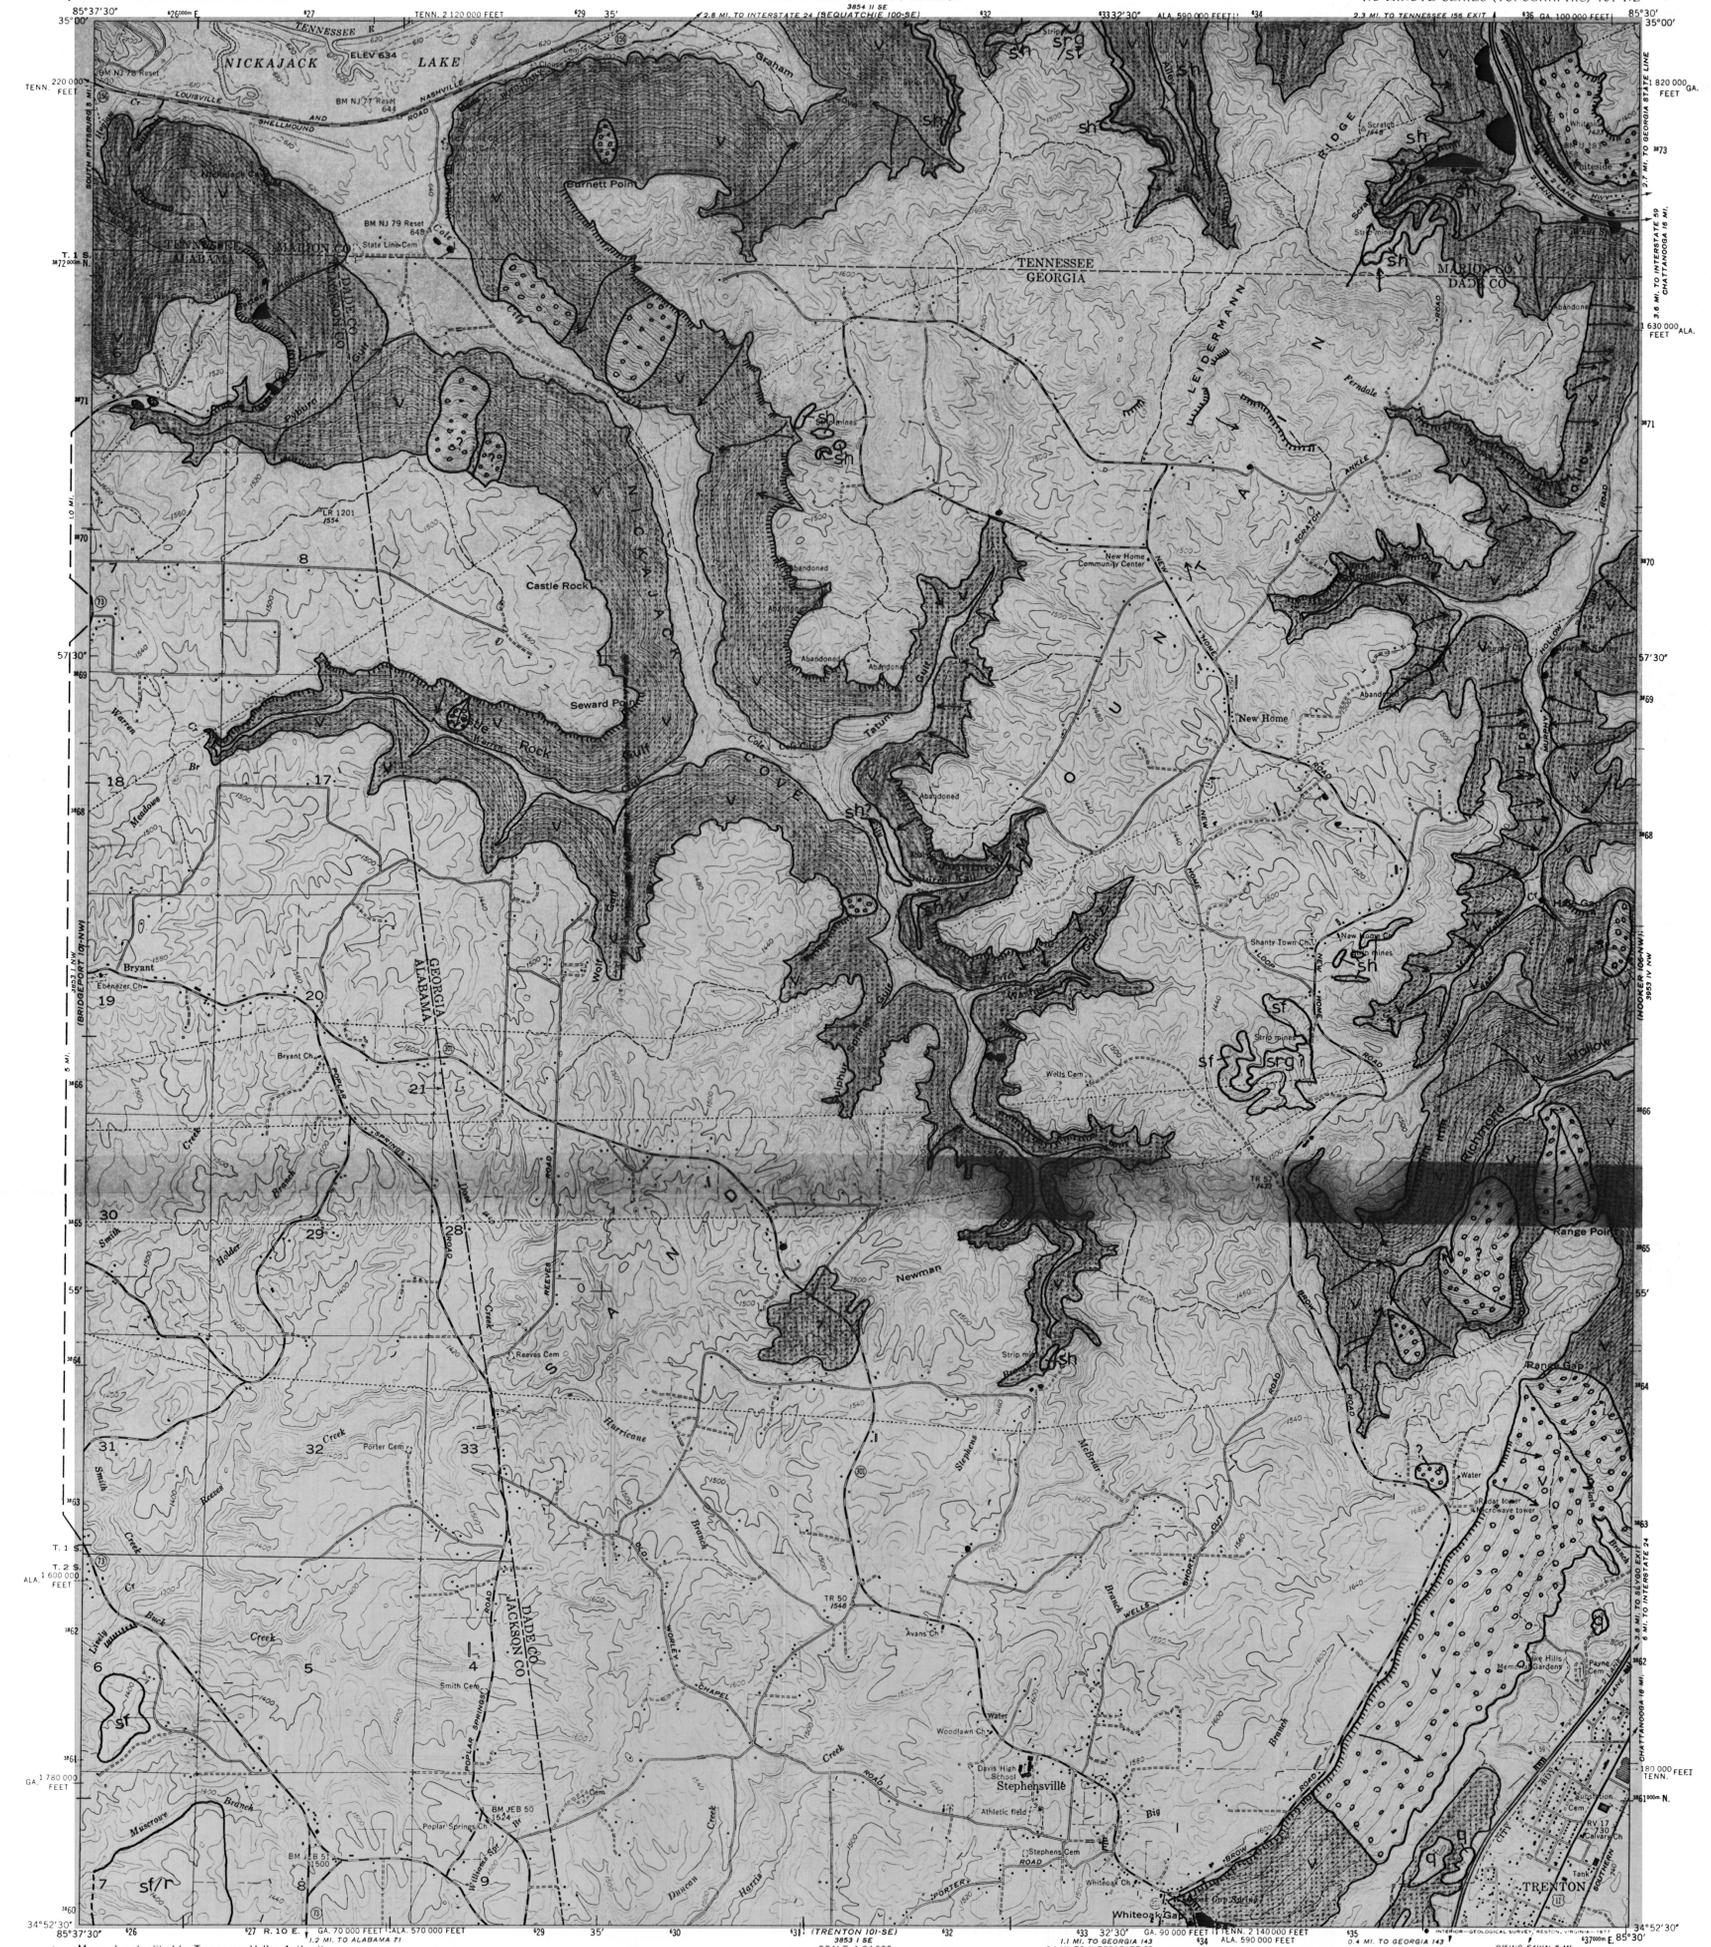
- ACTIVE OR RECENTLY ACTIVE LANDSLIDE**
Complex landslide composed of earthflow, debris slide, earth and rock slump. Identified from historical records, and from scars, debris and other field evidence. Ground extremely unstable; sliding accelerated by excavation, loading and changes in drainage conditions. May include areas with several active slides too small to be shown separately. Questioned where doubtful.

- OLD LANDSLIDE**
Area of extensive hummocky ground caused by earthflow and earth and rock slump. Lacks clear evidence of active sliding. Relatively stable in natural, undisturbed state, generally not affected by small structures properly sited in areas away from the edge of the toe; can be reactivated by extensive, rapid excavation, loading, and changes in ground water and surface water conditions. Area of old landslide probably includes recent ones not identified from field evidence or otherwise documented. Upslope boundary of landslide generally defined by modified scarp, but downslope (toe) may be gradational and not well defined. Questioned where doubtful.

- COMBINATION LANDSLIDE**
Area of recent and old slides in which individual slides are not identified.
- COLLUVIAL SLOPE**
Valley wall along major streams with slope as steep as 40° (85%); stony, clayey silt soil up to 50 ft. (15 m) thick; commonly buttressed by a terrace or bench at the toe of the slope; very susceptible to sliding by cutting of toe area, removal of terrace or bench, and overloading; slide commonly activated without apparent cause.

- COLLUVIAL SLOPES WITH LANDSLIDES**
Landslides too small or obscure to map individually.
- AREAS SUSCEPTIBLE TO DEBRIS FLOWS AND DEBRIS AVALANCHES**
Primarily shallow, narrow ravines and chutes with accumulation of stony colluvium generally 10 ft. (3 m) or less in thickness; susceptible to rapid movement during intense rainfall. Most ravines and chutes designated show evidence of former debris flows and avalanches. Symbol designates historical debris flow or debris avalanche.

- AREAS SUSCEPTIBLE TO ROCKFALL**
Steep, locally vertical, natural and man-made slopes and cliffs, 15 ft. (4.5 m) or more high; formed dominantly of sandstone, limestone, sandy shale, mudstone and claystone. Interbedded mudstone, claystone and shale weather rapidly leaving sandstone and limestone rock faces unsupported.

- SOIL AND ROCK SUSCEPTIBLE TO LANDSLIDING**
Soil and rock similar to that involved in landslides elsewhere in map area; primarily areas underlain by claystone, mudstone and shale associated with other rock types. Rock weathers rapidly on exposure forming clayey soil highly susceptible to sliding. Includes coves (U-shaped, shallow valleys) containing thick layers of clayey soil that are very susceptible to sliding where excavation breaks continuity of slope and where overloaded by artificial fill.

- AREAS LEAST PRONE TO LANDSLIDES**
Map areas in which no patterns or symbols are shown; primarily valley floors, ridge tops and broad benches; modification by excavation and fill may lead to local landslides.

- MAN-MADE FEATURES**
Strip mines (combination of letter symbols indicates complex formed of more than one type of strip mine)
sh bench with high wall
sf furrowed with high wall
sd multiple furrows and multiple benches
ss hilltop removed
srg reclaimed by grading
sru reclaimed by secondary use
sh/r regraded in part, high wall remains
- Coal refuse banks**
r identified on aerial photographs; not classified in field check
rb not burnt nor on fire
rbb burnt
rbd burning
rbs sludge
- Quarries**
q quarry site
qub spoil bank, quarry waste
- Gravel pits**
g site of gravel pit
- Slides in man-made features**
af earth flow in fill
a/s earth flow in strip castings
a/r earth flow in coal refuse

NOTE
Information shown is intended as a general guide to ground conditions as of the date of field check. Additional landslides and rockfalls should be anticipated in all map units. The map unit depicts the dominant condition in the area delineated and variations in slope stability may occur at any point in the unit. This map is suitable for general planning purposes and as a supplement to more detailed studies for site selection. The map cannot be used as a substitute for detailed geologic and engineering investigations to establish design and construction criteria of specific sites. Some symbols may not appear on this map because the description is applicable to a series of maps.
