LANDSLIDES AND RELATED FEATURES

OF THE SALTSBURG, PA. QUADRANGLE

by
John S. Pomeroy
1979

U. S. Geological Survey
OPEN FILE MAP 79-1314 (D-5)

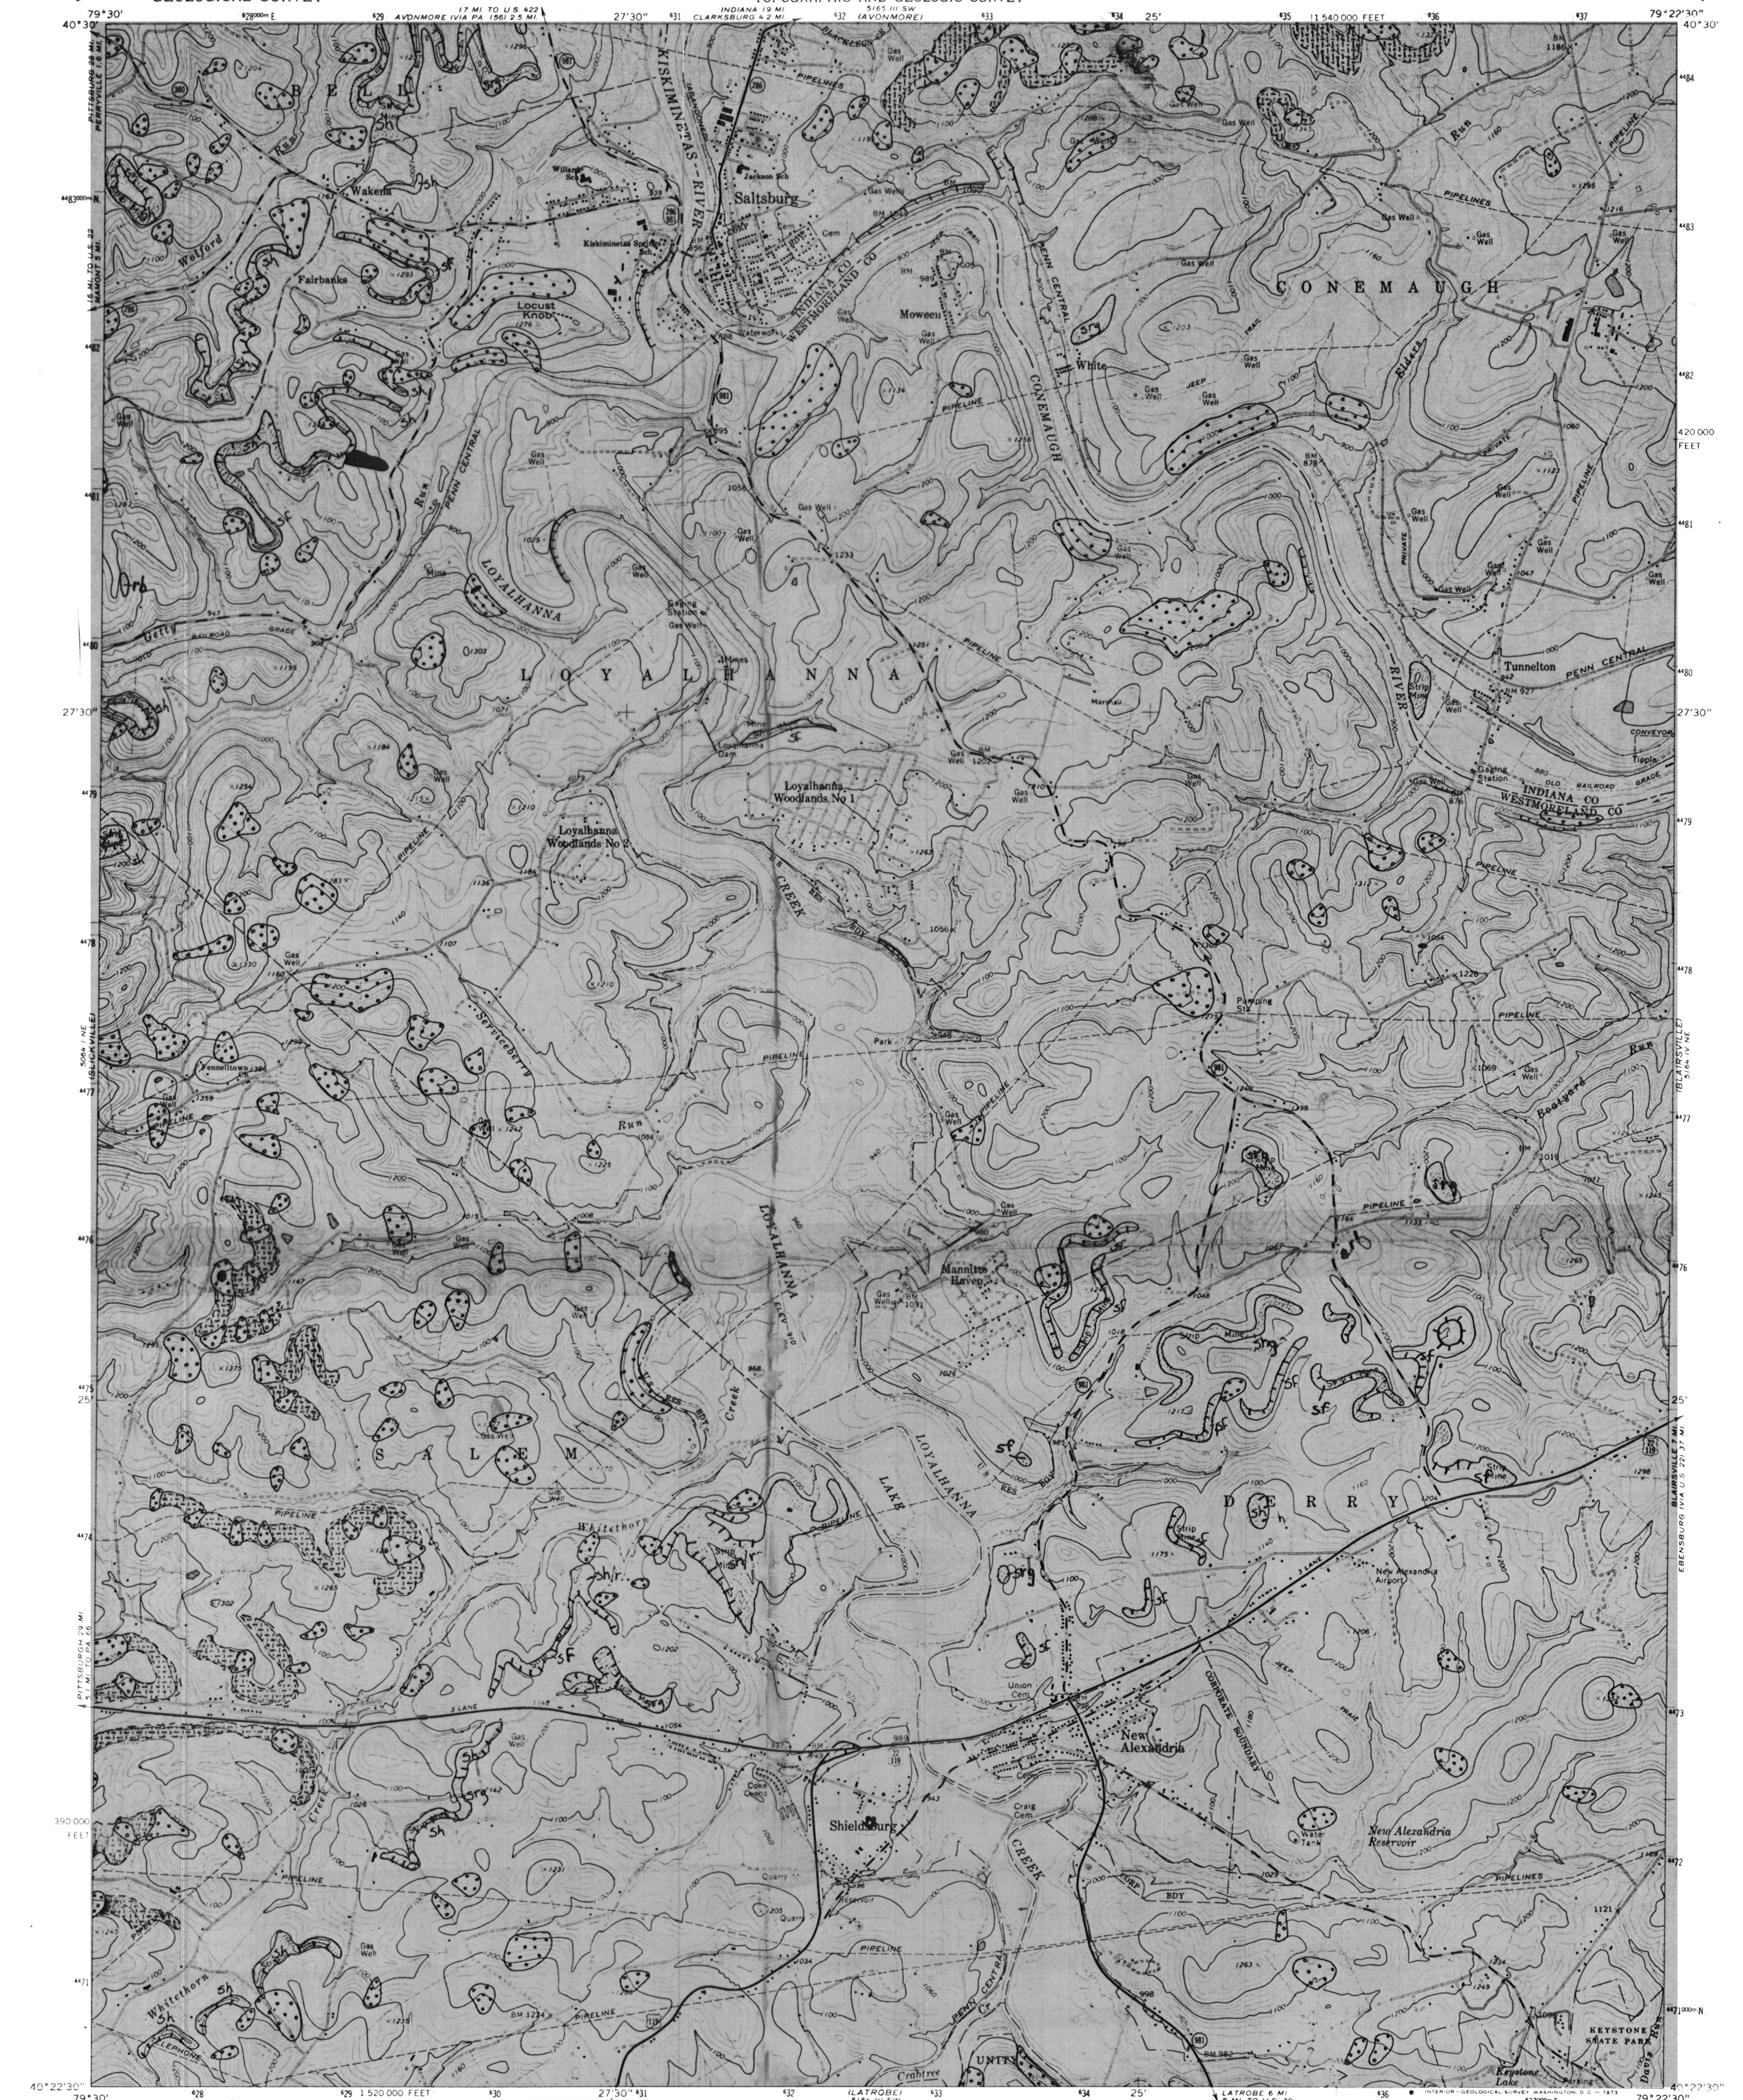
Landslides and related features interpreted
from aerial photographs:
1:40,000 (black and white) 1974

Photointerpretation and field check 1976
This map has not been edited or reviewed
for conformity with Geological Survey
standards and nomenclature.

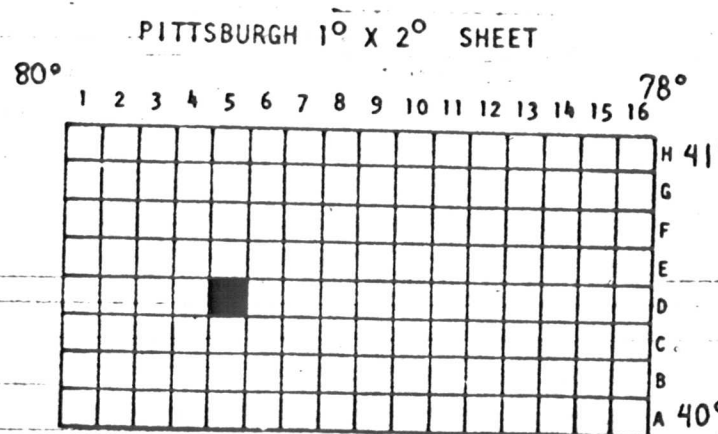
The first five digits of the open file number designate the
specific 1:250,000 scale map sheet of which this quadrangle
is a part. The last two digits designate the position of the
quadrangle in a subdivision of the 1:250,000 scale map based
on rows and tiers shown in the diagram to the right. The
location of this quadrangle is shown by the black square.
