MOUNT PLEASANT, PA.
N4007 5—W7930/7.5
1964
PHOTOREVISED 1973

Landslides and related features interpreted
from aerial photographs:
1:40,000 (black and white) 1974

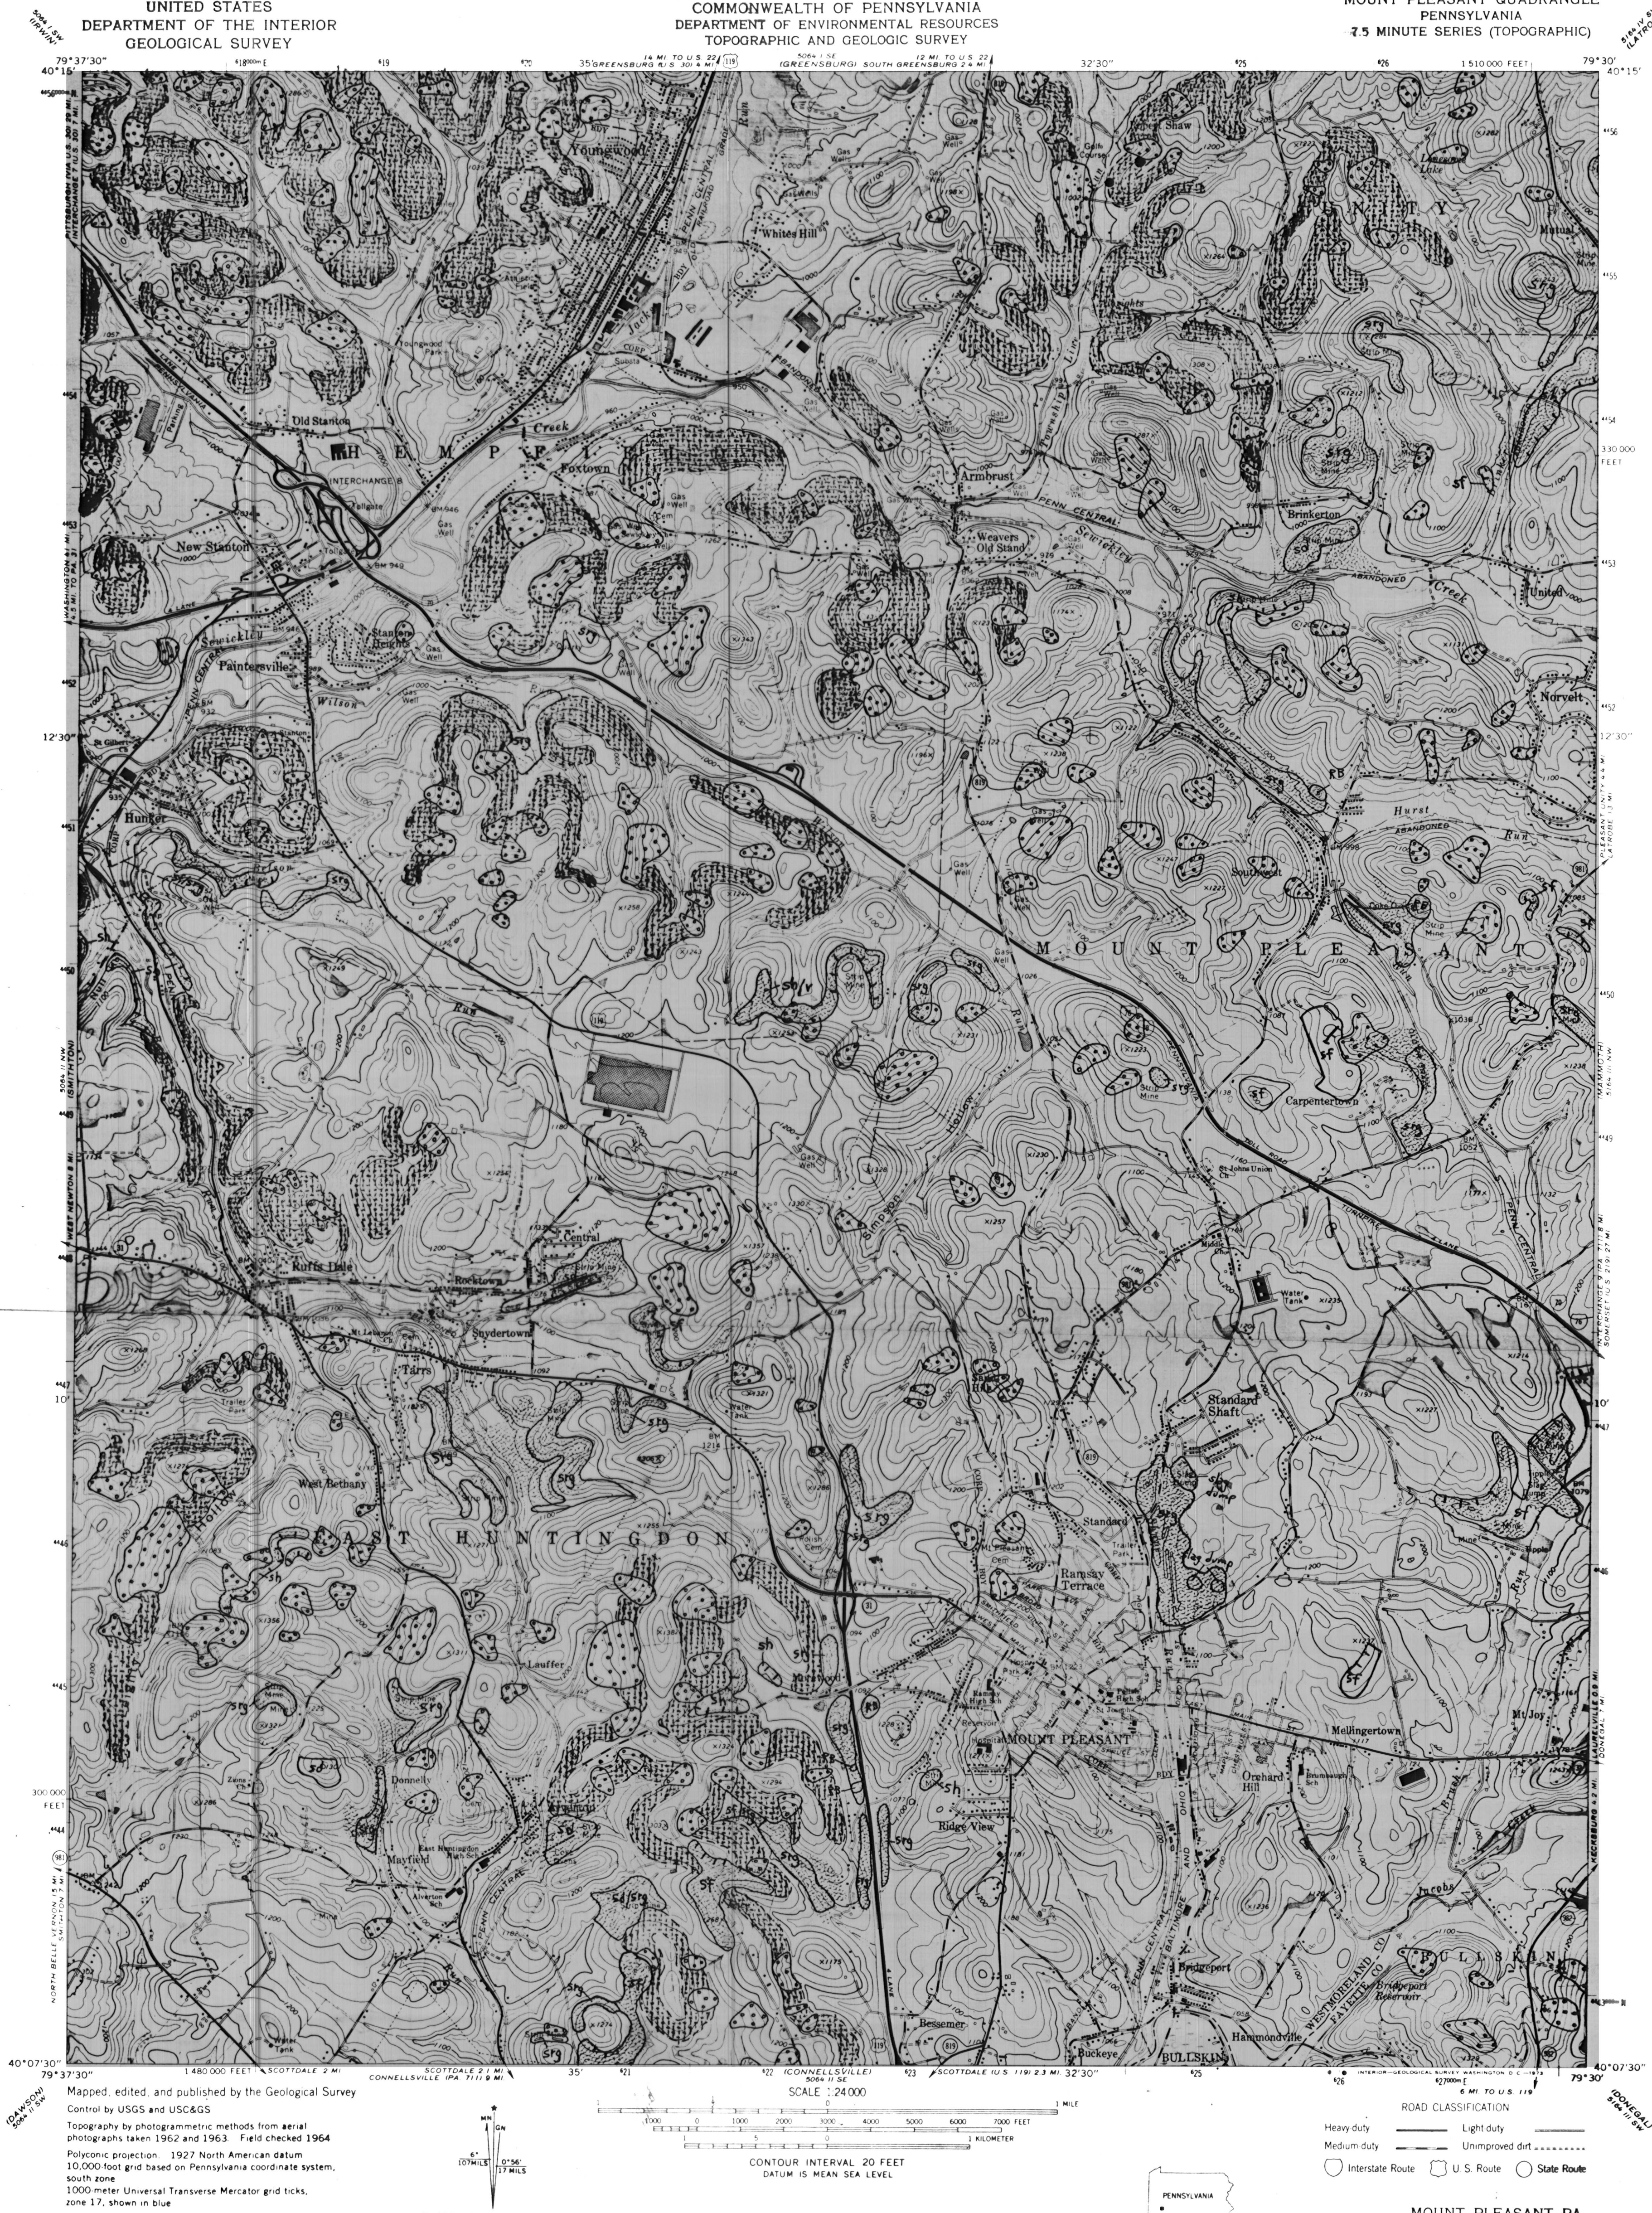
ACTIVE OR RECENTLY ACTIVE LANDSLIDE
Complex landslide composed of earthflow, debris
slide, earth and rock slump. Identified from
historical records, and from scars, debris and
other field evidence. Ground extremely unstable;
sliding accelerated by excavation, loading and
changes in drainage conditions. May include
areas with several active slides too small to
be shown separately. Questioned where doubtful.

OLD LANDSLIDE
Area of extensive hummocky ground caused by
earthflow and earth and rock slump. Lacks
clear evidence of active sliding. Relatively
stable in natural, undisturbed state,
generally not affected by small structures properly
sited in areas away from the edge of the toe;
can be reactivated by extensive, rapid exca-
vation, loading, and changes in ground water and
surface water conditions. Area of old landslide
probably includes recent ones not identified
from field evidence or otherwise documented.
Upslope boundary of landslide generally defined
by modified scarp, but downslope (toe) may be
gradational and not well defined. Questioned
where doubtful.

COLLUVIAL SLOPE
Valley wall along major streams with slope as
steep as 40° (85%); stony, clayey silt soil up
to 50 ft. (15 m) thick; commonly buttressed by
a terrace or bench at the toe of the slope; very
susceptible to sliding by cutting of toe area,
removal of terrace or bench, and overloading;
slide commonly activated without apparent cause.

**AREAS SUSCEPTIBLE TO DEBRIS FLOWS AND DEBRIS
AVALANCHES**
Primarily shallow, narrow ravines and chutes with
accumulation of stony colluvium generally 10 ft.
(3 m) or less in thickness; susceptible to rapid
movement during intense rainfall. Most ravines
and chutes designated show evidence of former
debris flows and avalanches. Symbol & desig-
nates historical debris flow or debris avalanche.

AREAS SUSCEPTIBLE TO ROCKFALL
Steep, locally vertical, natural and man-made
slopes and cliffs, 15 ft. (4.5 m) or more high;
formed dominantly of sandstone, limestone, sandy
shale, mudstone and claystone. Interbedded mud-
stone, claystone and shale weather rapidly leaving
sandstone and limestone rock faces unsupported.

SOIL AND ROCK SUSCEPTIBLE TO LANDSLIDING
Soil and rock similar to that involved in land-
slides elsewhere in map area; primarily areas
underlain by claystone, mudstone and shale
associated with other rock types. Rock weathers
rapidly on exposure forming clayey soil highly
susceptible to sliding. Includes coves (U-shaped,
shallow valleys) containing thick layers of clayey
soil that are very susceptible to sliding where
excavation breaks continuity of slope and where
overloaded by artificial fill.
