Landslides and related features interpreted
from aerial photographs:
1:40,000 (black and white) 1974

LANDSLIDES AND RELATED FEATURES

OF THE ELDERTON, PA. QUADRANGLE
by
John S. Pomeroy
1979
U.S. Geological Survey
OPEN FILE MAP 79-1314 (F-6)

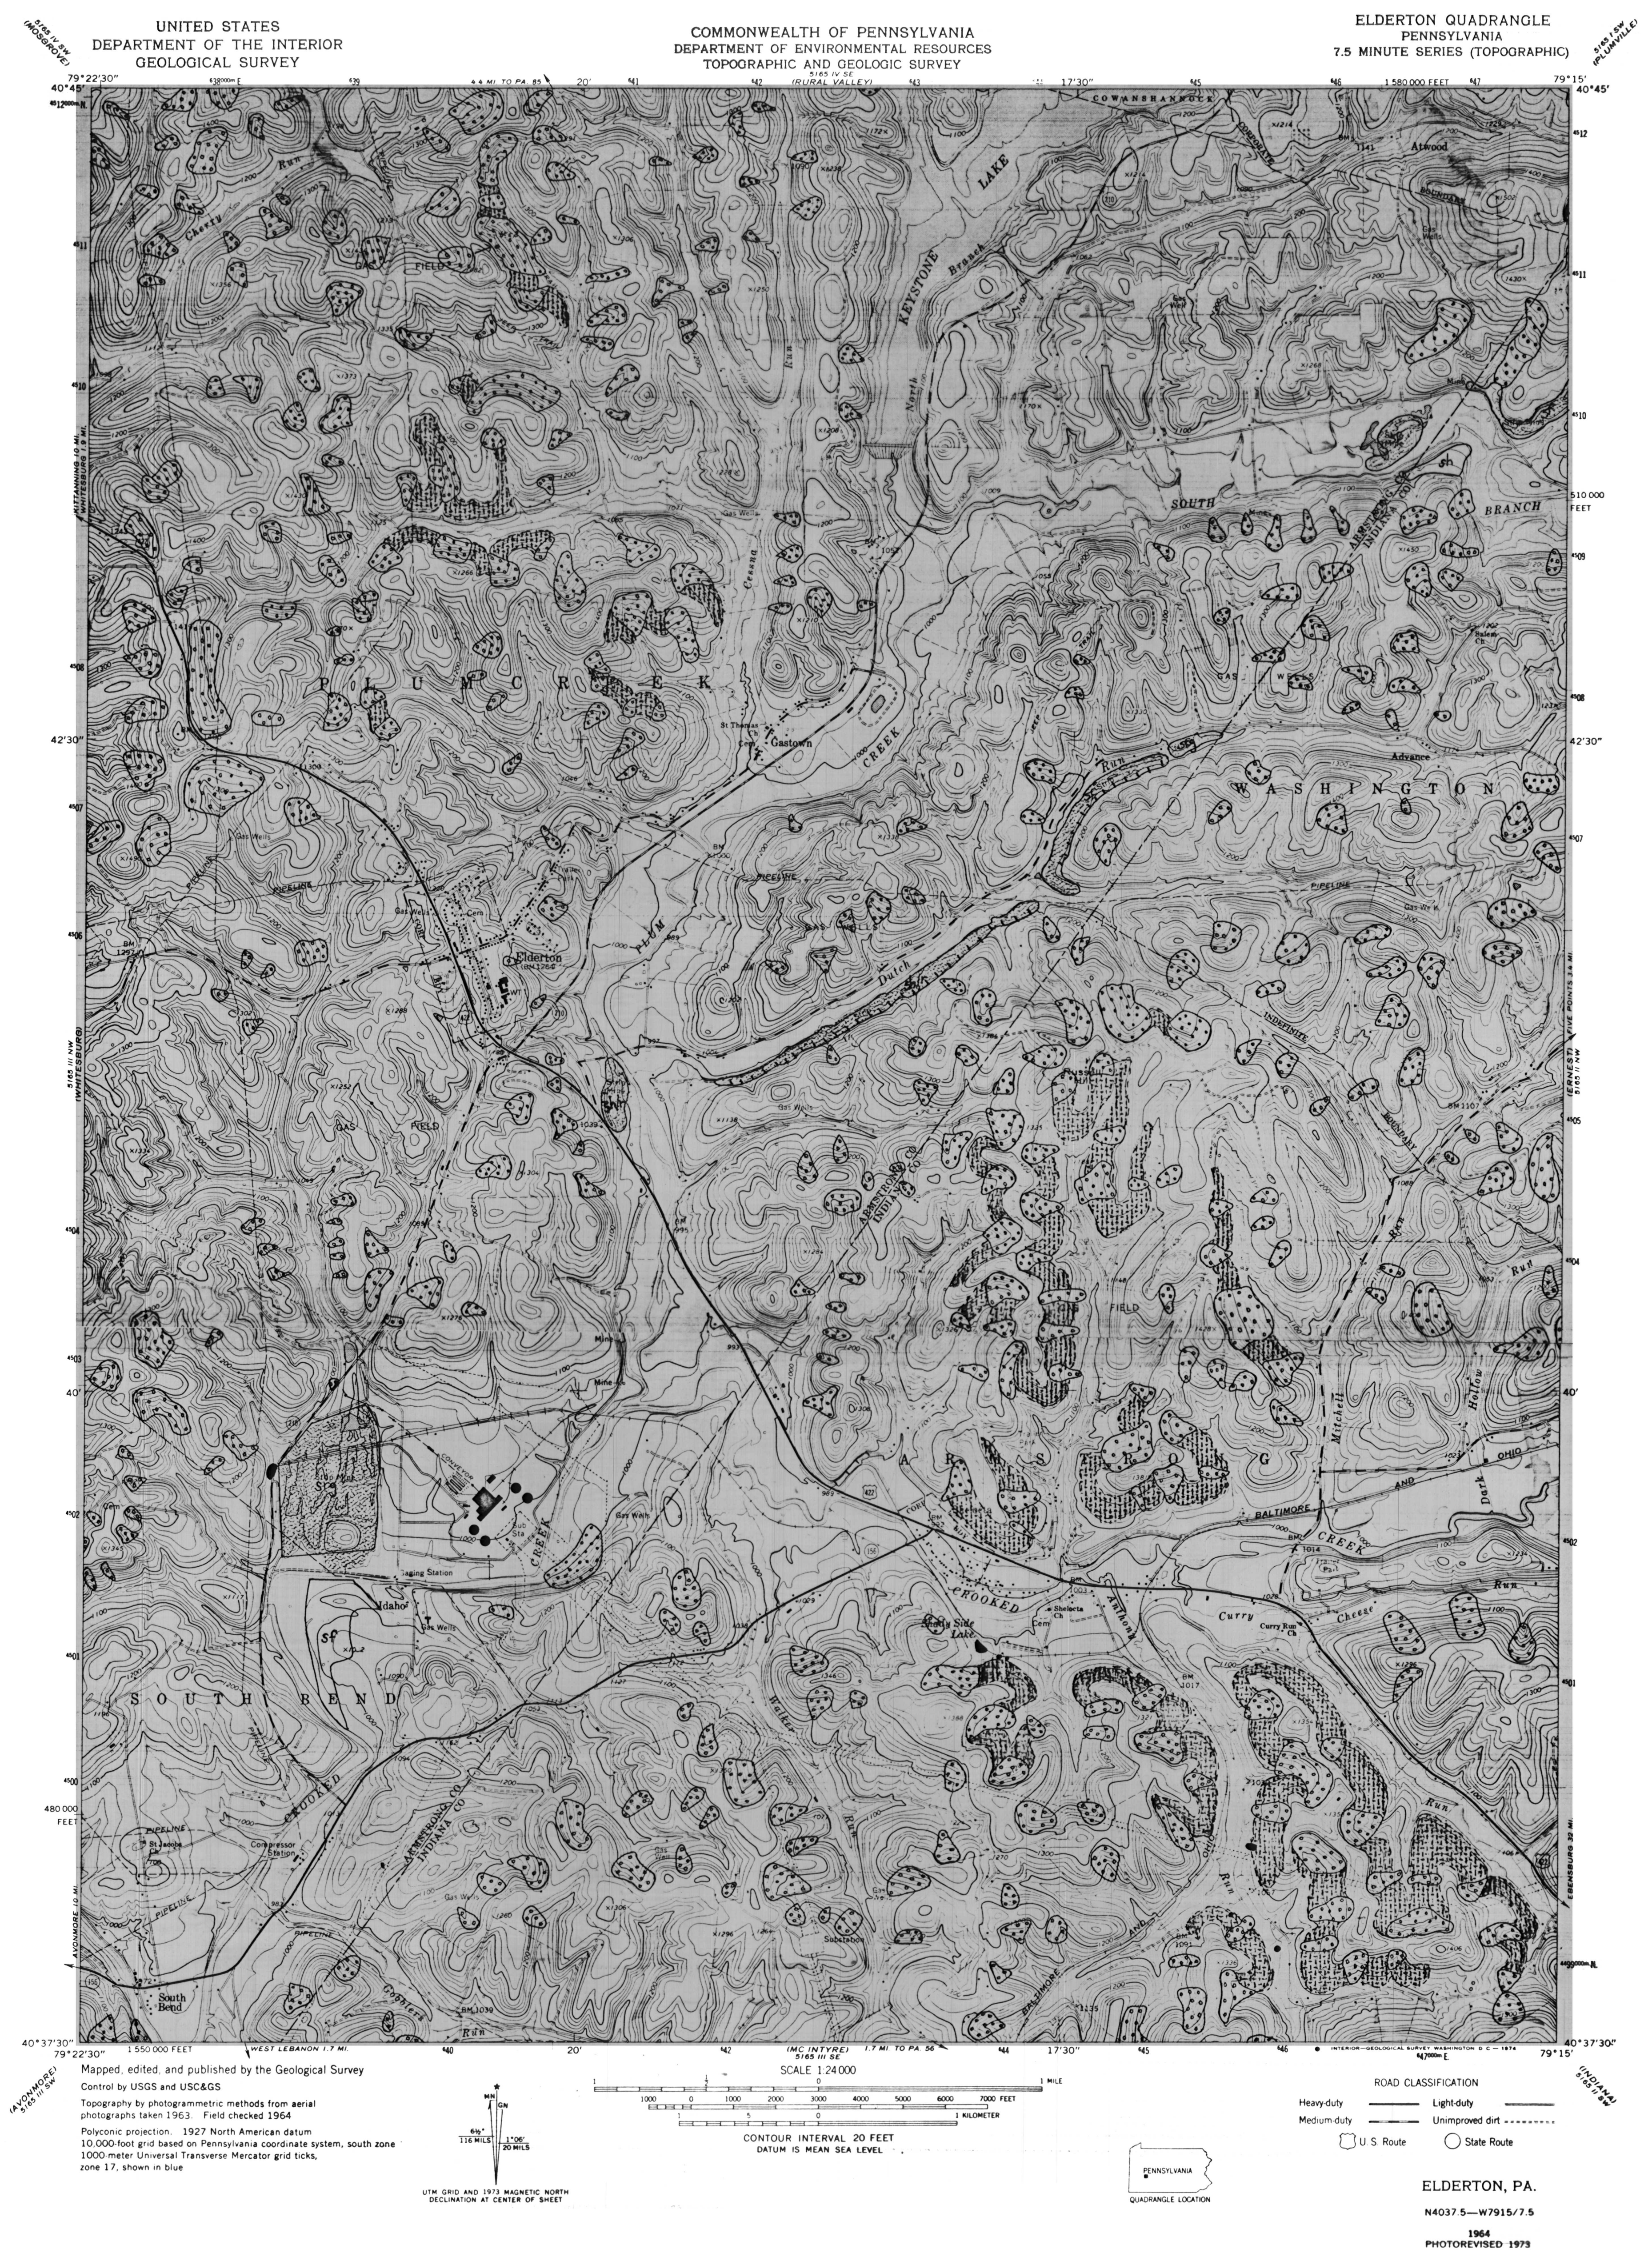
- ACTIVE OR RECENTLY ACTIVE LANDSLIDE**
Complex landslide composed of earthflow, debris slide, earth and rock slump. Identified from historical records, and from scars, debris and other field evidence. Ground extremely unstable; sliding accelerated by excavation, loading and changes in drainage conditions. May include areas with several active slides too small to be shown separately. Questioned where doubtful.

- OLD LANDSLIDE**
Area of extensive hummocky ground caused by earthflow and earth and rock slump. Lacks clear evidence of active sliding. Relatively stable in natural, undisturbed state, generally not affected by small structures properly sited in areas away from the edge of the toe; can be reactivated by extensive, rapid excavation, loading, and changes in ground water and surface water conditions. Area of old landslide probably includes recent ones not identified from field evidence or otherwise documented. Upslope boundary of landslide generally defined by modified scarps, but downslope (toe) may be gradational and not well defined. Questioned where doubtful.

- COMBINATION LANDSLIDE**
Area of recent and old slides in which individual slides are not identified.
- COLLUVIAL SLOPE**
Valley wall along major streams with slope as steep as 40° (85%); stony, clayey silt soil up to 50 ft. (15 m) thick; commonly buttressed by a terrace or bench at the toe of the slope; very susceptible to sliding by cutting of toe area, removal of terrace or bench, and overloading; slide commonly activated without apparent cause.

- SCREE**
Residual accumulations of coarse rock material lying on quartzite slopes of the Valley and Ridge province. Generally stable except where subjected to extreme rainfall.

- COLLUVIAL SLOPES WITH LANDSLIDES**
Landslides too small or obscure to map individually.
- AREAS SUSCEPTIBLE TO DEBRIS FLOWS AND DEBRIS AVALANCHES**
Primarily shallow, narrow ravines and chutes with accumulation of stony colluvium generally 10 ft. (3 m) or less in thickness; susceptible to rapid movement during intense rainfall. Most ravines and chutes designated show evidence of former debris flows and avalanches. Symbol & designates historical debris flow or debris avalanche.

- AREAS SUSCEPTIBLE TO ROCKFALL**
Steep, locally vertical, natural and man-made slopes and cliffs, 15 ft. (4.5 m) or more high; formed dominantly of sandstone, limestone, sandy shale, mudstone and claystone. Interbedded mudstone, claystone and shale weather rapidly leaving sandstone and limestone rock faces unsupported.

- SOIL AND ROCK SUSCEPTIBLE TO LANDSLIDING**
Soil and rock similar to that involved in landslides elsewhere in map area; primarily areas underlain by claystone, mudstone and shale associated with other rock types. Rock weathers rapidly on exposure forming clayey soil highly susceptible to sliding. Includes coves (U-shaped, shallow valleys) containing thick layers of clayey soil that are very susceptible to sliding where excavation breaks continuity of slope and where overloaded by artificial fill.

- AREAS LEAST PRONE TO LANDSLIDES**
Map areas in which no patterns or symbols are shown; primarily valley floors, ridge tops and broad benches; modification by excavation and fill may lead to local landslides. Includes slopes where landslides are sparse.

- MAN-MADE FEATURES**
Strip mines (combination of letter symbols indicates complex formed of more than one type of strip mine)
- sh bench with high wall (In Allegheny County benches and furrows are shown by sh).
 - sf furrowed with high wall
 - sd multiple furrows and multiple benches
 - ss hilltop removed
 - srq reclaimed by grading
 - sru reclaimed by secondary use
 - sh/r regraded in part, high wall remains
- Coal refuse banks**
r identified on aerial photographs; not classified in field check
- rb not burnt nor on fire
 - rbb burnt
 - rbd burning
 - rbs sludge
- Quarries**
q quarry site
qub spoil bank, quarry waste
- Gravel pits**
g site of gravel pit
- Slides in man-made features**
af earth flow in fill
a/s earth flow in strip castings
a/r earth flow in coal refuse

NOTE
Information shown is intended as a general guide to ground conditions as of the date of field check. Additional landslides and rockfalls should be anticipated in all map units. The map unit depicts the dominant condition in the area delineated and variations in slope stability may occur at any point in the unit. This map is suitable for general planning purposes and as a supplement to more detailed studies for site selection. The map cannot be used as a substitute for detailed geologic and engineering investigations to establish design and construction criteria of specific sites. Some symbols may not appear on this map because the description is applicable to a series of maps.

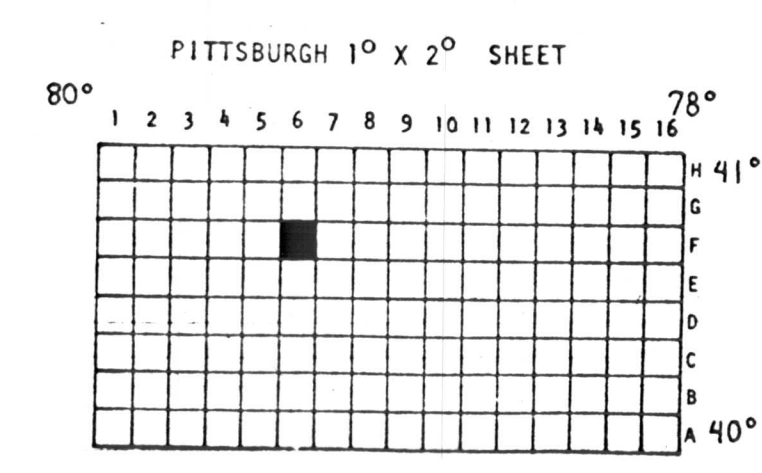
The first five digits of the open file number designate the specific 1:250,000 scale map sheet of which this quadrangle is a part. The last two digits designate the position of the quadrangle in a subdivision of the 1:250,000 scale map based on rows and tiers shown in the diagram to the right. The location of this quadrangle is shown by the black square.
