This map has not been edited or reviewed

PITTSBURGH 10 X 20 SHEET

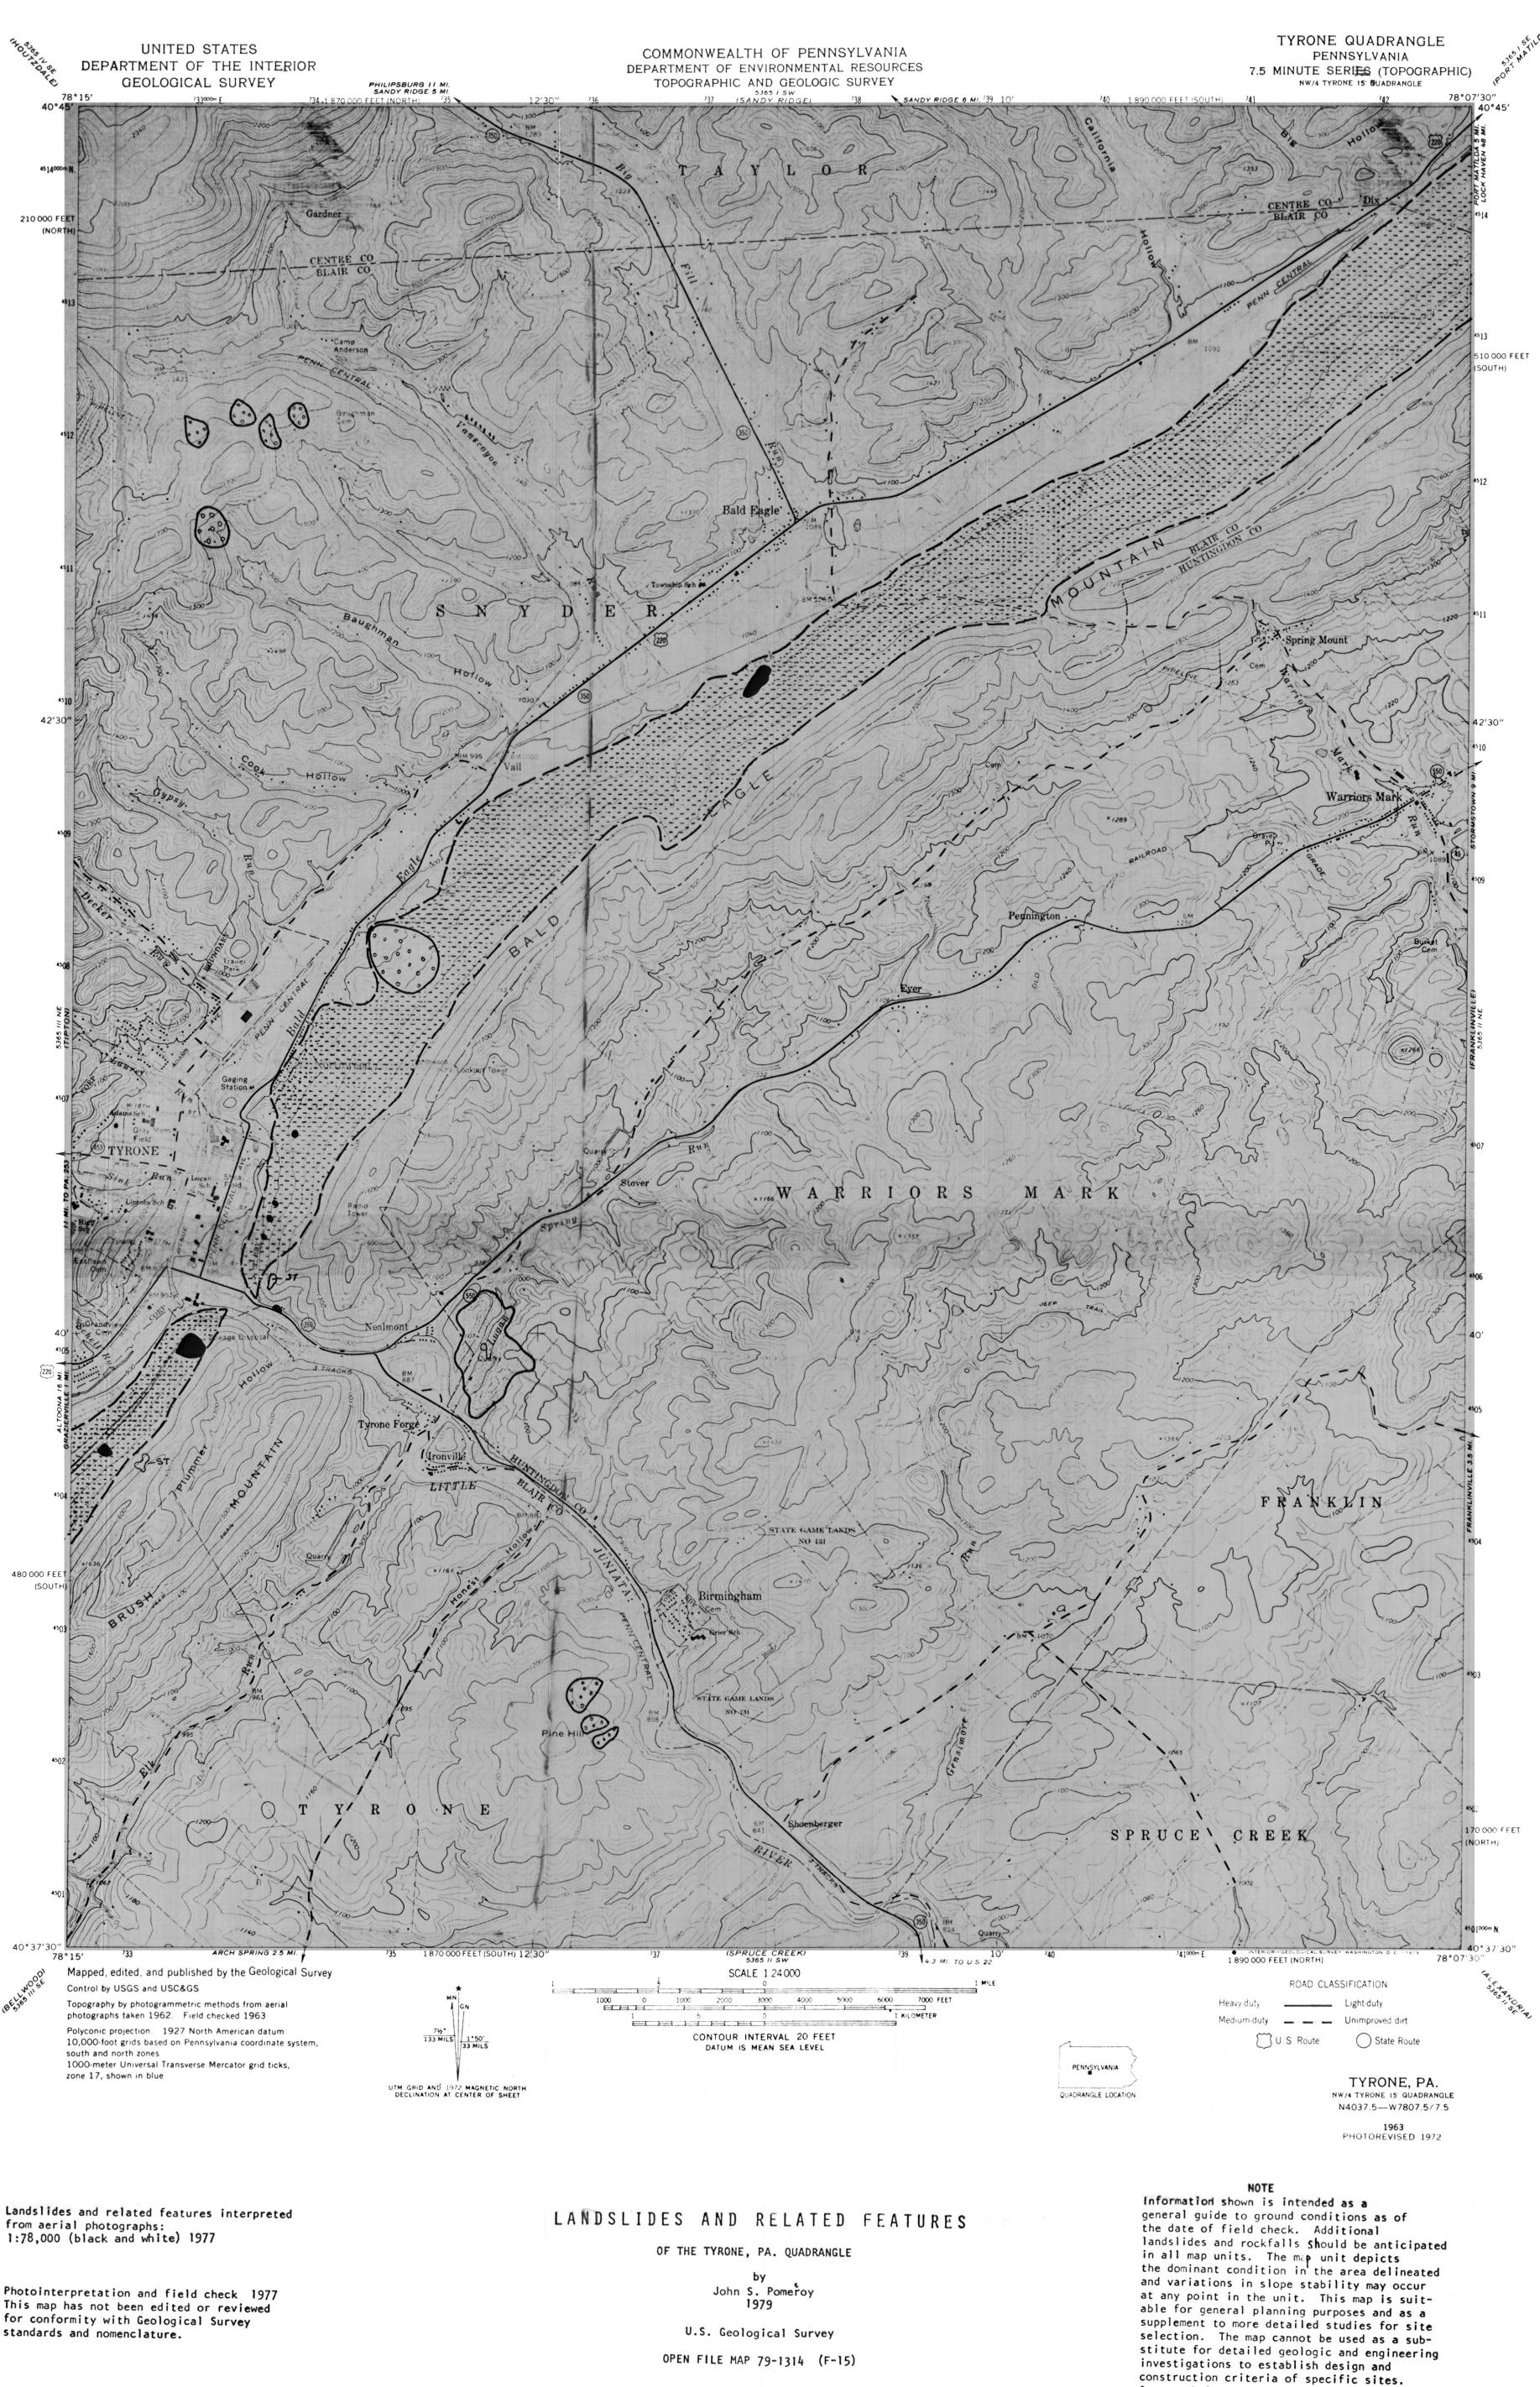
ACTIVE OR RECENTLY ACTIVE LANDSLIDE Complex landslide composed of earthflow, debris slide, earth and rock slump. Identified from historical records, and from scars, debris and other field evidence. Ground extremely unstable; eliding accelerated by excevation, loading and changes in drainage conditions. May include areas with several active slides too small to be shown separately. Questioned where doubtful.

OLD LANDSLIDE Area of extensive hummocky ground caused by earthflow and earth and rock slump. Lacks clear evidence of active sliding. Relatively stable in natural, undisturbed state,

generally not affected by small structures properly sited in areas away from the edge of the toe; can be reactivated by extensive, rapid excavation, loading, and changes in ground water and surface water conditions. Area of old landslide probably includes recent ones not identified from field evidence or otherwise documented. Upslope boundary of landslide generally defined by modified scarp, but downslope (toe) may be gradational and not well defined. Questioned where doubtful.

COMBINATION LANDSLIDE Area of recent and old slides in which individual slides are not identified.

Valley wall along major streams with slope as steep as 40° (85%); stony, clayey silt soil up to 50 ft. (15 m) thick; commonly buttressed by a terrace or bench at the toe of the slope; very susceptible to sliding by cutting of toe area, removal of terrace or bench, and overloading; slide commonly activated without apparent cause.

COLLUVIAL SLOPES WITH LANDSLIDES Landslides too small or obscure to map individually.

AREAS SUSCEPTIBLE TO DEBRIS FLOWS AND DEBRIS **AVALANCHES**

Primarily shallow, narrow ravines and chutes with accumulation of stony colluvium generally 10 ft. (3 m) or less in thickness; susceptible to rapid movement during intense rainfall. Most ravines and chutes designated show evidence of former

AREAS SUSCEPTIBLE TO ROCKFALL Steep, locally vertical, natural and man-made slopes and cliffs, 15 ft. (4.5 m) or more high; formed dominantly of sandstone, limestone, sandy shale, mudstone and claystone. Interbedded mudstone, claystone and shale weather rapidly leaving sandstone and limestone rock faces unsupported.

SOIL AND ROCK SUSCEPTIBLE TO LANDSLIDING Soil and rock similar to that involved in landslides elsewhere in map area; primarily areas underlain by claystone, mudstone and shale associated with other rock types. Rock weathers rapidly on exposure forming clayey soil highly susceptible to sliding. includes coves (U-shaped. shallow valleys) containing thick layers of clayey soil that are very susceptible to sliding where excavation breaks continuity of slope and where overloaded by artificial fill.

AREAS LEAST PRONE TO LANDSLIDES Map areas in which no patterns or symbols are shown; primarily valley floors, ridge tops and broad benches; modification by excavation and fill may lead to local landslides.
