LANDSLIDES AND RELATED FEATURES

OF THE CARROLLTOWN, PA. QUADRANGLE

by
John S. Pomeroy
1979

OPEN FILE MAP 79-1314 (E-11)

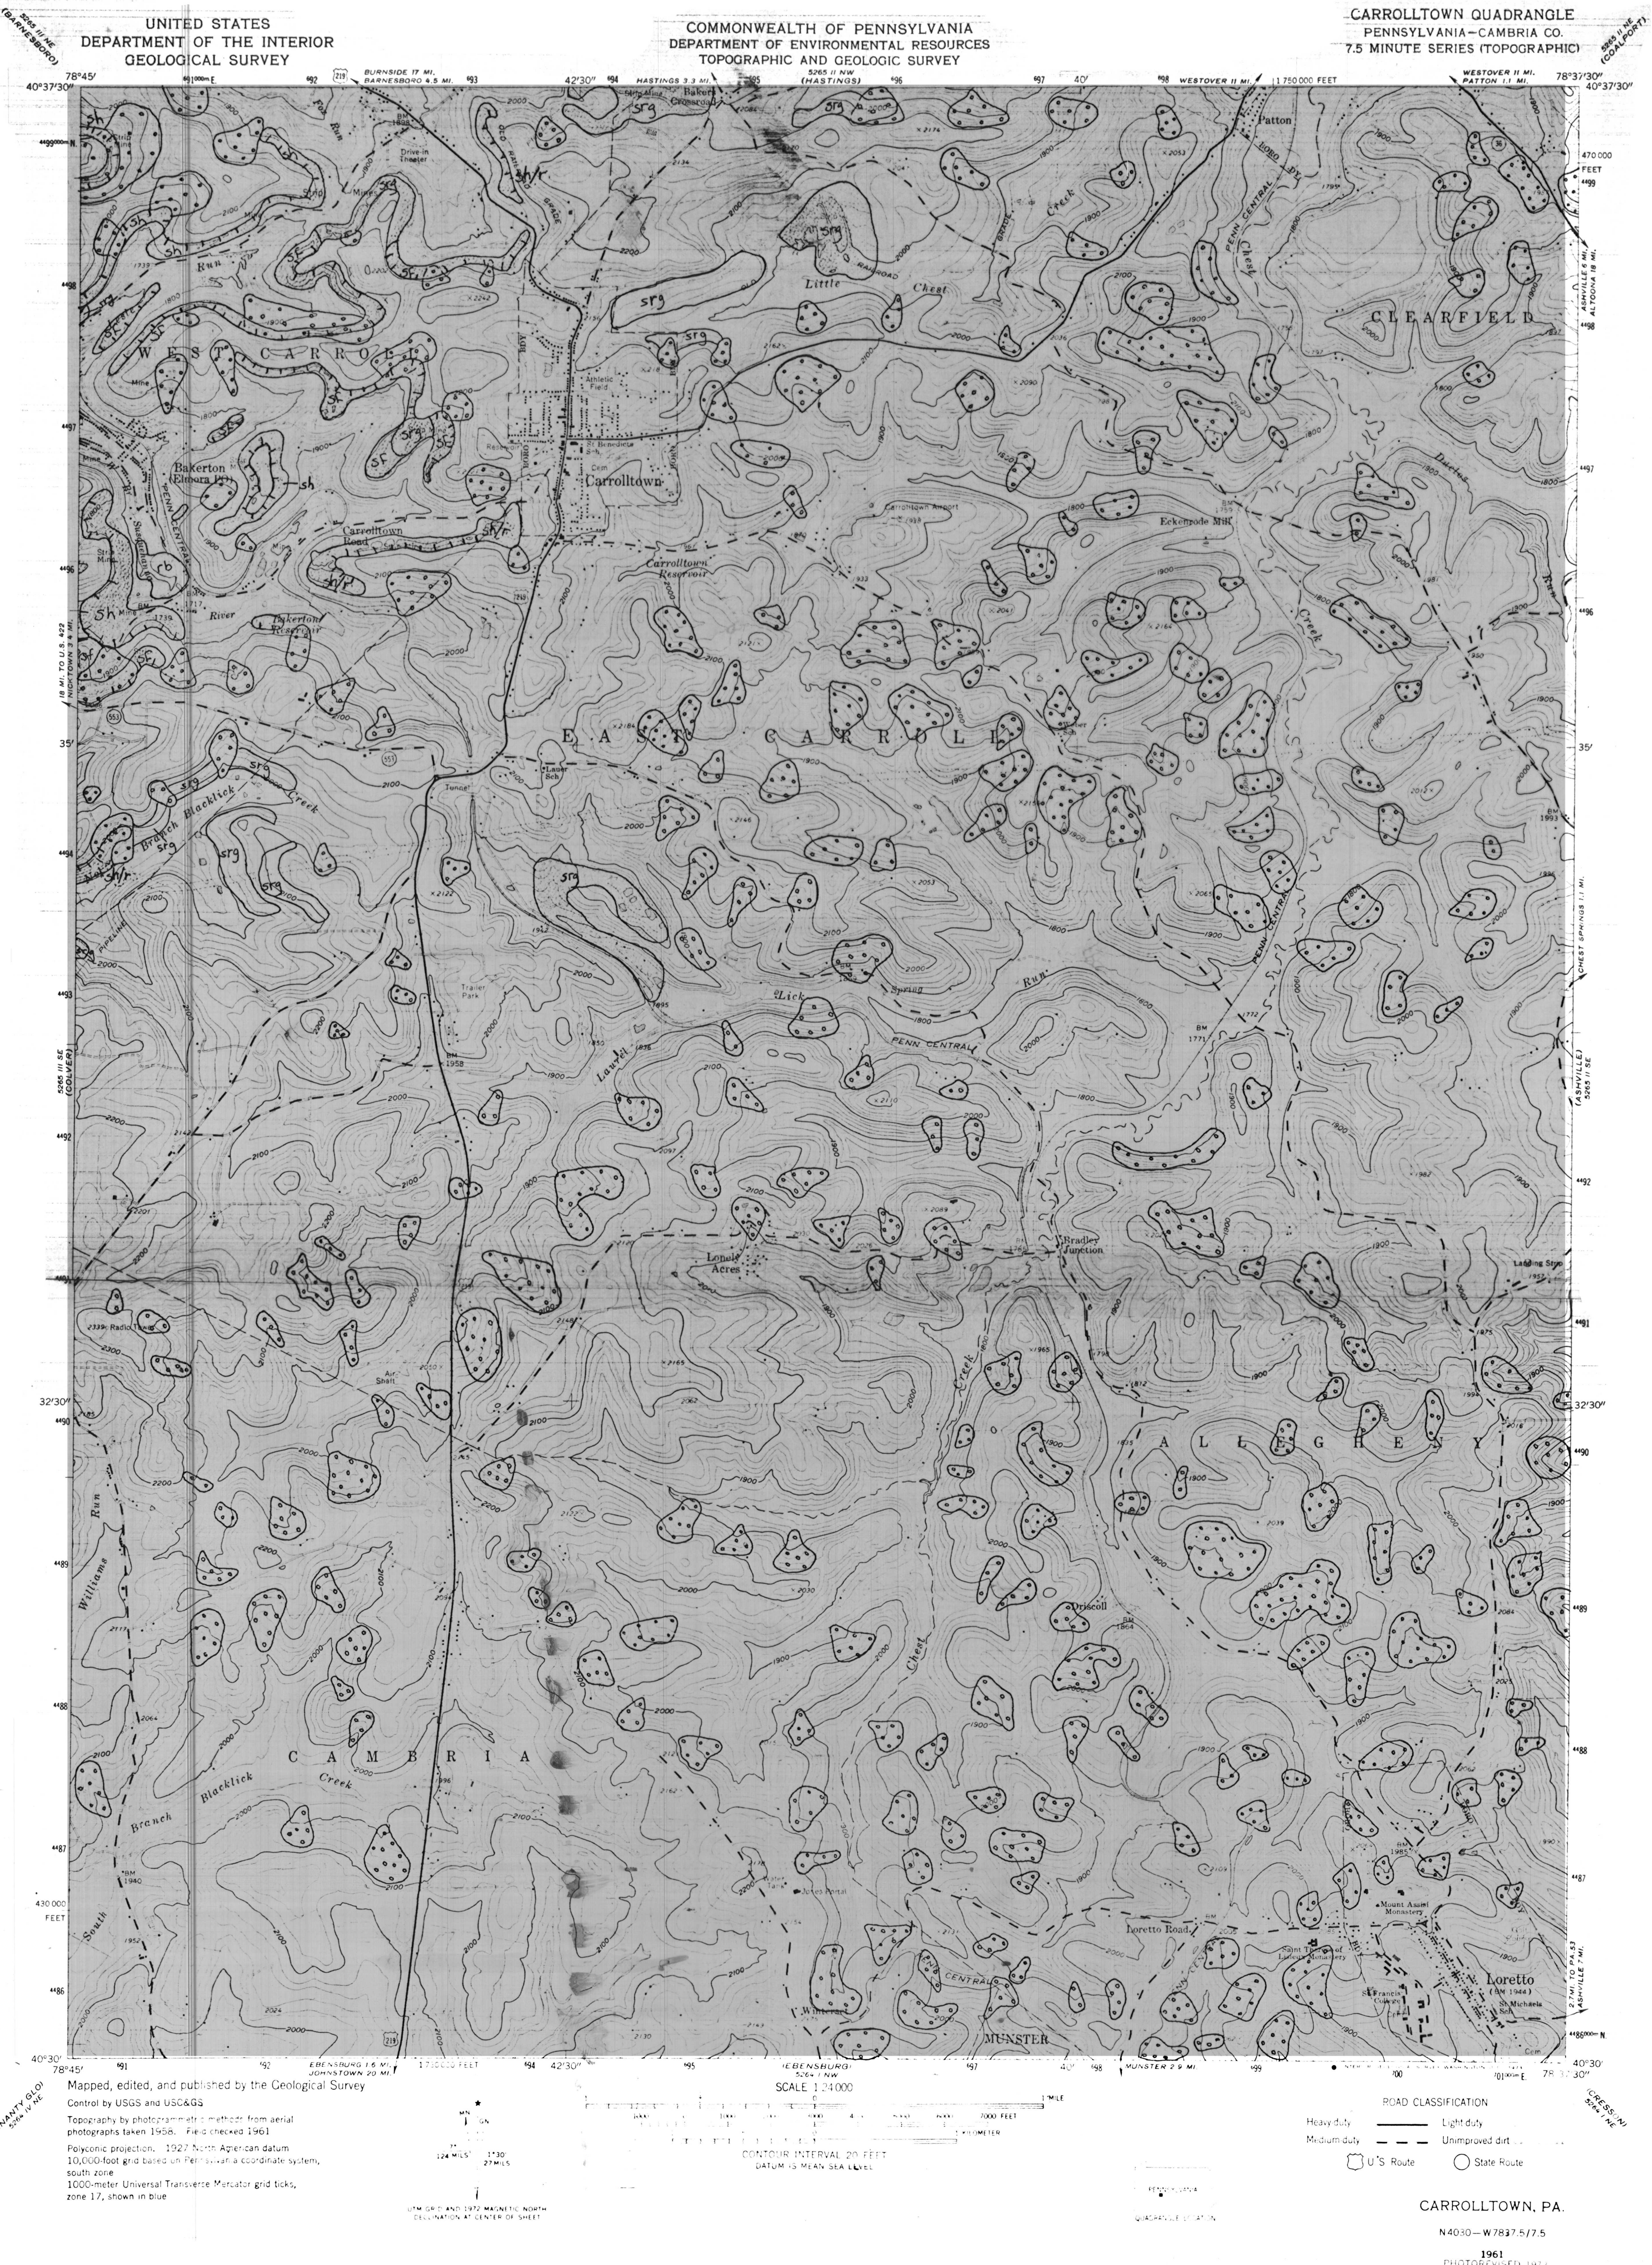
Landslides and related features interpreted from aerial photographs: 1:78,000 (black and white) 1977

Photointerpretation and field check 1977
This map has not been edited or reviewed for conformity with Geological Survey standards and nomenclature.

ACTIVE OR RECENTLY ACTIVE LANDSLIDE

Complex landslide composed of earthflow, debris slide, earth and rock slump. Identified from historical records, and from scars, debris and other field evidence. Ground extremely unstable; sliding accelerated by excavation, loading and changes in drainage conditions. May include areas with several active slides too small to be shown separately. Questioned where doubtful.

OLD LANDSLIDE

Area of extensive hummocky ground caused by earthflow and earth and rock slump. Lacks clear evidence of active sliding. Relatively stable in natural, undisturbed state, generally not affected by small structures properly sited in areas away from the edge of the toe; can be reactivated by extensive, rapid excavation, loading, and changes in ground water and surface water conditions. Area of old landslide probably includes recent ones not identified from field evidence or otherwise documented. Upslope boundary of landslide generally defined by modified scarp, but downslope (toe) may be gradational and not well defined. Questioned where doubtful.

AREAS SUSCEPTIBLE TO DEBRIS FLOWS AND DEBRIS AVALANCHES

Primarily shallow, narrow ravines and chutes with accumulation of stony colluvium generally 10 ft. (3 m) or less in thickness; susceptible to rapid movement during intense rainfall. Most ravines and chutes designated show evidence of former debris flows and avalanches. Symbol also designates historical debris flow or debris avalanche.

AREAS SUSCEPTIBLE TO ROCKFALL

Steep, locally vertical, natural and man-made slopes and cliffs, 15 ft. (4.5 m) or more high; formed dominantly of sandstone, limestone, sandy shale, mudstone and claystone. Interbedded mudstone, claystone and shale weather rapidly leaving sandstone and limestone rock faces unsupported.

SOIL AND ROCK SUSCEPTIBLE TO LANDSLIDING

Soil and rock similar to that involved in landslides elsewhere in map area; primarily areas underlain by claystone, mudstone and shale associated with other rock types. Rock weathers rapidly on exposure forming clayey soil highly susceptible to sliding. Includes coves (U-shaped, shallow valleys) containing thick layers of clayey soil that are very susceptible to sliding where excavation breaks continuity of slope and where overloaded by artificial fill.

AREAS LEAST PRONE TO LANDSLIDES

Map areas in which no patterns or symbols are shown, primarily valley floors, ridge tops and broad benches; modification by excavation and fill may lead to local landslides. Includes slopes where landslides are sparse.
