### LANDSLIDES AND RELATED FEATURES

OF THE HASTINGS, PA. QUADRANGLE

by  
John S. Pomeroy  
1979

OPEN FILE MAP 79-1314 (F-11)

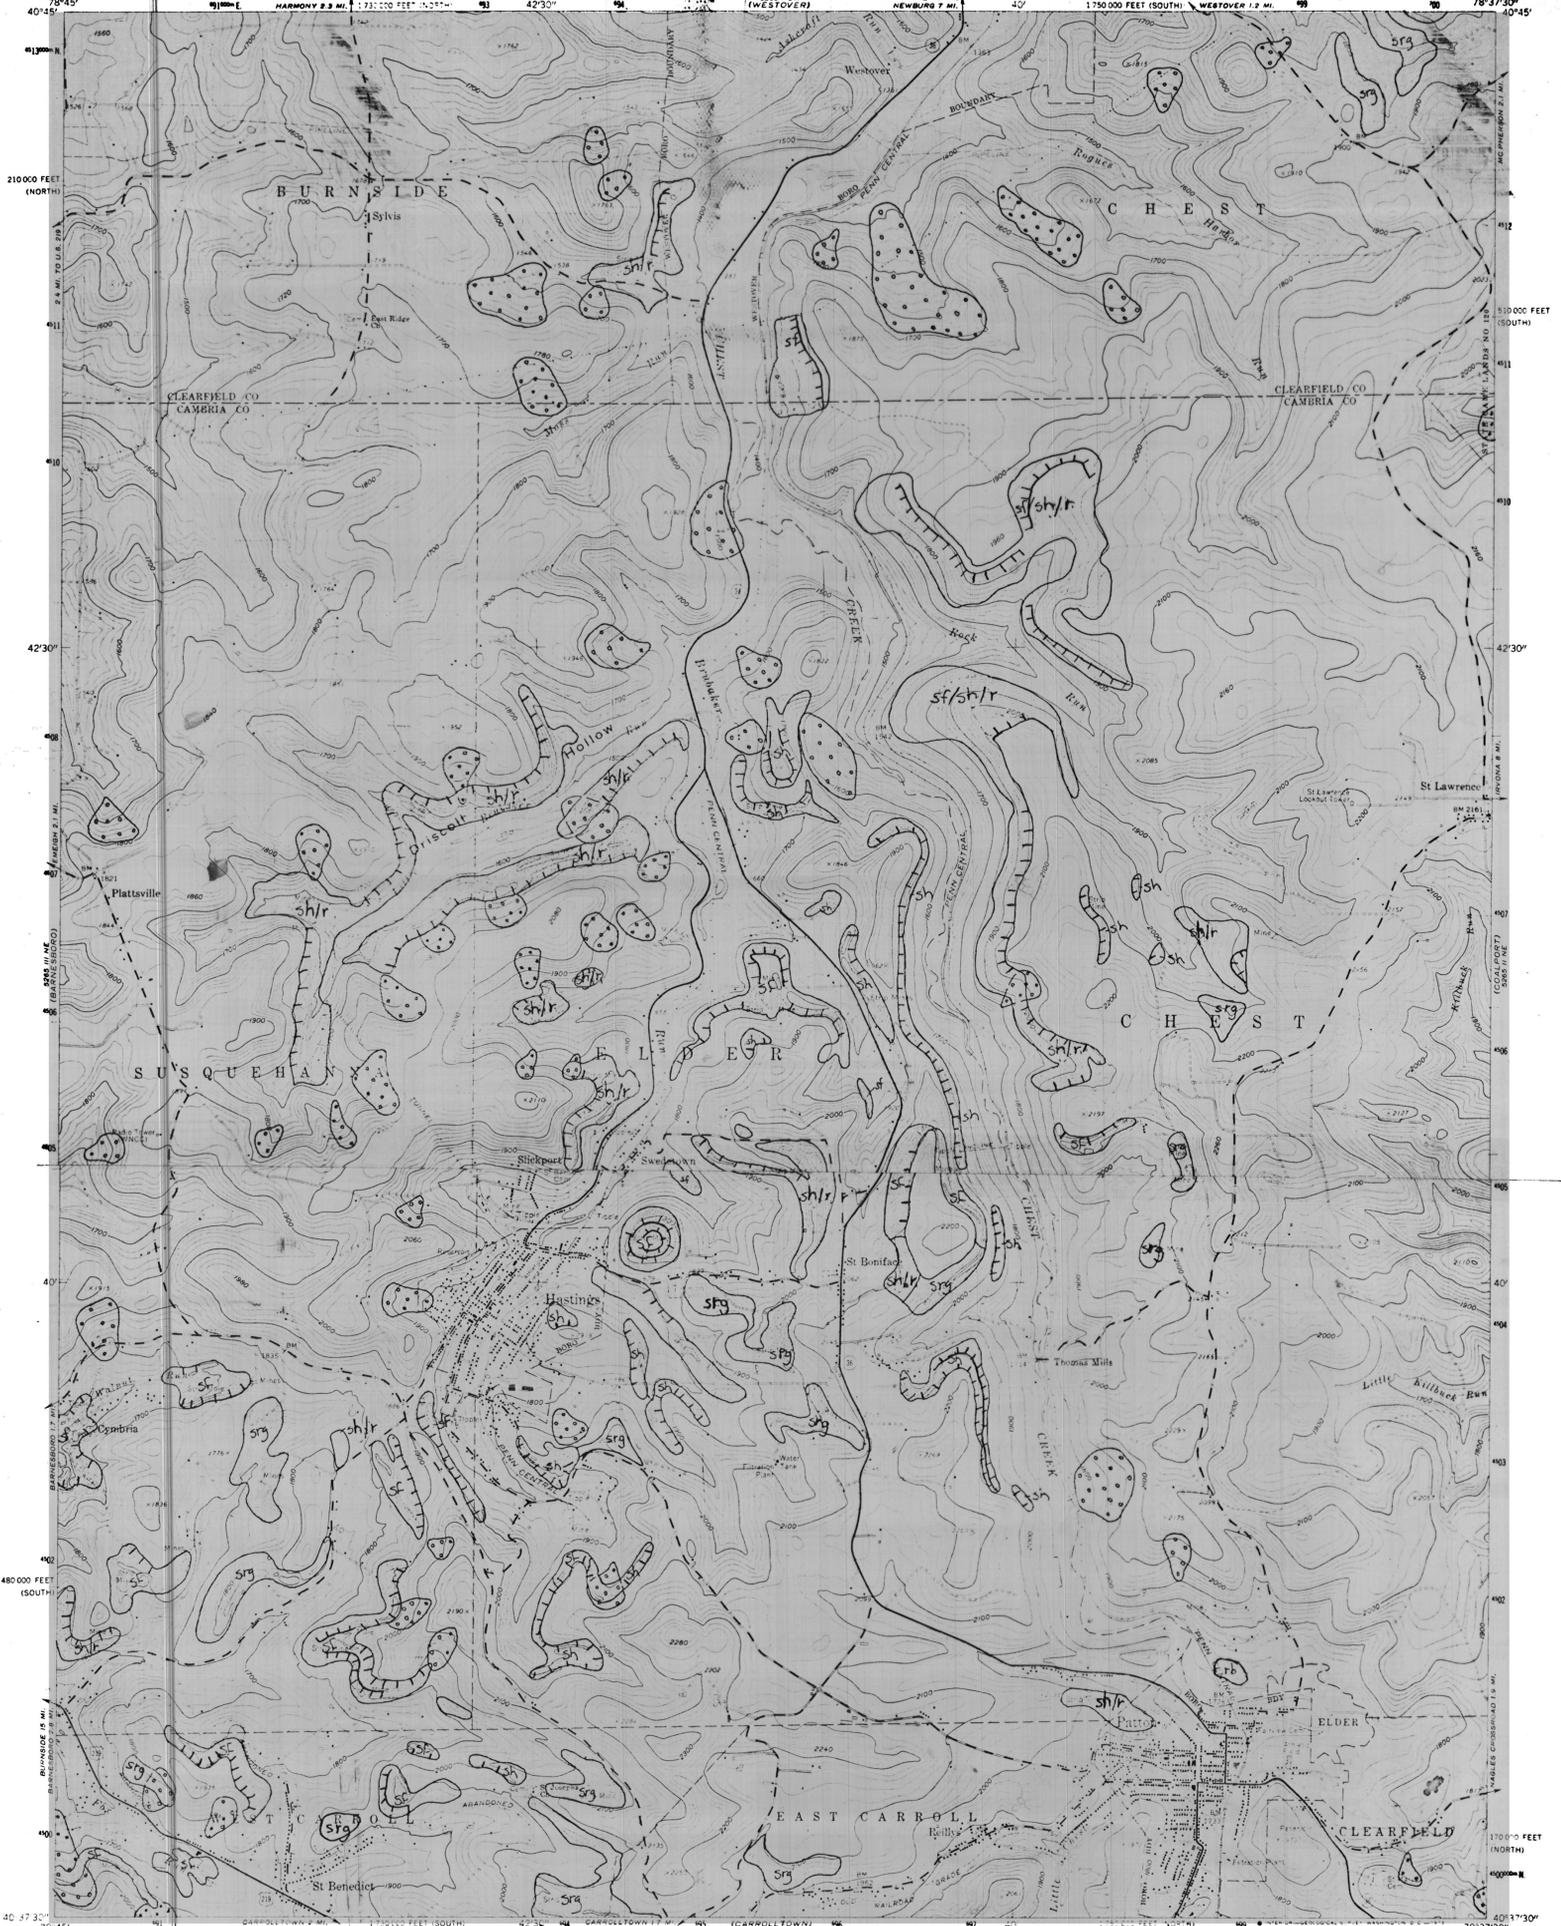
HASTINGS, PA.  
N4337.5-W7837.5/7.5  
1961  
PHOTOREVISED 1972

Landslides and related features interpreted  
from aerial photographs:  
1:70,000 (black and white) 1977

Photointerpretation and field check 1977  
This map has not been edited or reviewed  
for conformity with Geological Survey  
standards and nomenclature.
