### LANDSLIDES AND RELATED FEATURES

OF THE HOUTZDALE, PA. QUADRANGLE

by  
John S. Pomeroy  
1979

OPEN FILE MAP 79-1314 (G-14)

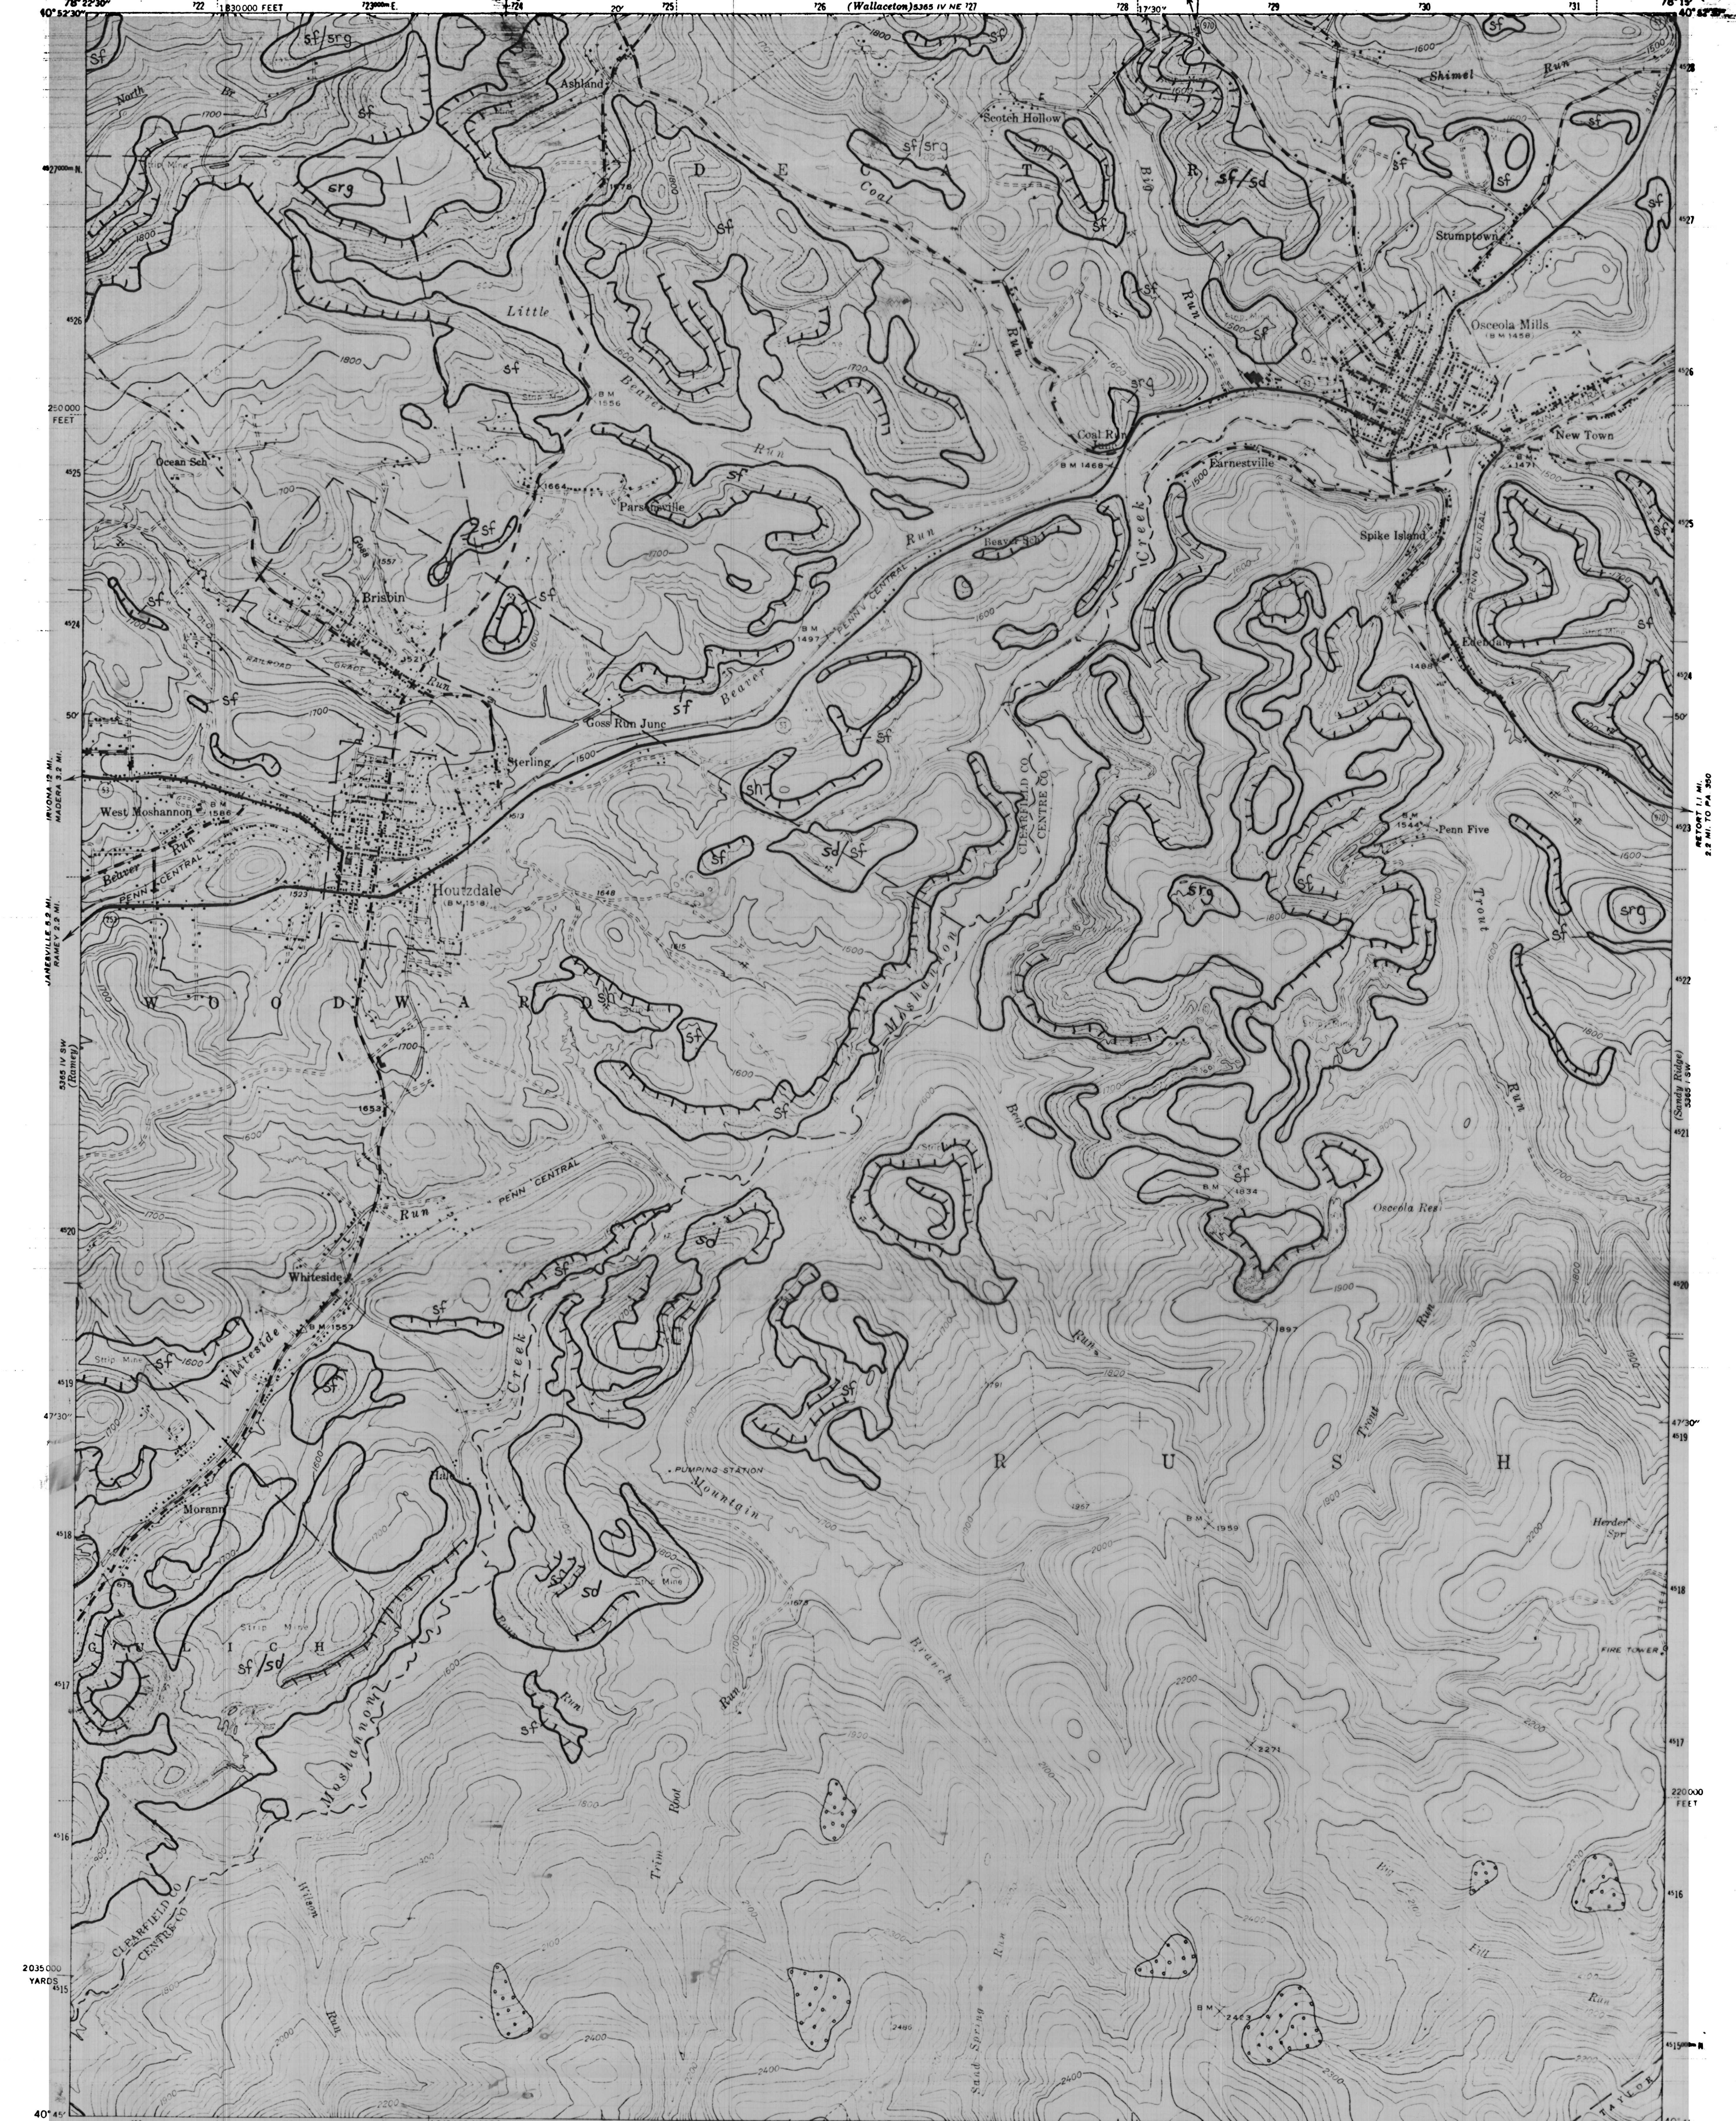
Landslides and related features interpreted  
from aerial photographs:  
1:78,000 (black and white) 1977

Photointerpretation and field check 1977  
This map has not been edited or reviewed  
for conformity with Geological Survey  
standards and nomenclature.
