LANDSLIDES AND RELATED FEATURES

OF THE EAST BUTLER, PA. QUADRANGLE

by
John S. Pomeroy
1979

OPEN FILE MAP 79-1314 (H-2)

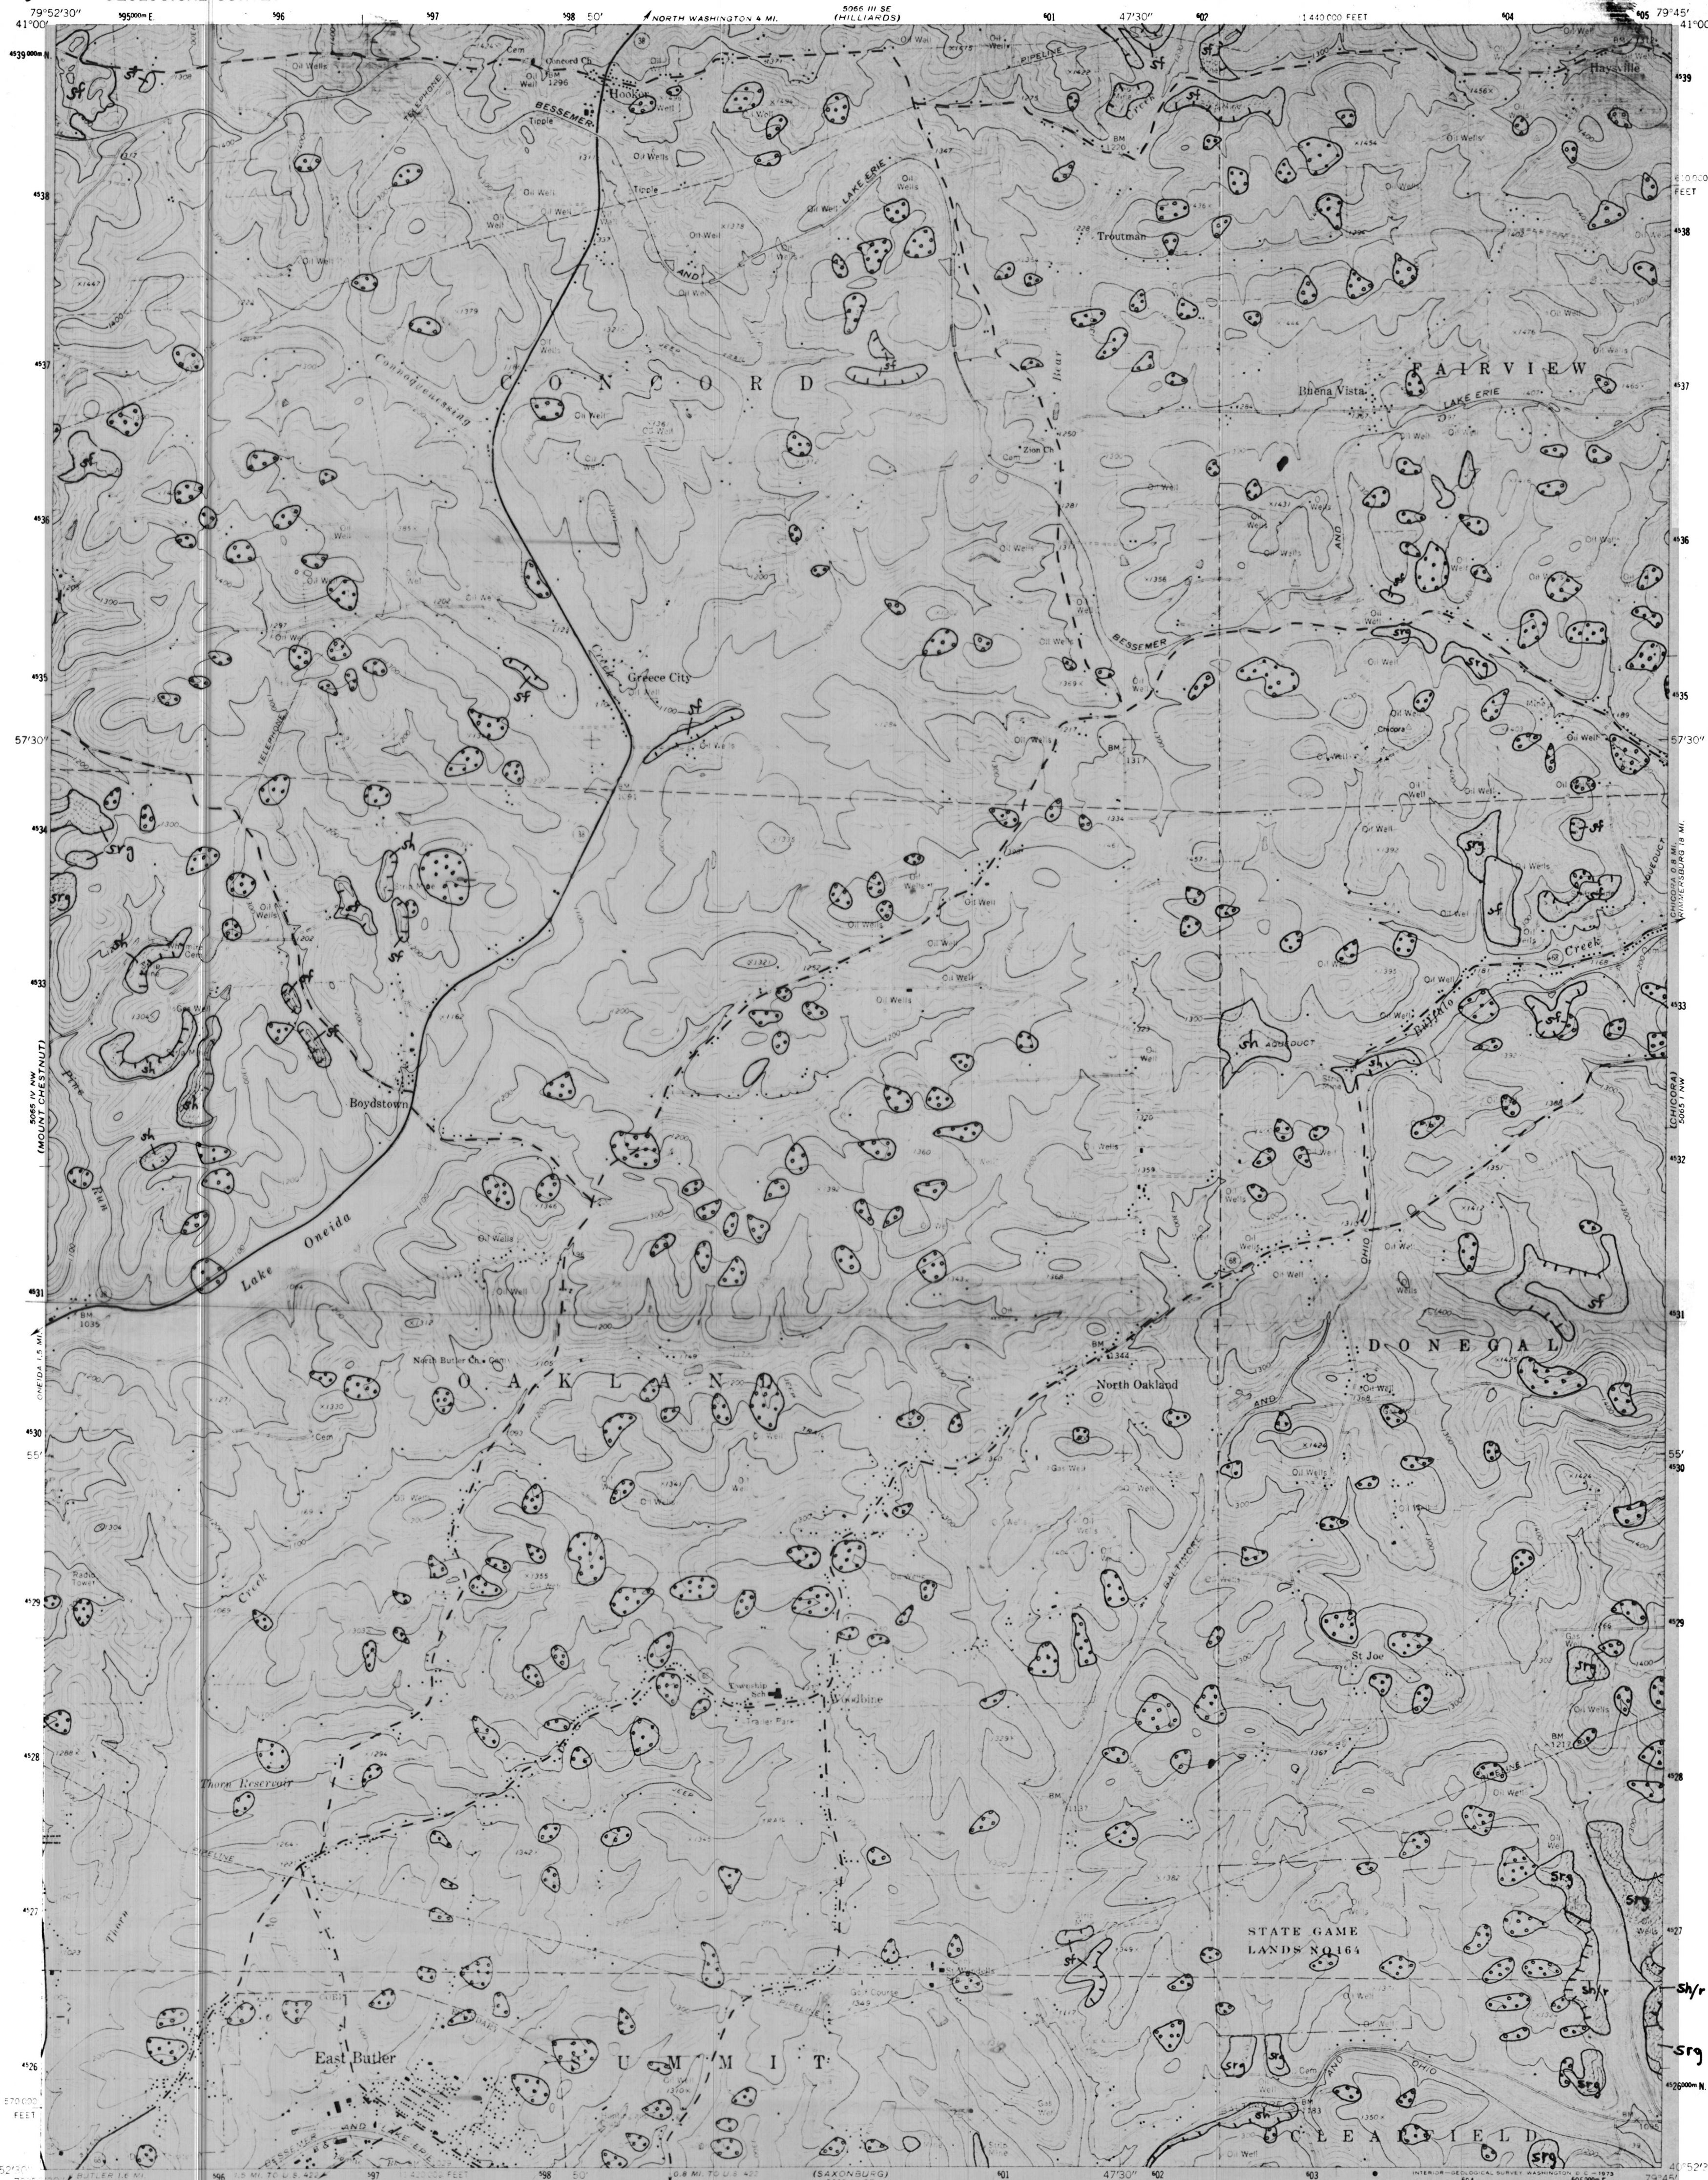
EAST BUTLER, PA.
N4052.5—W7945.7.5
1964
PHOTOREVISED 1972

Landslides and related features interpreted
from aerial photographs:
1:24,000 (black and white) 1975

Photointerpretation and field check 1975
This map has not been edited or reviewed
for conformity with Geological Survey
standards and nomenclature.
