LANDSLIDES AND RELATED FEATURES

OF THE MAHAFFEY, PA. QUADRANGLE

by
John S. Pomeroy
1979

OPEN FILE MAP 79-1314 (H-11)

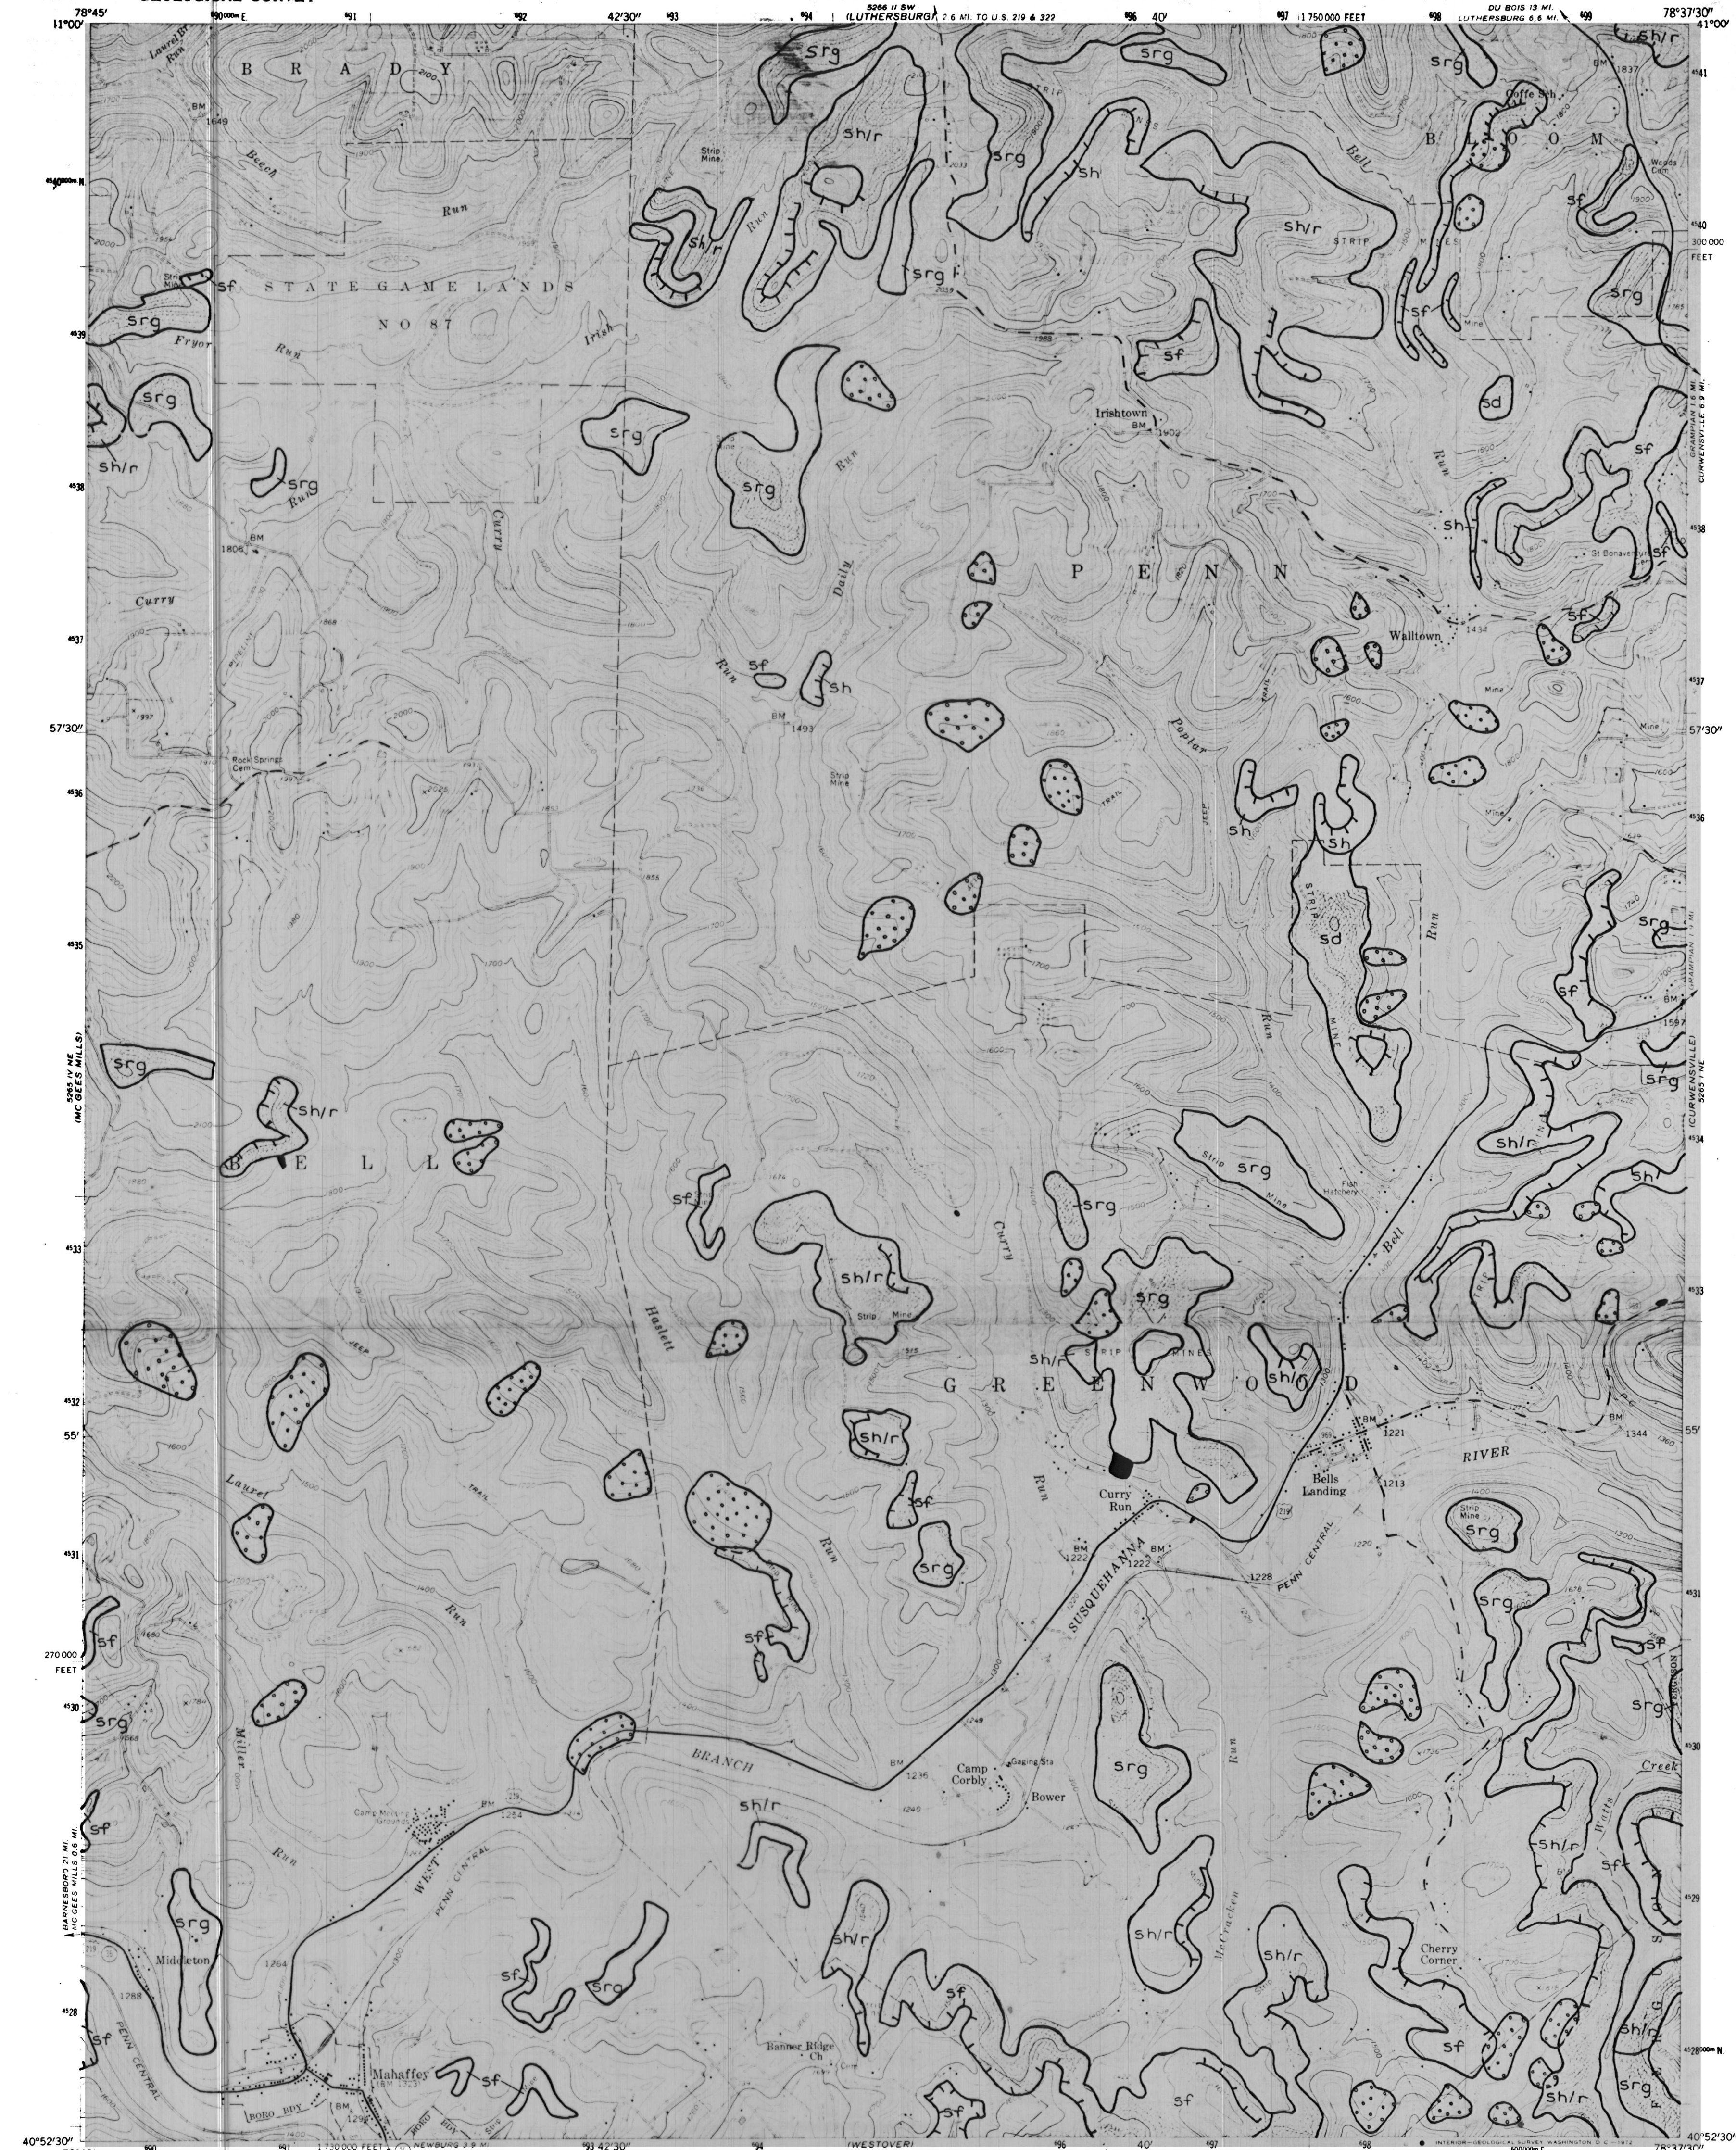
MAHAFFEY, PA.
N 4052.5—W 7837.5/7.5
1959
PHOTOREVISED 1971

Landslides and related features interpreted
from aerial photographs:
1:78,000 (black and white) 1977

ACTIVE OR RECENTLY ACTIVE LANDSLIDE
Complex landslide composed of earthflow, debris
slide, earth and rock slump. Identified from
historical records, and from scars, debris and
other field evidence. Ground extremely unstable;
sliding accelerated by excavation, loading and
changes in drainage conditions. May include
areas with several active slides too small to
be shown separately. Questioned where doubtful.

OLD LANDSLIDE
Area of extensive hummocky ground caused by
earthflow and earth and rock slump. Lacks
clear evidence of active sliding. Relatively
stable in natural, undisturbed state,
generally not affected by small structures properly
sited in areas away from the edge of the toe;
can be reactivated by extensive, rapid exca-
vation, loading, and changes in ground water and
surface water conditions. Area of old landslide
probably includes recent ones not identified
from field evidence or otherwise documented.
Upslope boundary of landslide generally defined
by modified scarp, but downslope (toe) may be
gradational and not well defined. Questioned
where doubtful.

COMBINATION LANDSLIDE
Area of recent and old slides in which
individual slides are not identified.

COLLUVIAL SLOPE
Valley wall along major streams with slope as
steep as 40° (85%); stony, clayey silt soil up
to 50 ft. (15 m) thick; commonly buttressed by
a terrace or bench at the toe of the slope; very
susceptible to sliding by cutting of toe area,
removal of terrace or bench, and overloading;
slide commonly activated without apparent cause.

SCREE
Residual accumulations of coarse rock material
lying on quartzite slopes of the Valley and
Ridge province. Generally stable except where
subjected to extreme rainfall.

COLLUVIAL SLOPES WITH LANDSLIDES
Landslides too small or obscure to map
individually.

**AREAS SUSCEPTIBLE TO DEBRIS FLOWS AND DEBRIS
AVALANCHES**
Primarily shallow, narrow ravines and chutes with
accumulation of stony colluvium generally 10 ft.
(3 m) or less in thickness; susceptible to rapid
movement during intense rainfall. Most ravines
and chutes designated show evidence of former
debris flows and avalanches. Symbol & design-
ates historical debris flow or debris avalanche.

AREAS SUSCEPTIBLE TO ROCKFALL
Steep, locally vertical, natural and man-made
slopes and cliffs, 15 ft. (4.5 m) or more high;
formed dominantly of sandstone, limestone, sandy
shale, mudstone and claystone. Interbedded mud-
stone, claystone and shale weather rapidly leaving
sandstone and limestone rock faces unsupported.

SOIL AND ROCK SUSCEPTIBLE TO LANDSLIDING
Soil and rock similar to that involved in land-
slides elsewhere in map area; primarily areas
underlain by claystone, mudstone and shale
associated with other rock types. Rock weathers
rapidly on exposure forming clayey soil highly
susceptible to sliding. Includes coves (U-shaped,
shallow valleys) containing thick layers of clayey
soil that are very susceptible to sliding where
excavation breaks continuity of slope and where
overloaded by artificial fill.

AREAS LEAST PRONE TO LANDSLIDES
Map areas in which no patterns or symbols are shown;
primarily valley floors, ridge tops and broad
benches; modification by excavation and fill may
lead to local landslides.
Includes slopes where landslides are sparse.

information shown is intended as a
general guide to ground conditions as of
the date of field check. Additional
landslides and rockfalls should be anticipated
in all map units. The map unit depicts
the dominant condition in the area delineated
and variations in slope stability may occur
at any point in the unit. This map is suit-
able for general planning purposes and as a
supplement to more detailed studies for site
selection. The map cannot be used as a sub-
stitute for detailed geologic and engineering
investigations to establish design and
construction criteria of specific sites.
Some symbols may not appear on this map
because the description is applicable to a
series of maps.
