## LANDSLIDES AND RELATED FEATURES

OF THE CURWENSVILLE, PA. QUADRANGLE

by  
John S. Pomeroy  
1979

OPEN FILE MAP 79-1314 (H-12)

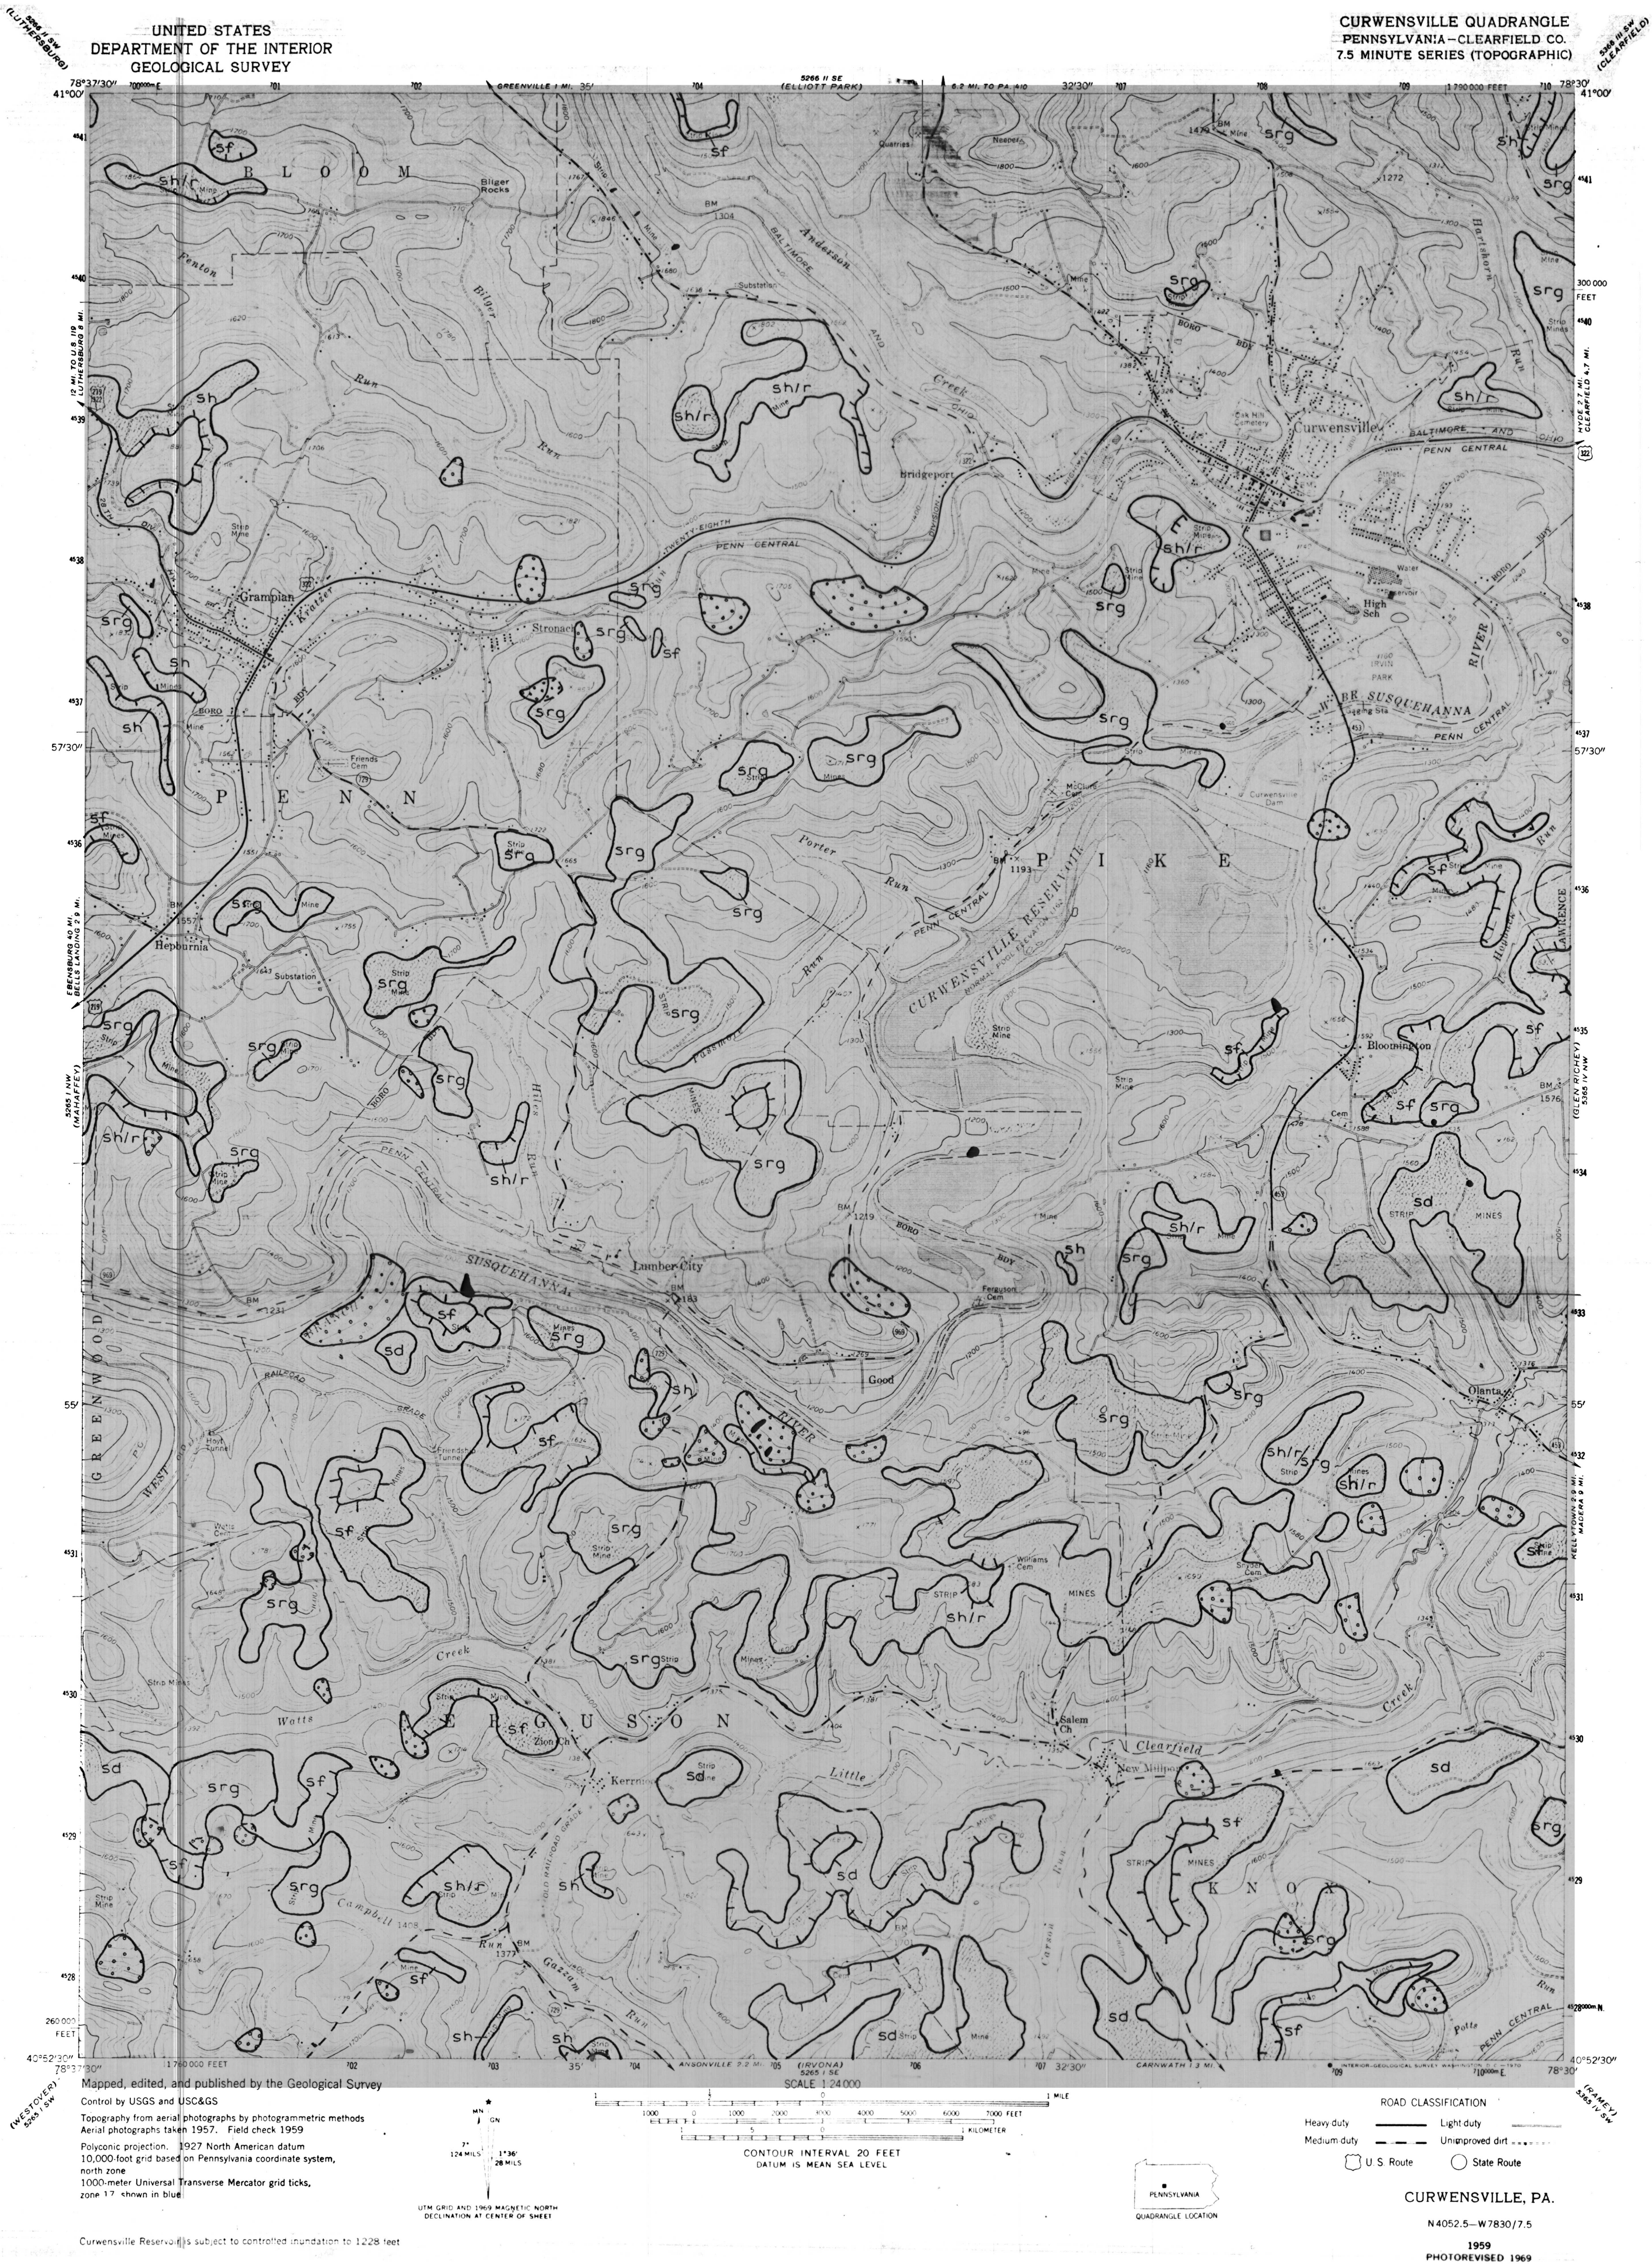
Landslides and related features interpreted from aerial photographs: 1:78,000 (black and white) 1977

Photointerpretation and field check 1977  
This map has not been edited or reviewed for conformity with Geological Survey standards and nomenclature.

Information shown is intended as a general guide to ground conditions as of the date of field check. Additional landslides and rockfalls should be anticipated in all map units. The map unit depicts the dominant condition in the area delineated and variations in slope stability may occur at any point in the unit. This map is suitable for general planning purposes and as a supplement to more detailed studies for site selection. The map cannot be used as a substitute for detailed geologic and engineering investigations to establish design and construction criteria of specific sites. Some symbols may not appear on this map because the description is applicable to a series of maps.

**ACTIVE OR RECENTLY ACTIVE LANDSLIDE**  
Complex landslide composed of earthflow, debris slide, earth and rock slump. Identified from historical records, and from scars, debris and other field evidence. Ground extremely unstable; sliding accelerated by excavation, loading and changes in drainage conditions. May include areas with several active slides too small to be shown separately. Questioned where doubtful.

**OLD LANDSLIDE**  
Area of extensive hummocky ground caused by earthflow and earth and rock slump. Lacks clear evidence of active sliding. Relatively stable in natural, undisturbed state, generally not affected by small structures properly sited in areas away from the edge of the toe; can be reactivated by extensive, rapid excavation, loading, and changes in ground water and surface water conditions. Area of old landslide probably includes recent ones not identified from field evidence or otherwise documented. Upslope boundary of landslide generally defined by modified scarp, but downslope (toe) may be gradational and not well defined. Questioned where doubtful.

**COMBINATION LANDSLIDE**  
Area of recent and old slides in which individual slides are not identified.

**COLLUVIAL SLOPE**  
Valley wall along major streams with slope as steep as 40° (85%); thick, clayey silt soil up to 50 ft. (15 m) stony; commonly buttressed by a terrace or bench at the toe of the slope; very susceptible to sliding by cutting of toe area, removal of terrace or bench, and overloading; slide commonly activated without apparent cause.

**AREAS SUSCEPTIBLE TO DEBRIS FLOWS AND DEBRIS AVALANCHES**  
Primarily shallow, narrow ravines and chutes with accumulation of stony colluvium generally 10 ft. (3 m) or less in thickness; susceptible to rapid movement during intense rainfall. Most ravines and chutes designated show evidence of former debris flows and avalanches. Symbol & designates historical debris flow or debris avalanche.

**AREAS SUSCEPTIBLE TO ROCKFALL**  
Steep, locally vertical, natural and man-made slopes and cliffs, 15 ft. (4.5 m) or more high; formed dominantly of sandstone, limestone, sandy shale, mudstone and claystone. Interbedded mudstone, claystone and shale weather rapidly leaving sandstone and limestone rock faces unsupported.

**SOIL AND ROCK SUSCEPTIBLE TO LANDSLIDING**  
Soil and rock similar to that involved in landslides elsewhere in map area; primarily areas underlain by claystone, mudstone and shale associated with other rock types. Rock weathers rapidly on exposure forming clayey soil highly susceptible to sliding. Includes covers (U-shaped, shallow valleys) containing thick layers of clayey soil that are very susceptible to sliding where excavation breaks continuity of slope and where overloaded by artificial fill.

**AREAS LEAST PRONE TO LANDSLIDES**  
Map areas in which no patterns or symbols are shown; primarily valley floors, ridge tops and broad benches; modification by excavation and fill may lead to local landslides. Includes slopes where landslides are sparse.
