# LANDSLIDES AND RELATED FEATURES

OF THE WALLACETON, PA. QUADRANGLE

U.S. Geological Survey

OPEN FILE MAP 79-1314 (H-14)

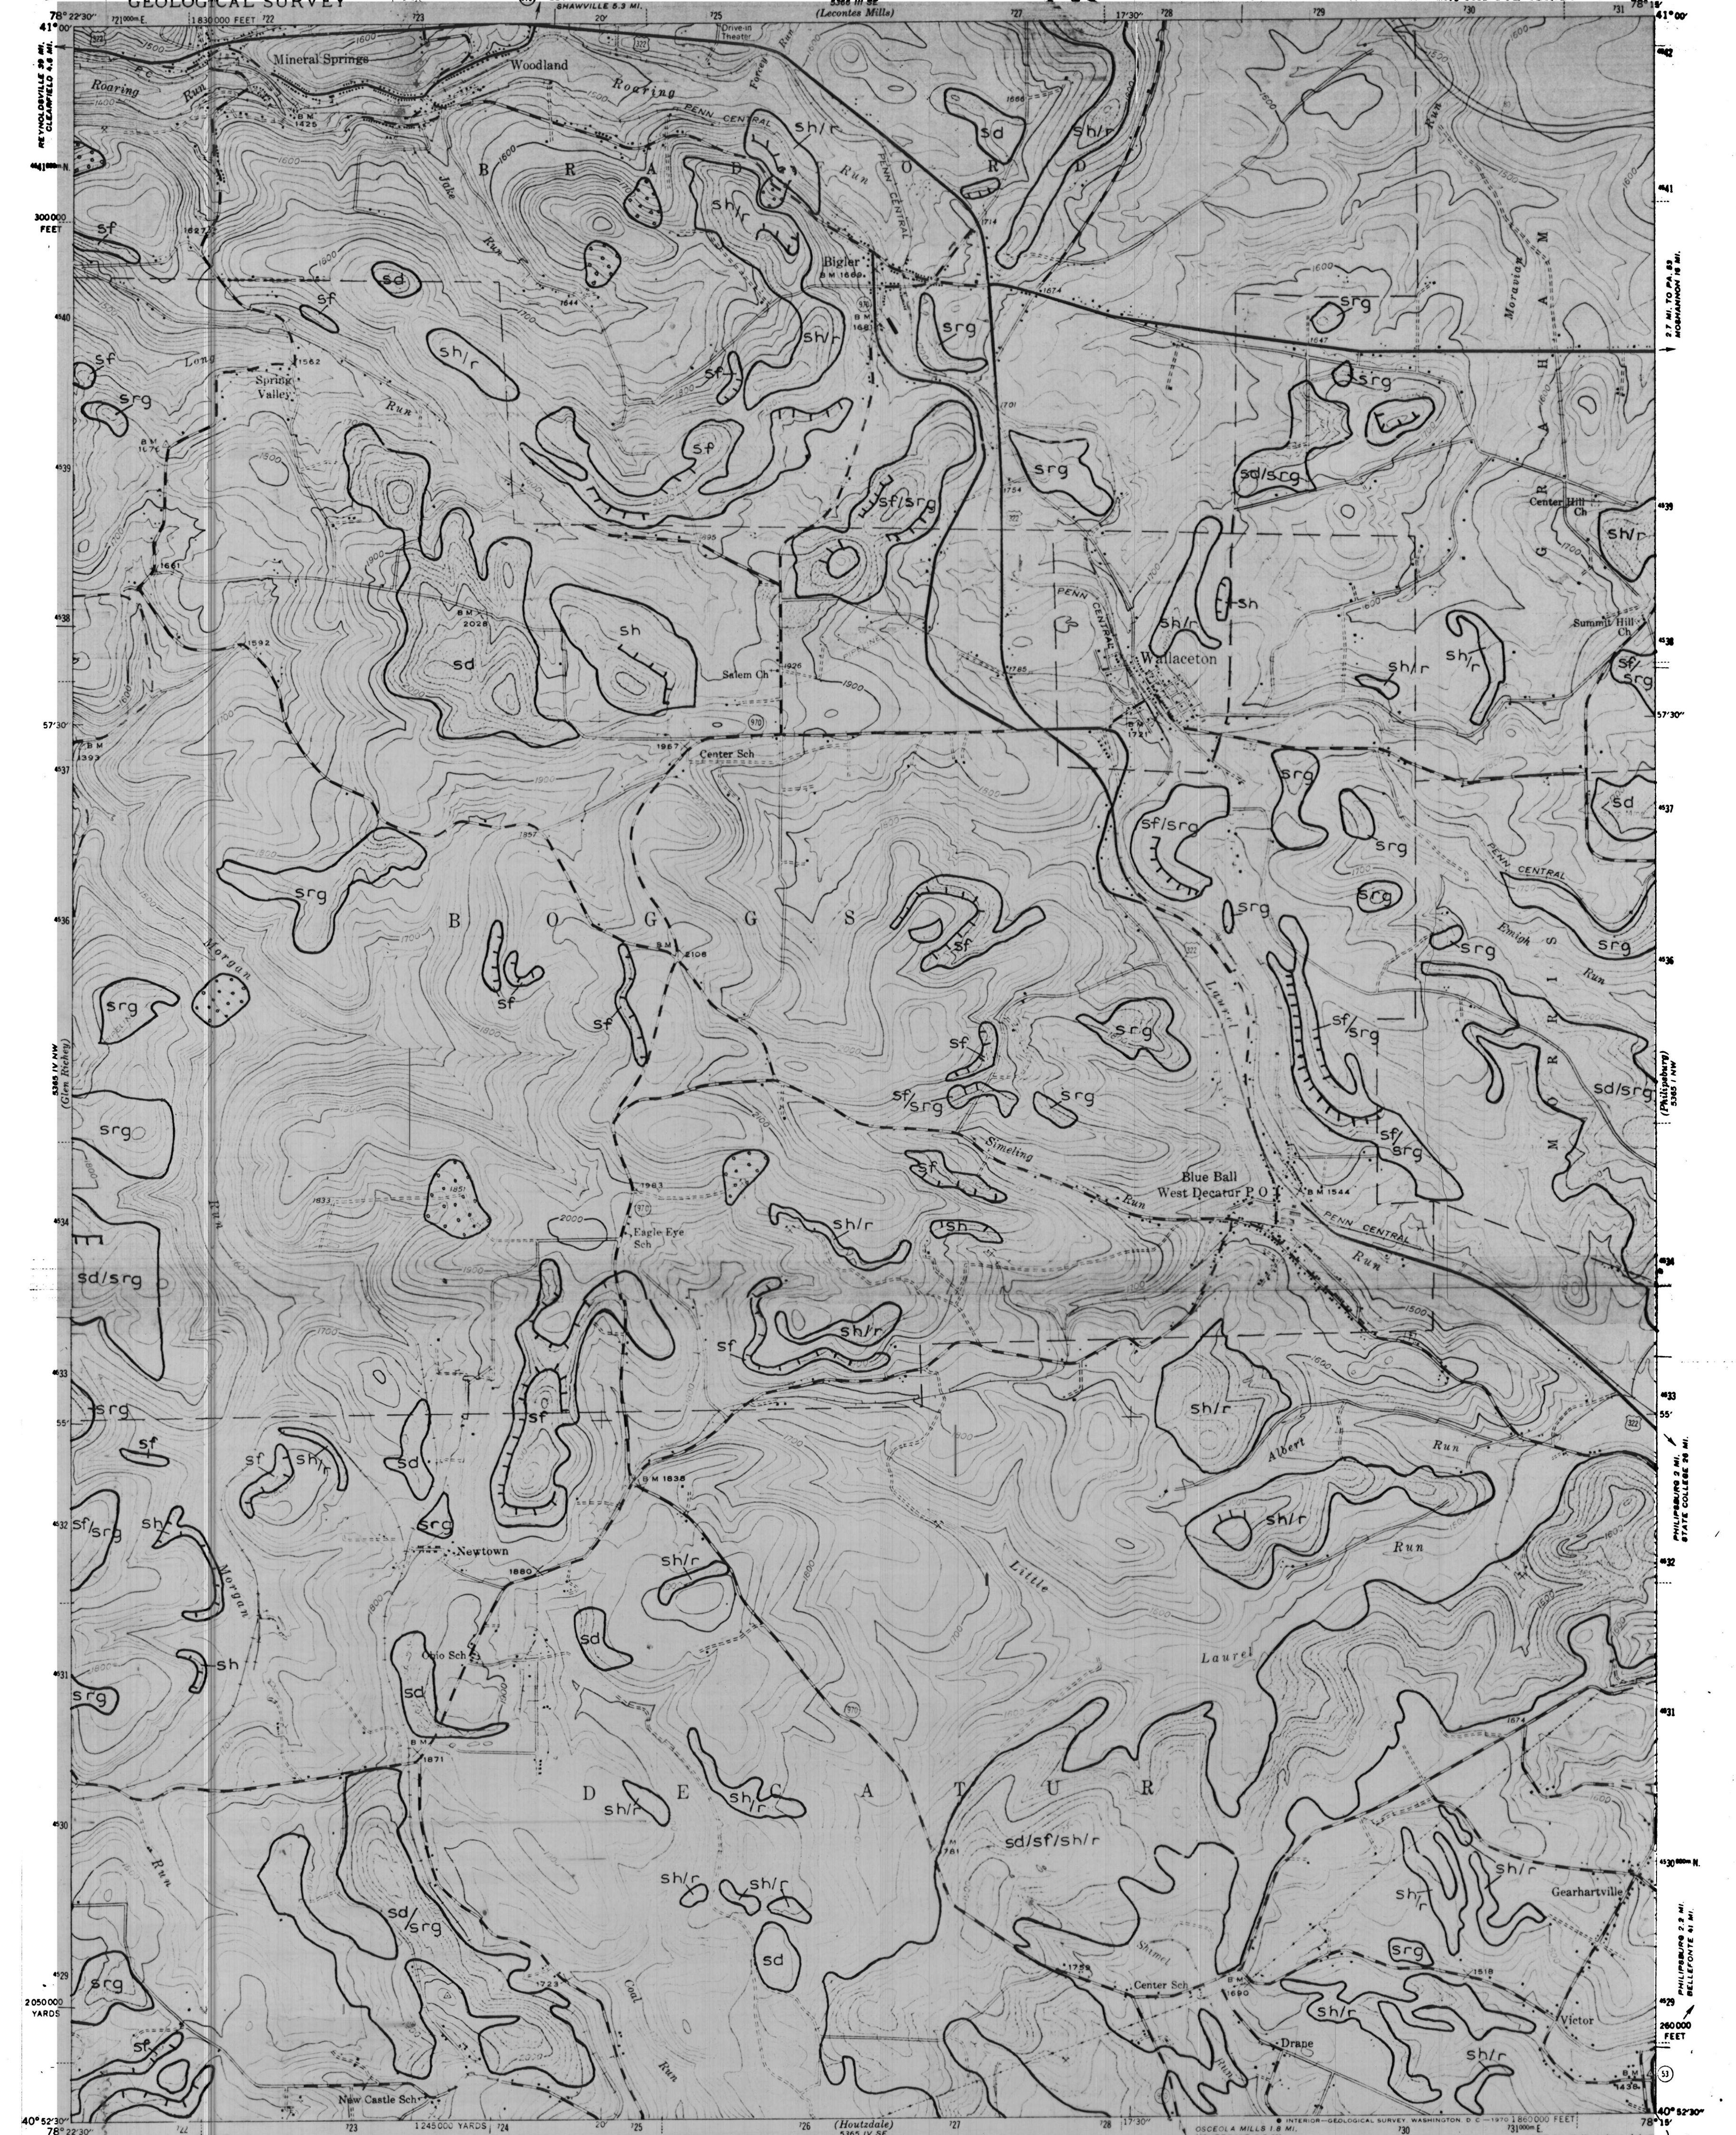
WALLACETON, PA.  
N 4052.5-W 7815/7.5  
1945  
PHOTOREVISED 1969

Landslides and related features interpreted from aerial photographs: 1:78,000 (black and white) 1977

**ACTIVE OR RECENTLY ACTIVE LANDSLIDE**  
Complex landslide composed of earthflow, debris slide, earth and rock slump. Identified from historical records, and from scars, debris and other field evidence. Ground extremely unstable, sliding accelerated by excavation, loading and changes in drainage conditions. May include areas with several active slides too small to be shown separately. Questioned where doubtful.

**OLD LANDSLIDE**  
Area of extensive hummocky ground caused by earthflow and earth and rock slump. Lacks clear evidence of active sliding. Relatively stable in natural, undisturbed state, generally not affected by small structures properly sited in areas away from the edge of the toe; can be reactivated by extensive, rapid excavation, loading, and changes in ground water and surface water conditions. Area of old landslide probably includes recent ones not identified from field evidence or otherwise documented. Upslope boundary of landslide generally defined by modified scarp, but downslope (toe) may be gradational and not well defined. Questioned where doubtful.

**COLLUVIAL SLOPE**  
Valley wall along major streams with slope as steep as 40° (85%), stony, clayey silt soil up to 50 ft. (15 m) thick; commonly buttressed by a terrace or bench at the toe of the slope; very susceptible to sliding by cutting of toe area, removal of terrace or bench, and overloading; slide commonly activated without apparent cause.

**AREAS SUSCEPTIBLE TO DEBRIS FLOWS AND DEBRIS AVALANCHES**  
Primarily shallow, narrow ravines and chutes with accumulation of stony colluvium generally 10 ft. (3 m) or less in thickness; susceptible to rapid movement during intense rainfall. Most ravines and chutes designated show evidence of former debris flows and avalanches. Symbol & designates historical debris flow or debris avalanche.

**AREAS SUSCEPTIBLE TO ROCKFALL**  
Steep, locally vertical, natural and man-made slopes and cliffs, 15 ft. (4.5 m) or more high; formed dominantly of sandstone, limestone, sandy shale, mudstone and claystone. Interbedded mudstone, claystone and shale weather rapidly leaving sandstone and limestone rock faces unsupported.

**SOIL AND ROCK SUSCEPTIBLE TO LANDSLIDING**  
Soil and rock similar to that involved in landslides elsewhere in map area; primarily areas underlain by claystone, mudstone and shale associated with other rock types. Rock weathers rapidly on exposure forming clayey soil highly susceptible to sliding. Includes coves (U-shaped, shallow valleys) containing thick layers of clayey soil that are very susceptible to sliding where excavation breaks continuity of slope and where overloaded by artificial fill.
