**MOUNTAIN GROVE, VA. - W. VA.**  
SW/4 WARM SPRINGS 15' QUADRANGLE  
N3800—W7952.5/7.5  
1961

## LANDSLIDES AND RELATED FEATURES

OF THE MOUNTAIN GROVE, VA.-W. VA. QUADRANGLE  
by  
Robert J. Hackman and Roger E. Thomas  
1980  
U.S. Geological Survey  
OPEN FILE MAP 30-194 (A-1)

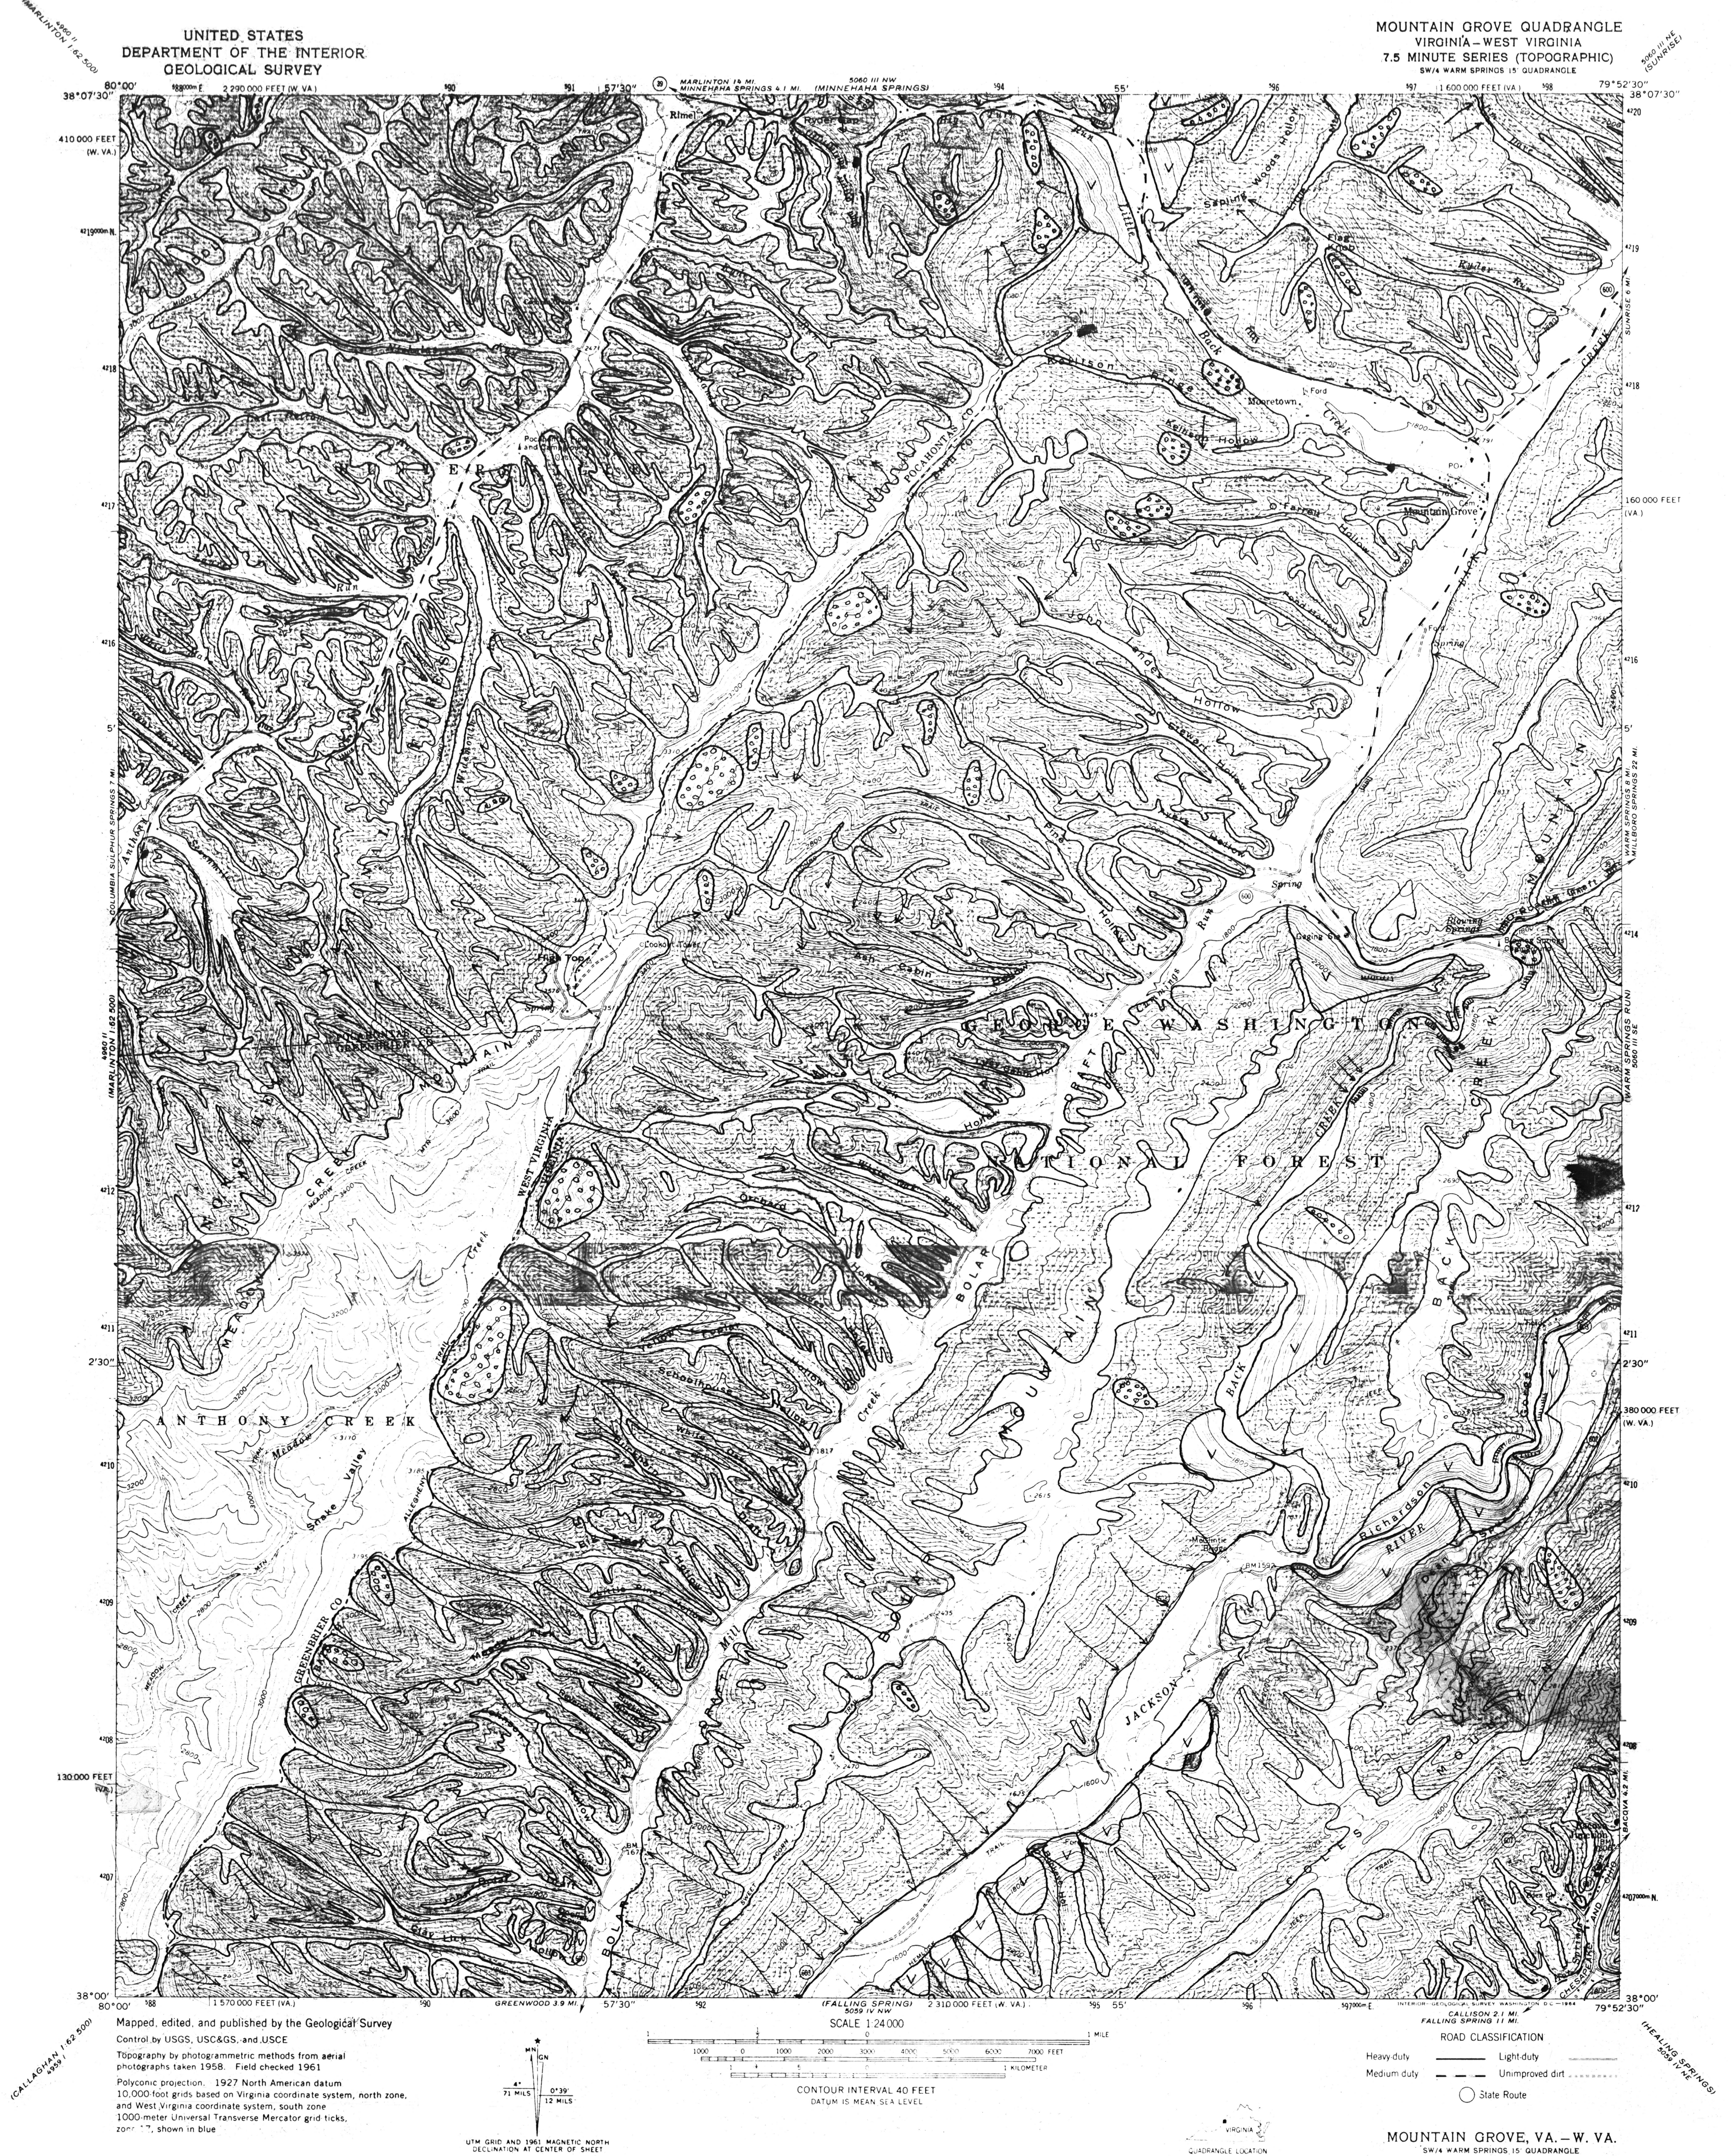
**Landslides and related features interpreted from aerial photographs:**  
1:60,000 (black and white) 1959  
1:79,000 (black and white) 1977

**Photointerpretation and field check 1979**  
This map has not been edited or reviewed for conformity with Geological Survey standards and nomenclature.

- ACTIVE OR RECENTLY ACTIVE LANDSLIDE**  
Complex landslide composed of earthflow, debris slide, earth and rock slump. Identified from historical records, and from scars, debris and other field evidence. Ground extremely unstable; sliding accelerated by excavation, loading and changes in drainage conditions. May include areas with several active slides too small to be shown separately. Questioned where doubtful.

- OLD LANDSLIDE**  
Area of extensive hummocky ground caused by earthflow and earth and rock slump. Lacks clear evidence of active sliding. Relatively stable in natural, undisturbed state, generally not affected by small structures properly sited in areas away from the edge of the toe; can be reactivated by extensive, rapid excavation, loading, and changes in ground water and surface water conditions. Area of old landslide probably includes recent ones not identified from field evidence or otherwise documented. Upslope boundary of landslide generally defined by modified scarp, but downslope (toe) may be gradational and not well defined. Questioned where doubtful.

- COMBINATION LANDSLIDE**  
Area of recent and old slides in which individual slides are not identified.
- COLLUVIAL SLOPE**  
Valley wall along major streams with slope as steep as 40° (85%); stony, clayey silt soil up to 50 ft. (15 m) thick; commonly buttressed by a terrace or bench at the toe of the slope; very susceptible to sliding by cutting of toe area, removal of terrace or bench, and overloading; slide commonly activated without apparent cause.

- COLLUVIAL SLOPES WITH LANDSLIDES**  
Landslides too small or obscure to map individually.
- AREAS SUSCEPTIBLE TO DEBRIS FLOWS AND DEBRIS AVALANCHES**  
Primarily shallow, narrow ravines and chutes with accumulation of stony colluvium generally 10-ft. (3 m) or less in thickness; susceptible to rapid movement during intense rainfall. Most ravines and chutes designated show evidence of former debris flows and avalanches. Symbol & designates historical debris flow or debris avalanche.

- AREAS SUSCEPTIBLE TO ROCKFALL**  
Steep, locally vertical, natural and man-made slopes and cliffs, 15 ft. (4.5 m) or more high; formed dominantly of sandstone, limestone, sandy shale, mudstone and claystone. Interbedded mudstone, claystone and shale weather rapidly leaving sandstone and limestone rock faces unsupported.

- SOIL AND ROCK SUSCEPTIBLE TO LANDSLIDING**  
Soil and rock similar to that involved in landslides elsewhere in map area; primarily areas underlain by claystone, mudstone and shale associated with other rock types. Rock weathers rapidly on exposure forming clayey soil highly susceptible to sliding. Includes coves (U-shaped, shallow valleys) containing thick layers of clayey soil that are very susceptible to sliding where excavation breaks continuity of slope and where overloaded by artificial fill.

- AREAS LEAST PRONE TO LANDSLIDES**  
Map areas in which no patterns or symbols are shown; primarily valley floors, ridge tops and broad benches; modification by excavation and fill may lead to local landslides.

- MAN-MADE FEATURES**  
Strip mines (combination of letter symbols indicates complex formed of more than one type of strip mine)  
sh bench with high wall  
sf furrowed with high wall  
sd multiple furrows and multiple benches  
ss hilltop removed  
srg reclaimed by grading  
sru reclaimed by secondary use  
sh/r regraded in part, high wall remains  
Coal refuse banks  
r identified on aerial photographs; not classified in field check  
rb not burnt nor on fire  
rbn burnt  
rbd burning  
rbs sludge  
Quarries  
q quarry site  
qub spoil bank, quarry waste  
Gravel pits  
g site of gravel pit  
Slides in man-made features  
af earth flow in fill  
a/s earth flow in strip castings  
a/r earth flow in coal refuse
