BULLIS MILLS, PA.-N.Y.
NE 4 SMETHPORT 15 QUADRANGLE
N41525-W781575
1970
AMS 5167 IV NE, SERIES V831

LANDSLIDES AND RELATED FEATURES
OF THE BULLIS MILLS, PA. QUADRANGLE

by
John S. Pomeroy
1981

U.S. Geological Survey
OPEN FILE MAP 81-238 (H-14)

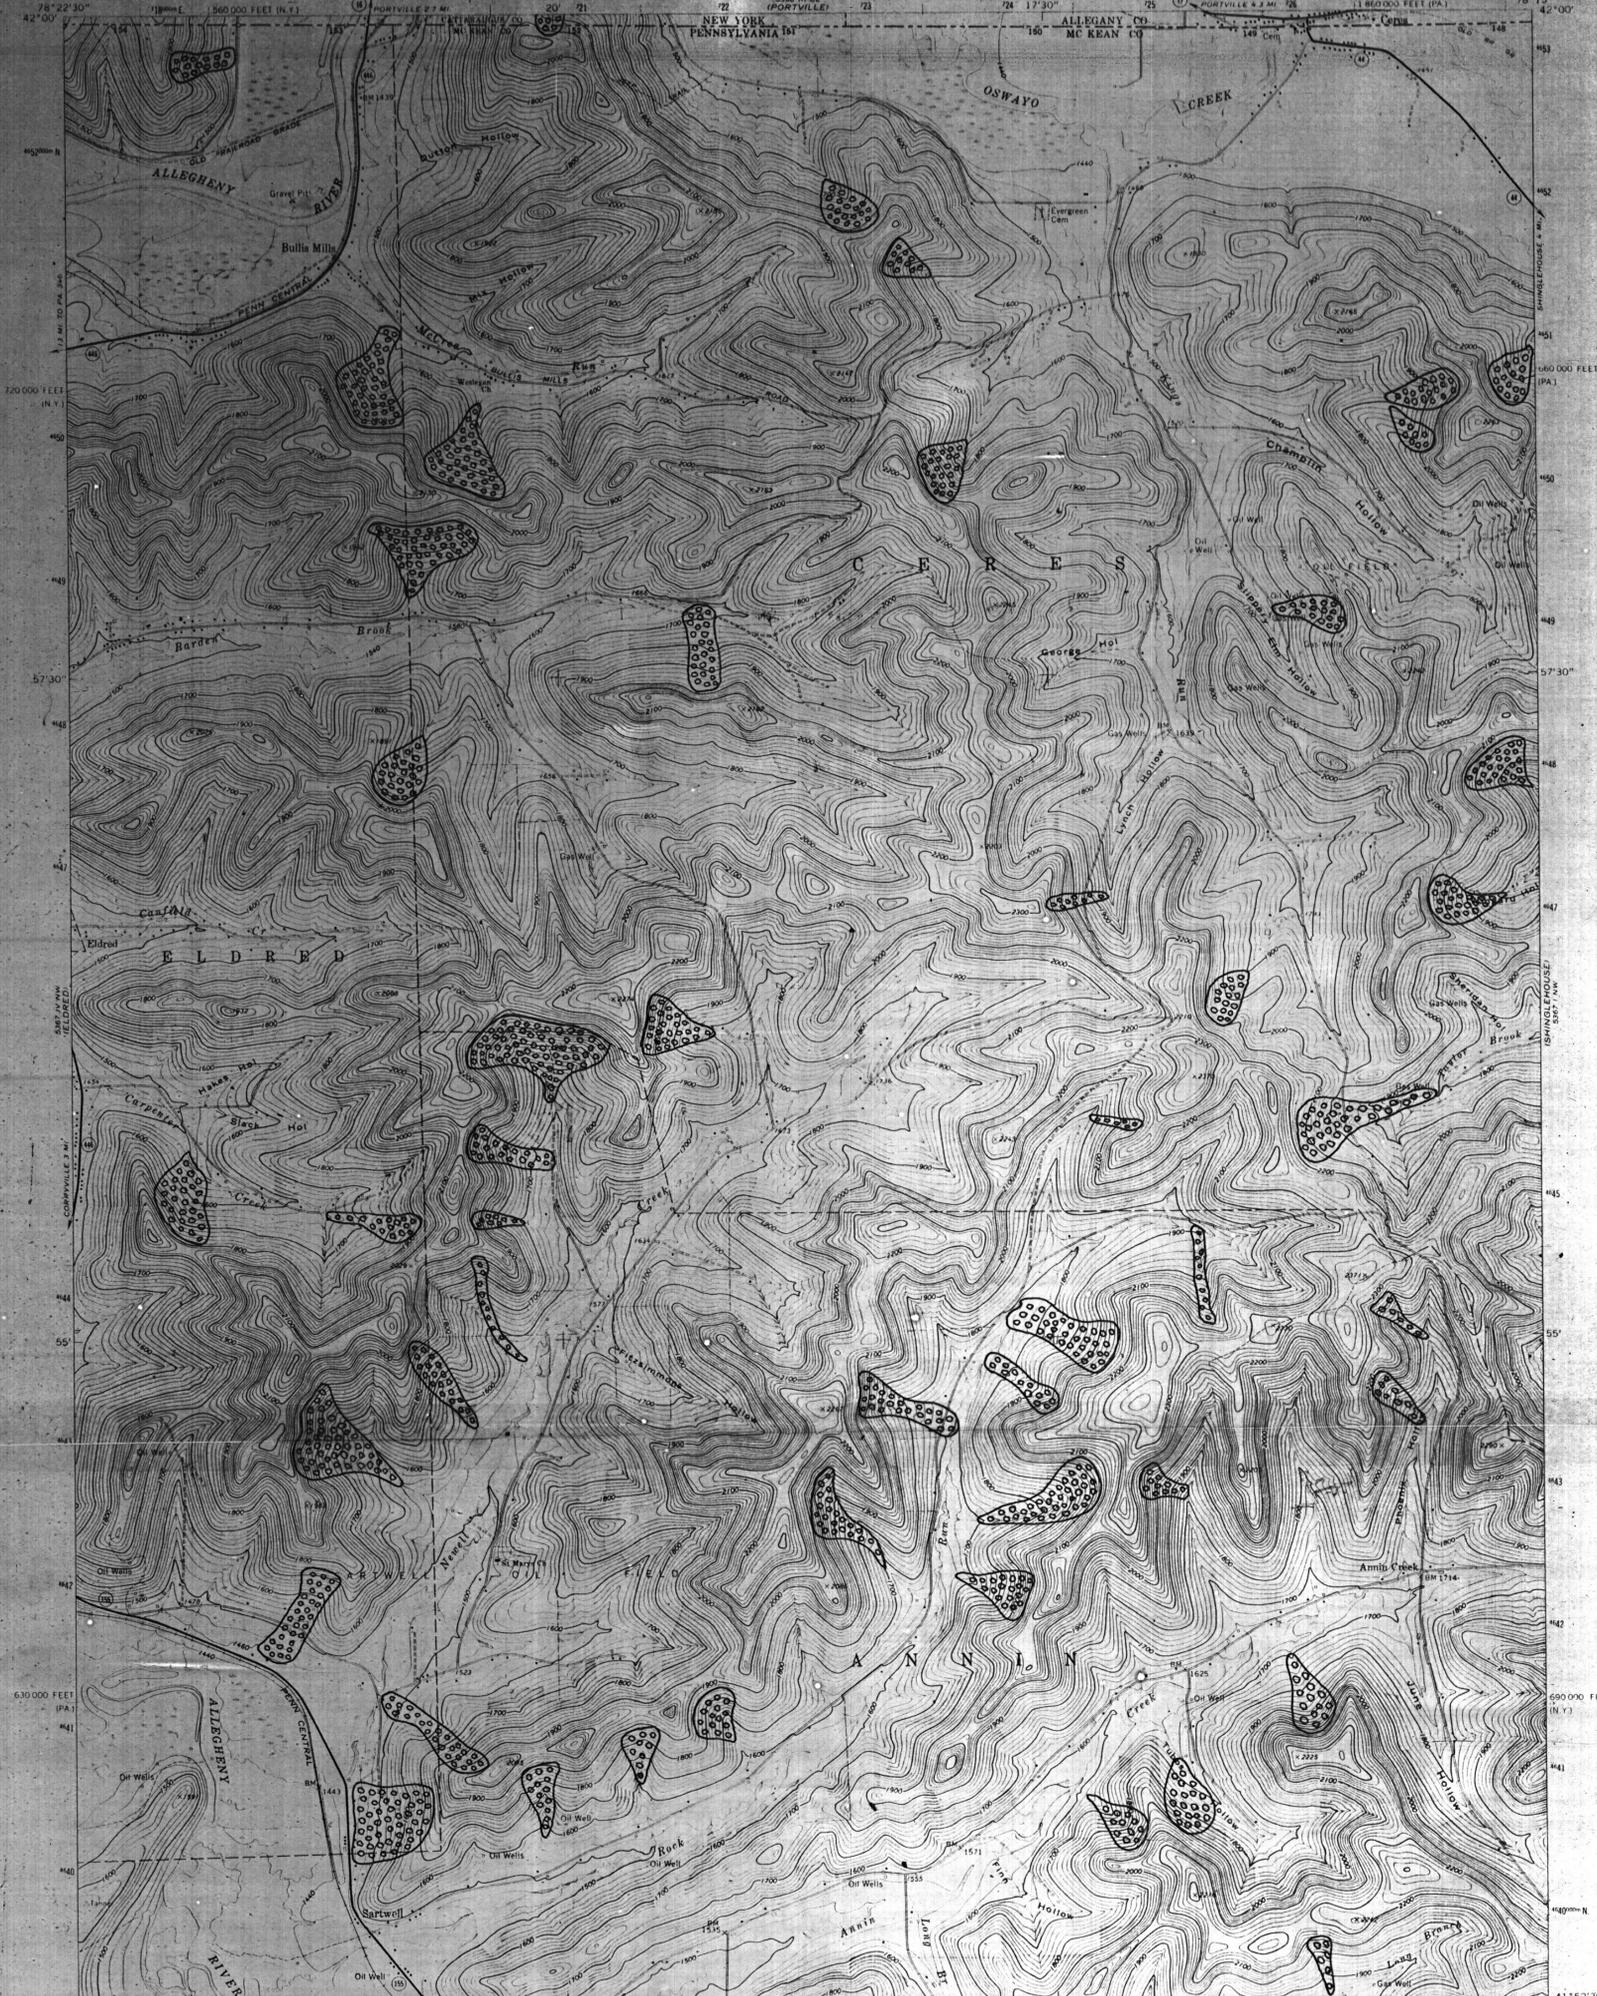
Landslides and related features interpreted
from aerial-photographs:
1:78,000 (black and white) 1977
Photointerpretation and field check 1978-1979
This map has not been edited or reviewed
for conformity with Geological Survey
standards and nomenclature.

ACTIVE OR RECENTLY ACTIVE LANDSLIDE
Complex landslide composed of earthflow, debris slide, earth and rock slump. Identified from historical records, and from scars, debris and other field evidence. Ground extremely unstable, sliding accelerated by excavation, loading and changes in drainage conditions. May include areas with several active slides too small to be shown separately. Questioned where doubtful. May be shown with symbol (A) where difficult to discern.

OLD LANDSLIDE
Area of extensive hummocky ground caused by earthflow and earth and rock slump. Lacks clear evidence of active sliding. Relatively stable in natural, undisturbed state, generally not affected by small structures properly sited in areas away from the edge of the toe; can be reactivated by extensive, rapid excavation, loading, and changes in ground water and surface water conditions. Area of old landslide probably includes recent ones not identified from field evidence or otherwise documented. Upslope boundary of landslide generally defined by modified scarp, but downslope (toe) may be gradational and not well defined. Questioned where doubtful.

COLLUVIAL SLOPE
Valley wall along major streams with slope as steep as 40° (85%); stony, clayey silt soil up to 50 ft. (15 m) thick; commonly buttressed by a terrace or bench at the toe of the slope; very susceptible to sliding by cutting of toe area, removal of terrace or bench, and overloading; slide commonly activated without apparent cause.

AREAS SUSCEPTIBLE TO DEBRIS FLOWS AND DEBRIS AVALANCHES
Primarily shallow, narrow ravines and chutes with accumulation of stony colluvium generally 10 ft. (3 m) or less in thickness; susceptible to rapid movement during intense rainfall. Most ravines and chutes designated show evidence of former debris flows and avalanches. Symbol (A) designates historical debris flow or debris avalanche.

AREAS SUSCEPTIBLE TO ROCKFALL
Steep, locally vertical, natural and man-made slopes and cliffs, 15 ft. (4.5 m) or more high; formed dominantly of sandstone, limestone, sandy shale, mudstone and claystone. Interbedded mudstone, claystone and shale weather rapidly leaving sandstone and limestone rock faces unsupported.

SOIL AND ROCK SUSCEPTIBLE TO LANDSLIDING
Soil and rock similar to that involved in landslides elsewhere in map area; primarily areas underlain by claystone, mudstone and shale associated with other rock types. Rock weathers rapidly on exposure forming clayey soil highly susceptible to sliding. Includes coves (U-shaped, shallow valleys) containing thick layers of clayey soil that are very susceptible to sliding where excavation breaks continuity of slope and where overloaded by artificial fill.

AREAS LEAST PRONE TO LANDSLIDES
Map areas in which no patterns or symbols are shown; primarily valley floors, ridge tops and broad benches; modification by excavation and fill may lead to local landslides. Includes slopes where landslides are sparse.

Quadrangle does not contain landslides or related features.
