NEW BETHLEHEM, PA.  
 SE 1/4 CLARION 15' QUADRANGLE  
 N4100-W7915/7.5  
 1969

### LANDSLIDES AND RELATED FEATURES

OF THE NEW BETHLEHEM, PA. QUADRANGLE

by John S. Pomeroy 1981  
 U.S. Geological Survey  
 OPEN FILE MAP 81-238 A-G

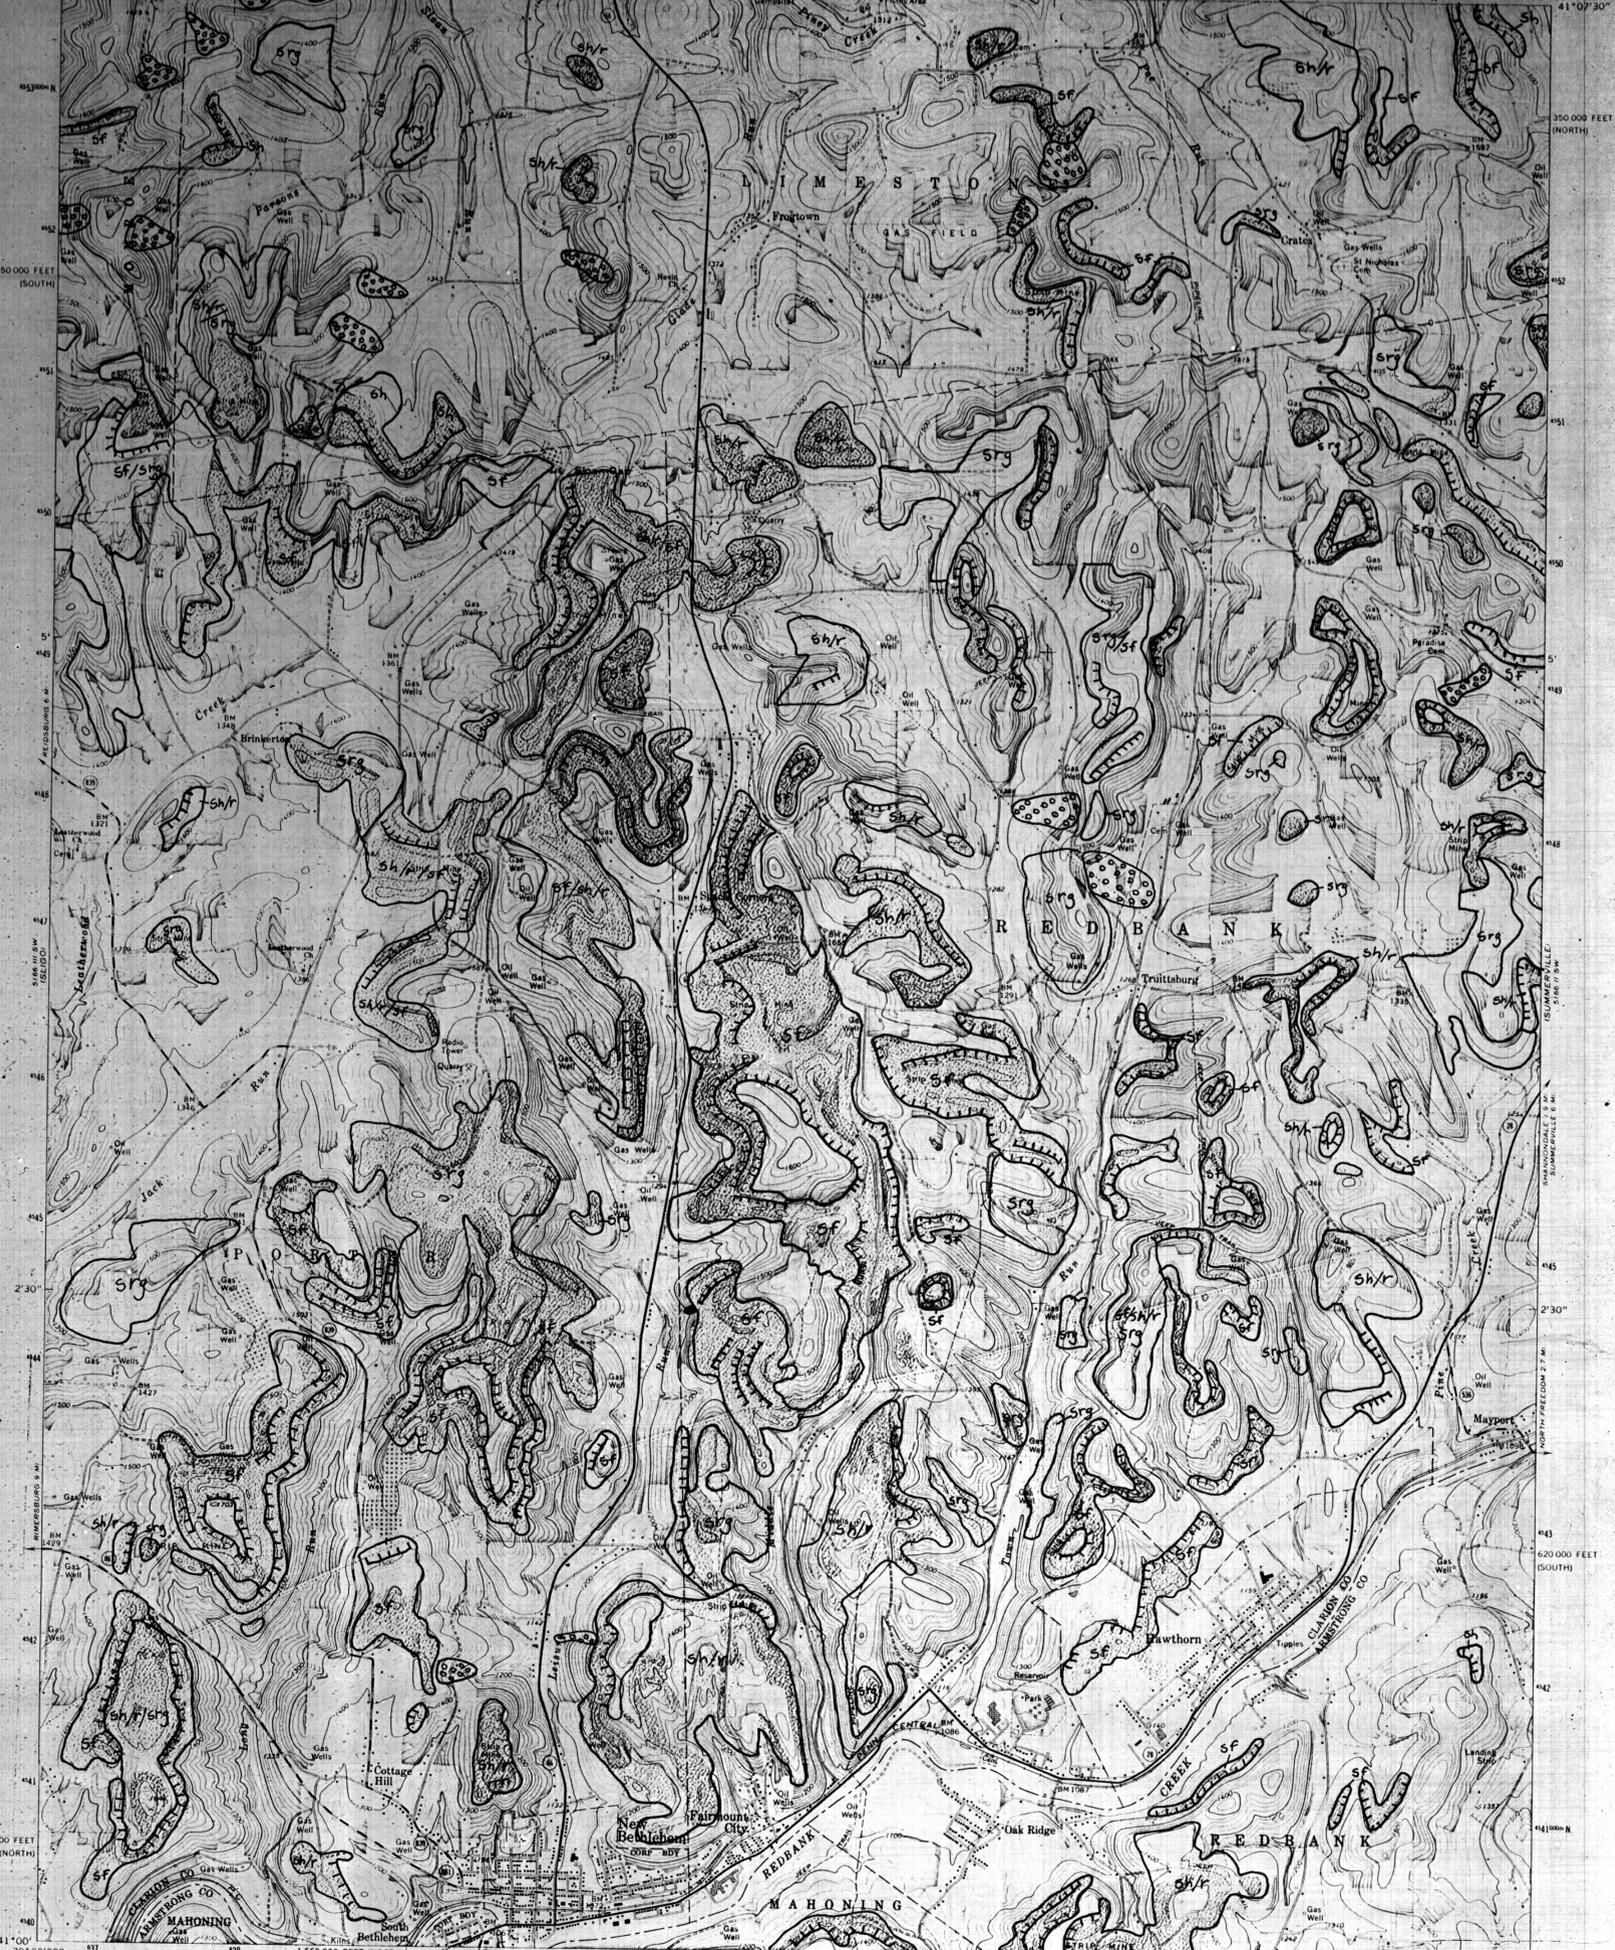
ACTIVE OR RECENTLY ACTIVE LANDSLIDE  
 Complex landslide composed of earthflow, debris slide, earth and rock slump. Identified from historical records, and from scars, debris and other field evidence. Ground extremely unstable; sliding accelerated by excavation, loading and changes in drainage conditions. May include areas with several active slides too small to be shown separately. Questioned where doubtful. May be shown with symbol (A) where difficult to discern.

OLD LANDSLIDE  
 Area of extensive hummocky ground caused by earthflow and earth and rock slump. Lacks clear evidence of active sliding. Relatively stable in natural, undisturbed state, generally not affected by small structures properly sited in areas away from the edge of the toe; can be reactivated by extensive, rapid excavation, loading, and changes in ground water and surface water conditions. Area of old landslide probably includes recent ones not identified from field evidence or otherwise documented. Upslope boundary of landslide generally defined by modified scarp, but downslope (toe) may be gradational and not well defined. Questioned where doubtful.

COLLUVIAL SLOPE  
 Valley wall along major streams with slope as steep as 40° (85%); stony, clayey silt soil up to 50 ft. (15 m) thick; commonly buttressed by a terrace or bench at the toe of the slope; very susceptible to sliding by cutting of toe area, removal of terrace or bench, and overloading; slide commonly activated without apparent cause.

AREAS SUSCEPTIBLE TO DEBRIS FLOWS AND DEBRIS AVALANCHES  
 Primarily shallow, narrow ravines and chutes with accumulation of stony colluvium generally 10 ft. (3 m) or less in thickness; susceptible to rapid movement during intense rainfall. Most ravines and chutes designated show evidence of former debris flows and avalanches. Symbol (A) designates historical debris flow or debris avalanche.

AREAS SUSCEPTIBLE TO ROCKFALL  
 Steep, locally vertical, natural and man-made slopes and cliffs, 15 ft. (4.5 m) or more high; formed dominantly of sandstone, limestone, sandy shale, mudstone and claystone. Interbedded mudstone, claystone and shale weather rapidly leaving sandstone and limestone rock faces unsupported.

SOIL AND ROCK SUSCEPTIBLE TO LANDSLIDING  
 Soil and rock similar to that involved in landslides elsewhere in map area; primarily areas underlain by claystone, mudstone and shale associated with other rock types. Rock weathers rapidly on exposure forming clayey soil highly susceptible to sliding. Includes coves (U-shaped, shallow valleys) containing thick layers of clayey soil that are very susceptible to sliding where excavation breaks continuity of slope and where overladen by artificial fill.

AREAS LEAST PRONE TO LANDSLIDES  
 Map areas in which no patterns or symbols are shown; primarily valley floors, ridge tops and broad benches; modification by excavation and fill may lead to local landslides.  
 Includes slopes where landslides are sparse.
