BURROW COVE, TENN.
N3515-W8545-7.5
1947
FIRST REVISED 1971

LANDSLIDES AND RELATED FEATURES
OF THE BURROW COVE, TENN. QUADRANGLE

by
Roger E. Thomas
1981

U.S. Geological Survey
OPEN FILE MAP 81-1318 (c-2)

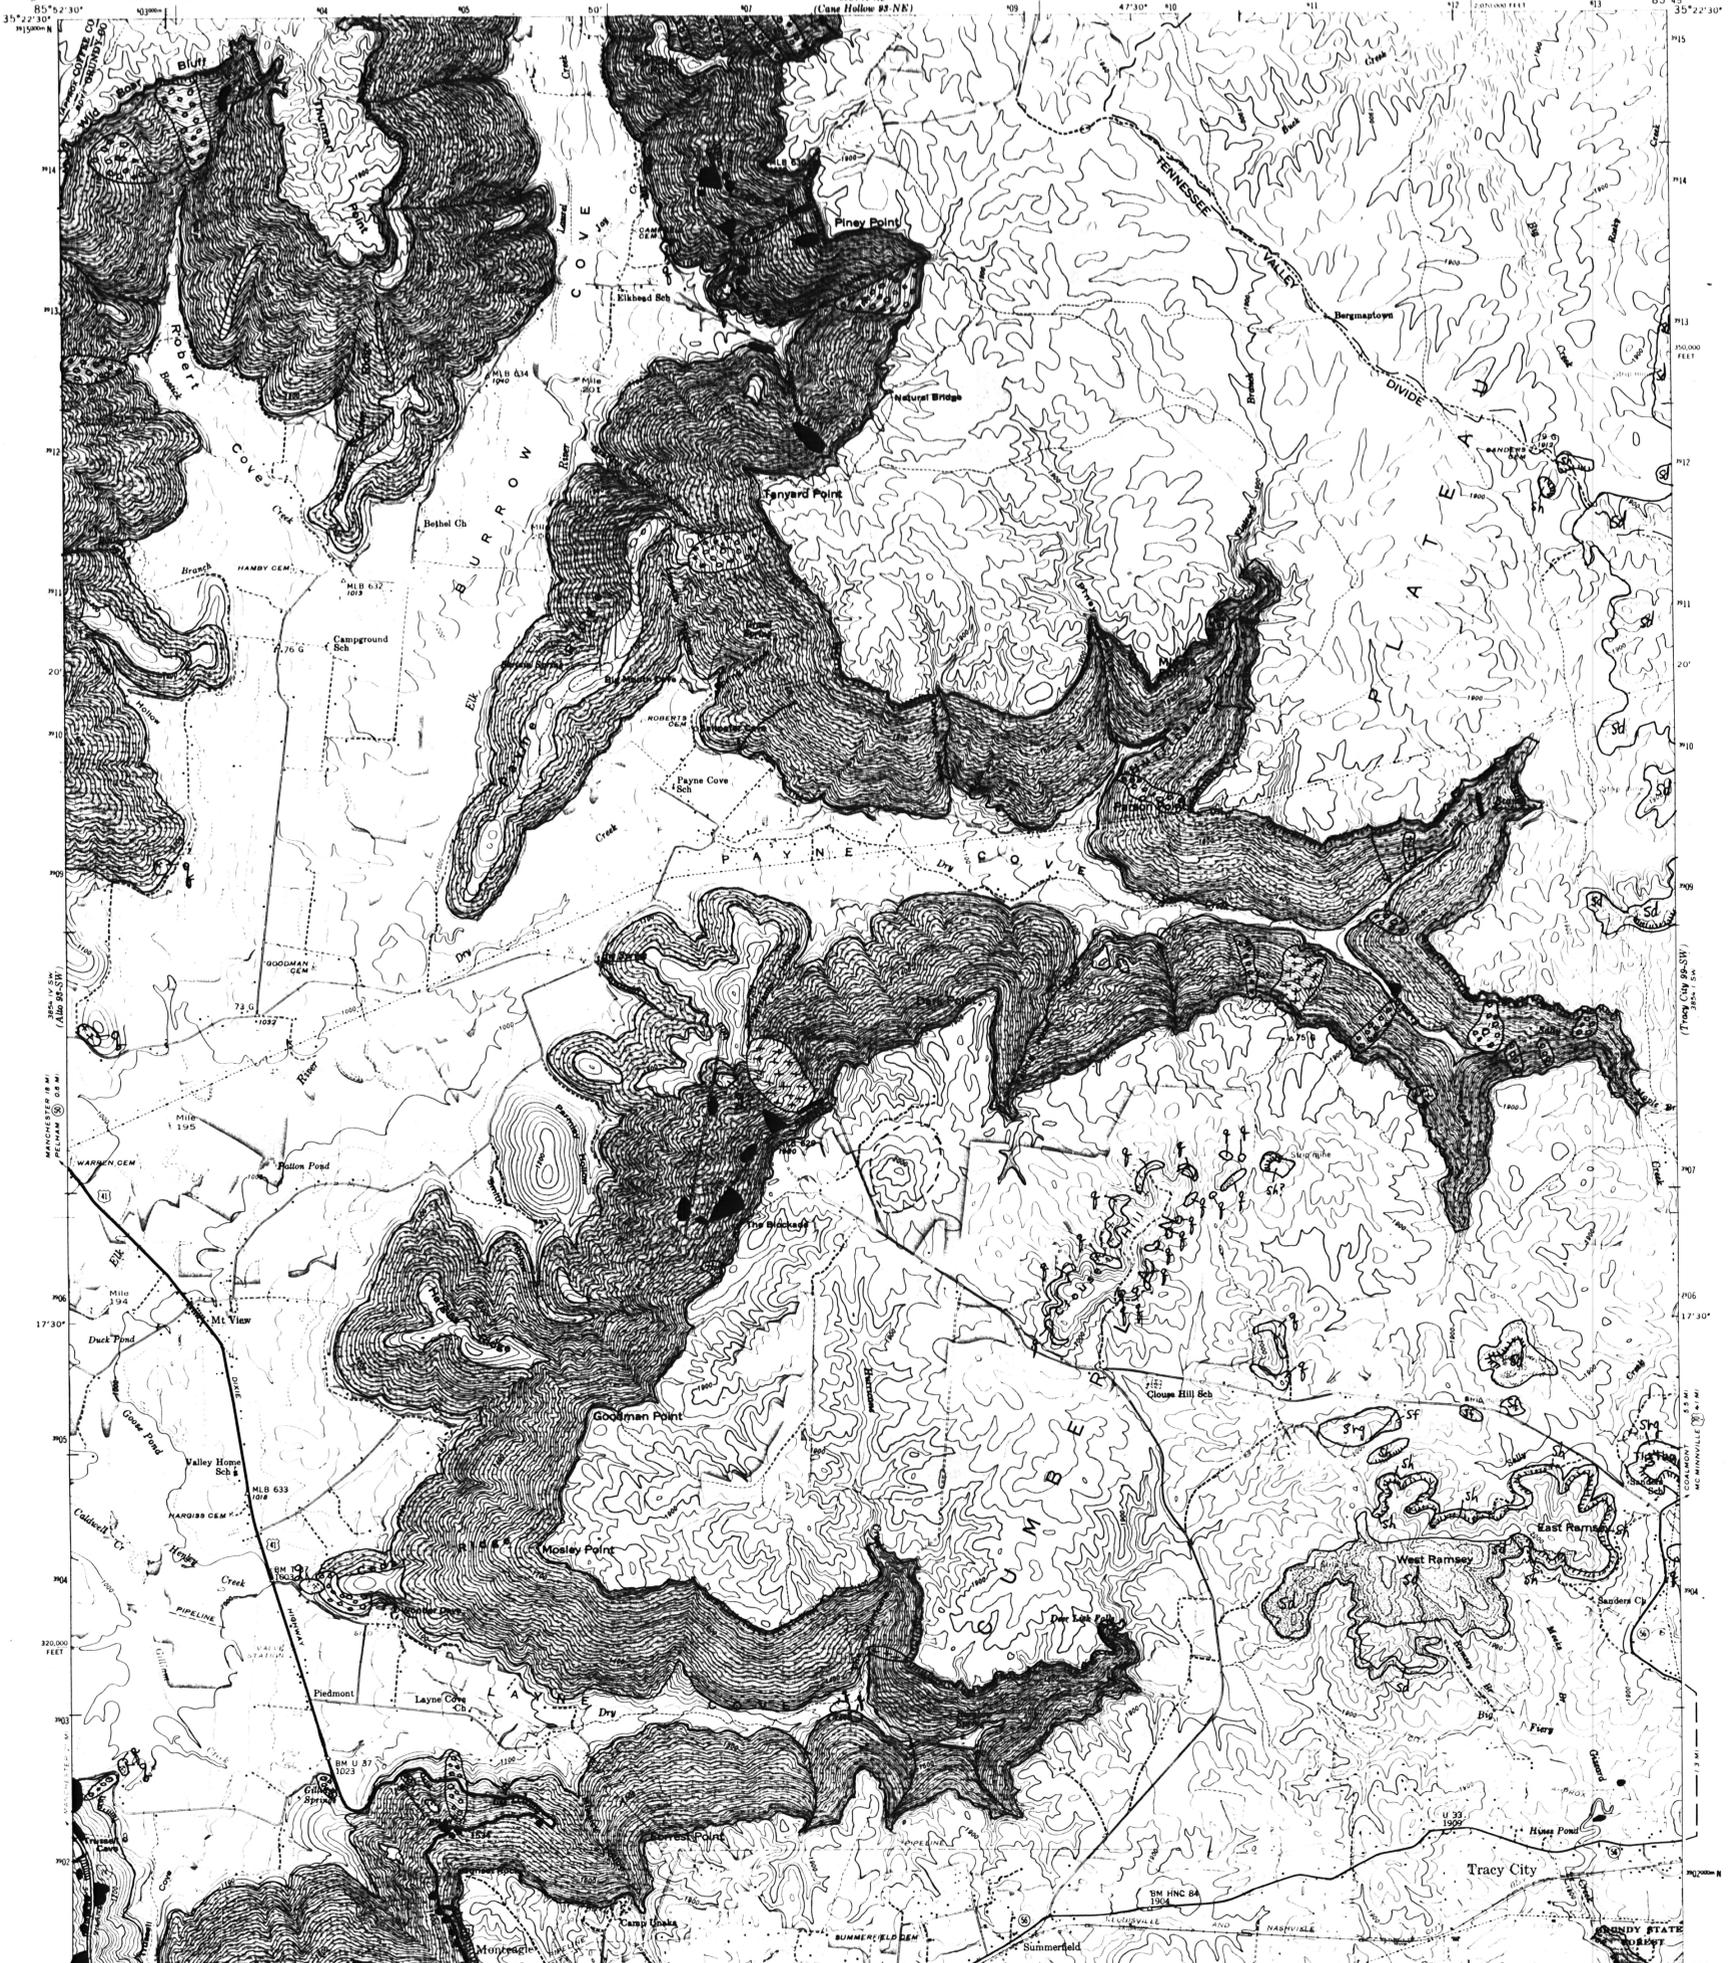
Landslides and related features interpreted
from aerial photographs:
1:75,000 (Black and White) 1974
1:20,000 (Black and White) 1973

Photointerpretation and field check 1981
This report is preliminary and has not
been reviewed for conformity with U.S.
Geological Survey editorial standards.

- ACTIVE OR RECENTLY ACTIVE LANDSLIDE**
Complex landslide composed of earthflow, debris slide, earth and rock slump. Identified from historical records and from scars, debris and other field evidence. Ground extremely unstable; sliding accelerated by excavation, loading and changes in drainage conditions. May include areas with several active slides too small to be shown separately. Questioned where doubtful.

- OLD LANDSLIDE**
Area of extensive hummocky ground caused by earthflow and earth and rock slump. Lacks clear evidence of active sliding. Relatively stable in natural, undisturbed state, generally not affected by small structures properly sited in areas away from the edge of the toe; can be reactivated by extensive, rapid excavation, loading, and changes in ground water and surface water conditions. Area of old landslide probably includes recent ones not identified from field evidence or otherwise documented. Upslope boundary of landslide generally defined by modified scarp, but downslope (toe) may be gradational and not well defined. Questioned where doubtful.

- COMBINATION LANDSLIDE**
Area of recent and old slides in which individual slides are not identified.
- COLLUVIAL SLOPE**
Valley wall along major streams with slope as steep as 40 (85%); stony, clayey silt soil up to 50 ft. (15 m) thick; commonly buttressed by a terrace or bench at the toe of the slope; very susceptible to sliding by cutting of toe area, removal of terrace or bench, and overloading; slide commonly activated without apparent cause.

- COLLUVIAL SLOPES WITH LANDSLIDES**
Landslides too small or obscure to map individually.
- AREAS SUSCEPTIBLE TO DEBRIS FLOWS AND DEBRIS AVALANCHES**
Primarily shallow, narrow ravines and chutes with accumulation of stony colluvium generally 10 ft. (3 m) or less in thickness; susceptible to rapid movement during intense rainfall. Most ravines and chutes designated show evidence of former debris flows and avalanches.

- AREAS SUSCEPTIBLE TO ROCKFALL**
Steep, locally vertical, natural and man-made slopes and cliffs, 15 ft. (4.5 m) or more high; formed dominantly of sandstone, limestone, sandy shale, mudstone and claystone. Interbedded mudstone, claystone and shale weather rapidly leaving sandstone and limestone rock faces unsupported.

- SOIL AND ROCK SUSCEPTIBLE TO LANDSLIDING**
Soil and rock similar to that involved in landslides elsewhere in map area; primarily areas underlain by claystone, mudstone and shale associated with other rock types. Rock weathers rapidly on exposure forming clayey soil highly susceptible to sliding. Includes coves (U-shaped, shallow valleys) containing thick layers of clayey soil that are very susceptible to sliding where excavation breaks continuity of slope and where overloaded by artificial fill.

AREAS LEAST PRONE TO LANDSLIDES
Map areas in which no patterns or symbols are shown; primarily valley floors, ridge tops and broad benches; modification by excavation and fill may lead to local landslides.

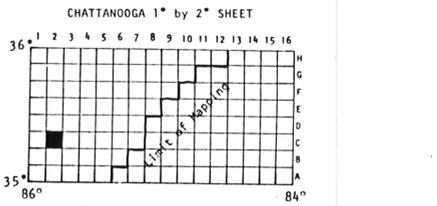
The first six digits of the open file number designate the specific 1:250,000 scale map sheet of which this quadrangle is a part. The last two digits designate the position of the quadrangle in a subdivision of the 1:250,000 scale map based on rows and tiers shown in the diagram to the right. The location of this quadrangle is shown by the black square.
