LANDSLIDES AND RELATED FEATURES

OF THE TRACY CITY, TENN. QUADRANGLE

by
Roger E. Thomas
1981

U.S. Geological Survey
OPEN FILE MAP 81-1318 (C-3)

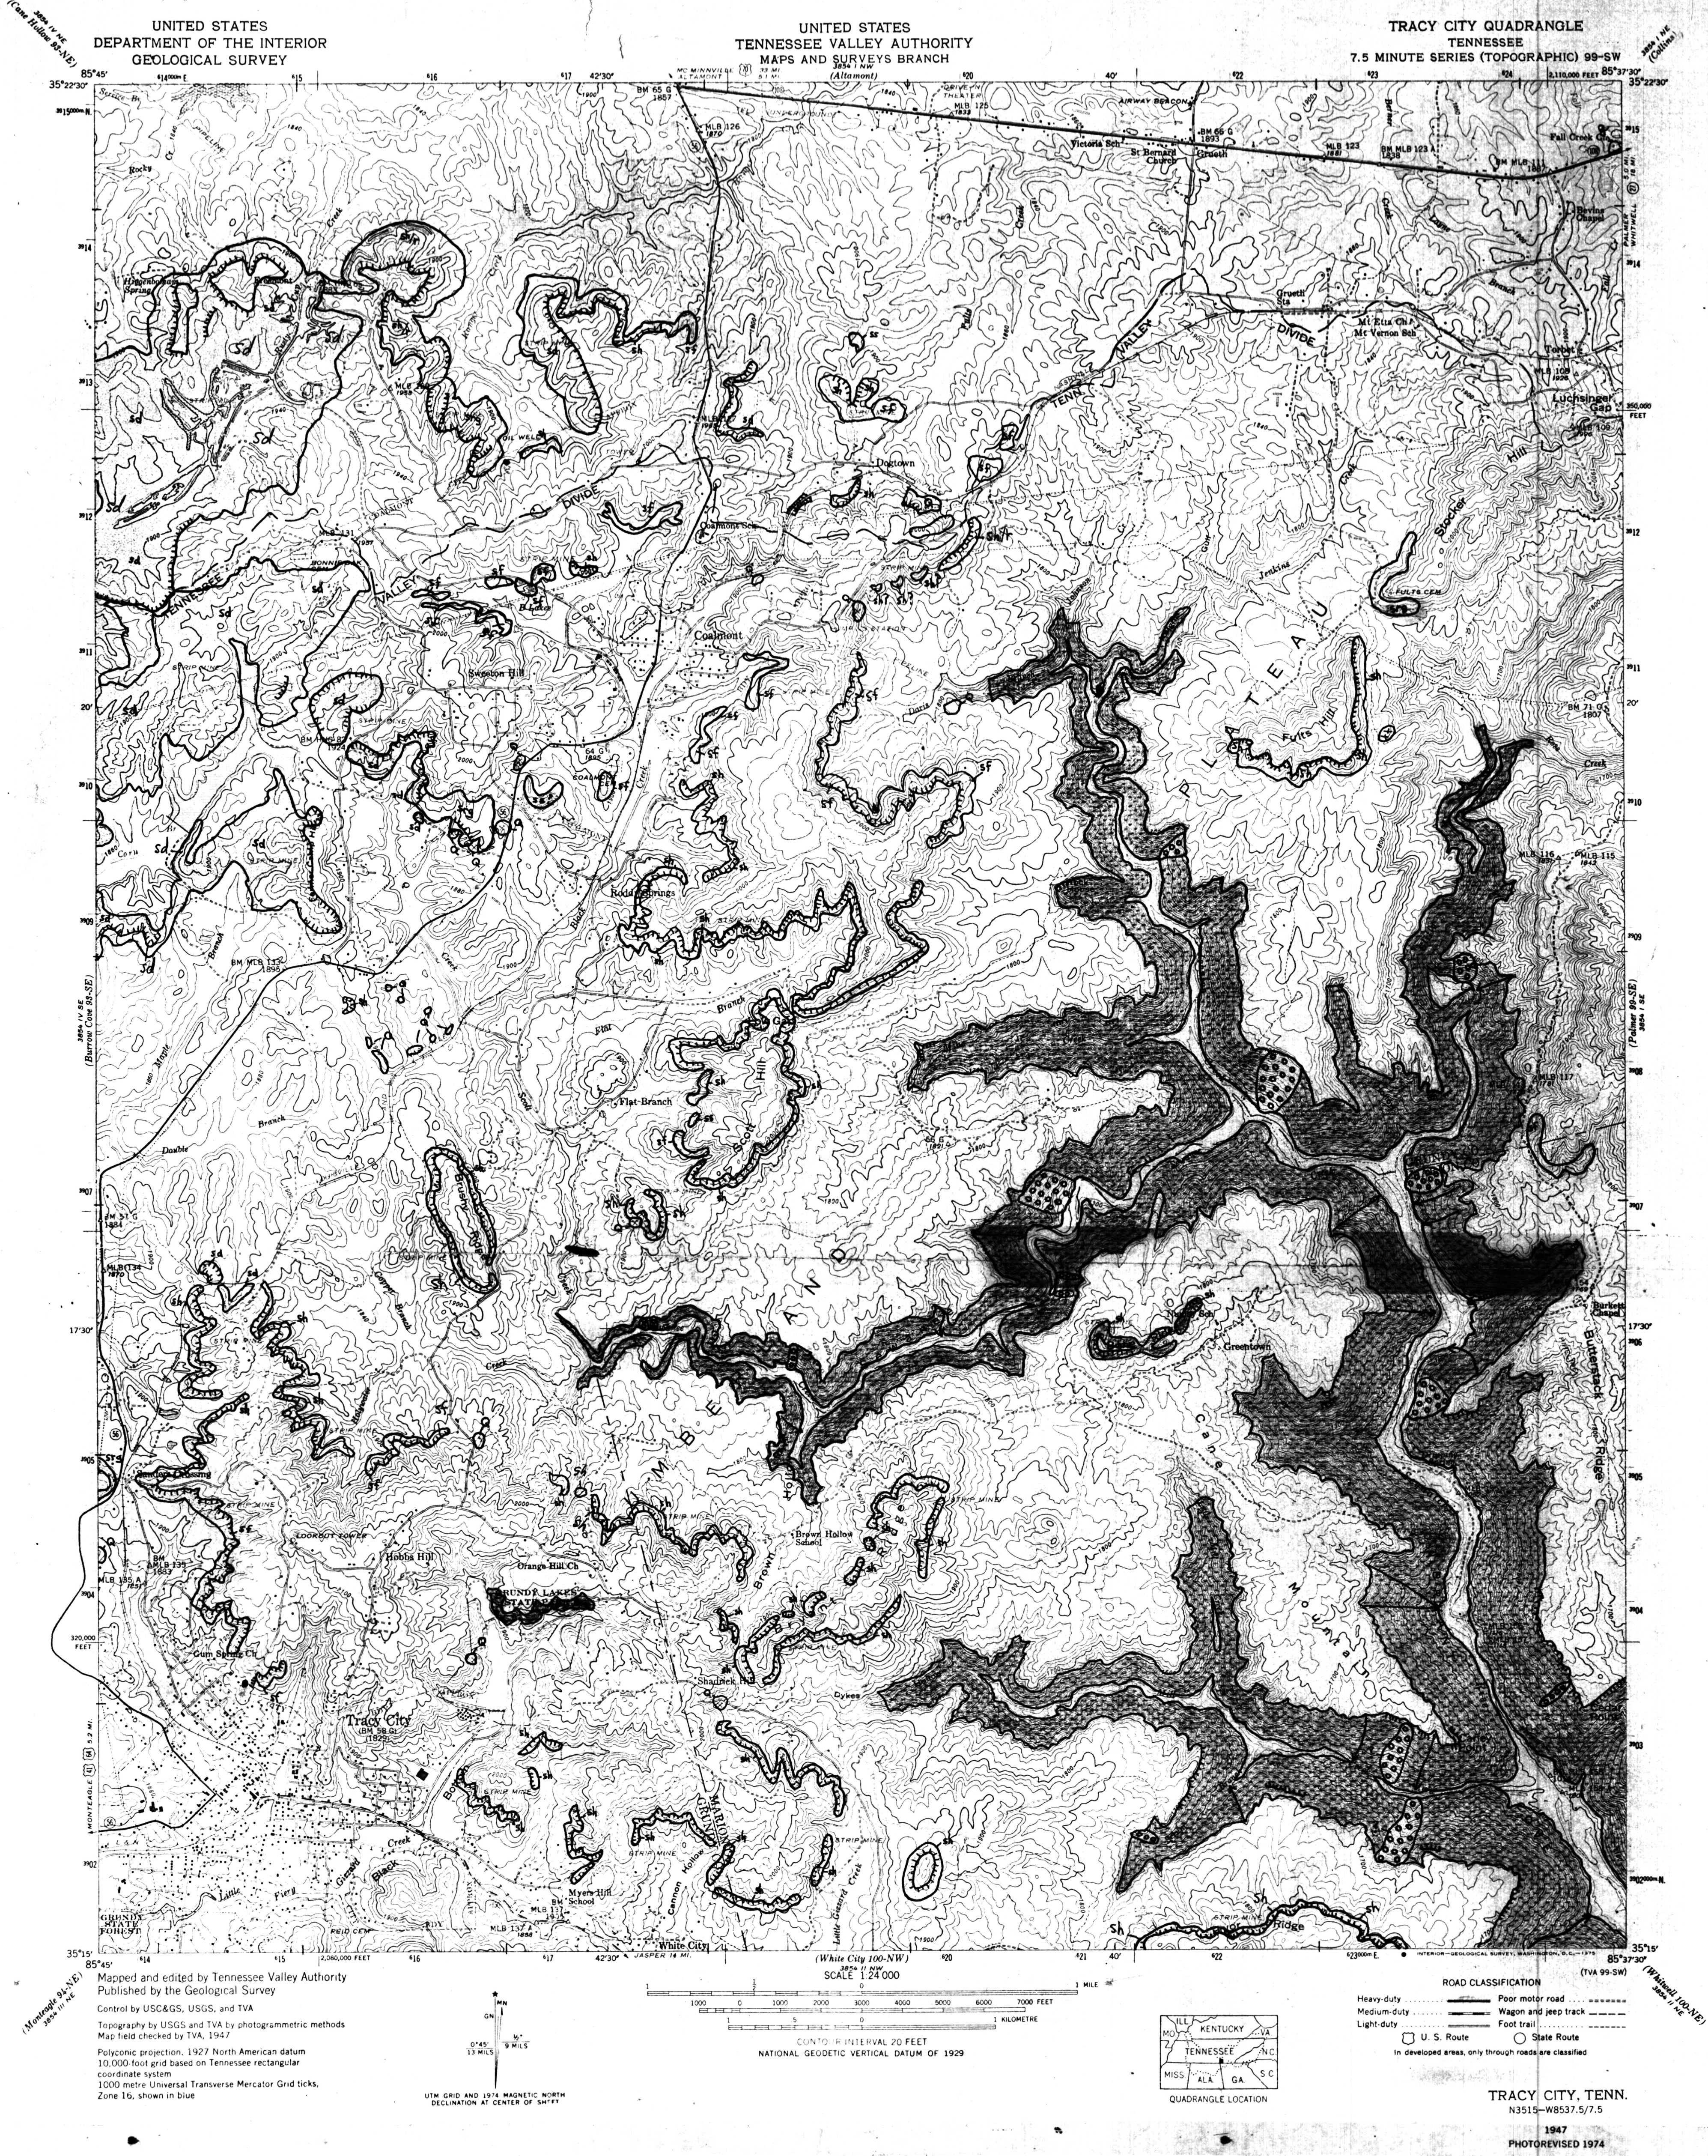
Landslides and related features interpreted from aerial photographs:
1:79,000 (Black and White) 1974
1:20,000 (Black and White) 1973

Photointerpretation and field check 1981
This report is preliminary and has not been reviewed for conformity with U.S. Geological Survey editorial standards.

ACTIVE OR RECENTLY ACTIVE LANDSLIDE

Complex landslide composed of earthflow, debris slide, earth and rock slump. Identified from historical records, and from scars, debris and other field evidence. Ground extremely unstable; sliding accelerated by excavation, loading and changes in drainage conditions. May include areas with several active slides too small to be shown separately. Questioned where doubtful.

OLD LANDSLIDE

Area of extensive hummocky ground caused by earthflow and earth and rock slump. Lacks clear evidence of active sliding. Relatively stable in natural, undisturbed state, generally not affected by small structures properly sited in areas away from the edge of the toe; can be reactivated by extensive, rapid excavation, loading, and changes in ground water and surface water conditions. Area of old landslide probably includes recent ones not identified from field evidence or otherwise documented. Upslope boundary of landslide generally defined by modified scarp, but downslope (toe) may be gradational and not well defined. Questioned where doubtful.

COMBINATION LANDSLIDE

Area of recent and old slides in which individual slides are not identified.

COLLUVIAL SLOPE

Valley wall along major streams with slope as steep as 40 (85%); stony, clayey silt soil up to 50 ft. (15 m) thick; commonly buttressed by a terrace or bench at the toe of the slope; very susceptible to sliding by cutting of toe area, removal of terrace or bench, and overloading; slide commonly activated without apparent cause.

COLLUVIAL SLOPES WITH LANDSLIDES

Landslides too small or obscure to map individually.

AREAS SUSCEPTIBLE TO DEBRIS FLOWS AND DEBRIS AVALANCHES

Primarily shallow, narrow ravines and chutes with accumulation of stony colluvium generally 10 ft. (3 m) or less in thickness; susceptible to rapid movement during intense rainfall. Most ravines and chutes designated show evidence of former debris flows and avalanches.

AREAS SUSCEPTIBLE TO ROCKFALL

Steep, locally vertical, natural and man-made slopes and cliffs, 15 ft. (4.5 m) or more high; formed dominantly of sandstone, limestone, sandy shale, mudstone and claystone. Interbedded mudstone, claystone and shale weather rapidly leaving sandstone and limestone rock faces unsupported.

SOIL AND ROCK SUSCEPTIBLE TO LANDSLIDING

Soil and rock similar to that involved in landslides elsewhere in map area; primarily areas underlain by claystone, mudstone and shale associated with other rock types. Rock weathers rapidly on exposure forming clayey soil highly susceptible to sliding. Includes coves (U-shaped, shallow valleys) containing thick layers of clayey soil that are very susceptible to sliding where excavation breaks continuity of slope and where overloaded by artificial fill.

AREAS LEAST PRONE TO LANDSLIDES

Map areas in which no patterns or symbols are shown; primarily valley floors, ridge tops and broad benches; modification by excavation and fill may lead to local landslides.

Information shown is intended as a general guide to ground conditions as of the date of field check. Additional landslides and rockfalls should be anticipated in all map units. The map unit depicts the dominant condition in the area delineated and variations in slope stability may occur at any point in the unit. This map is suitable for general planning purposes and as a supplement to more detailed studies for site selection. The map cannot be used as a substitute for detailed geologic and engineering investigations to establish design and construction criteria of specific sites. Some symbols may not appear on this map because the description is applicable to a series of maps.

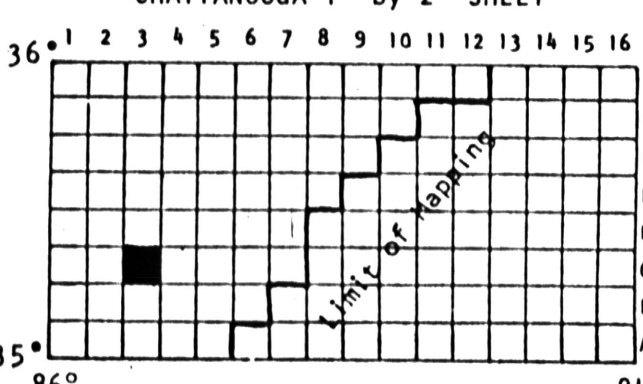
CHATTANOOGA 1" by 2" SHEET

The first six digits of the open file number designate the specific 1:250,000 scale map sheet of which this quadrangle is a part. The last two digits designate the position of the quadrangle in a subdivision of the 1:250,000 scale map based on rows and tiers shown in the diagram to the right. The location of this quadrangle is shown by the black square.
