LANDSLIDES AND RELATED FEATURES

OF THE De ROSSETT, TENN. QUADRANGLE

by
Roger E. Thomas
1981
U.S. Geological Survey
OPEN FILE MAP 81-1318 (H-6)

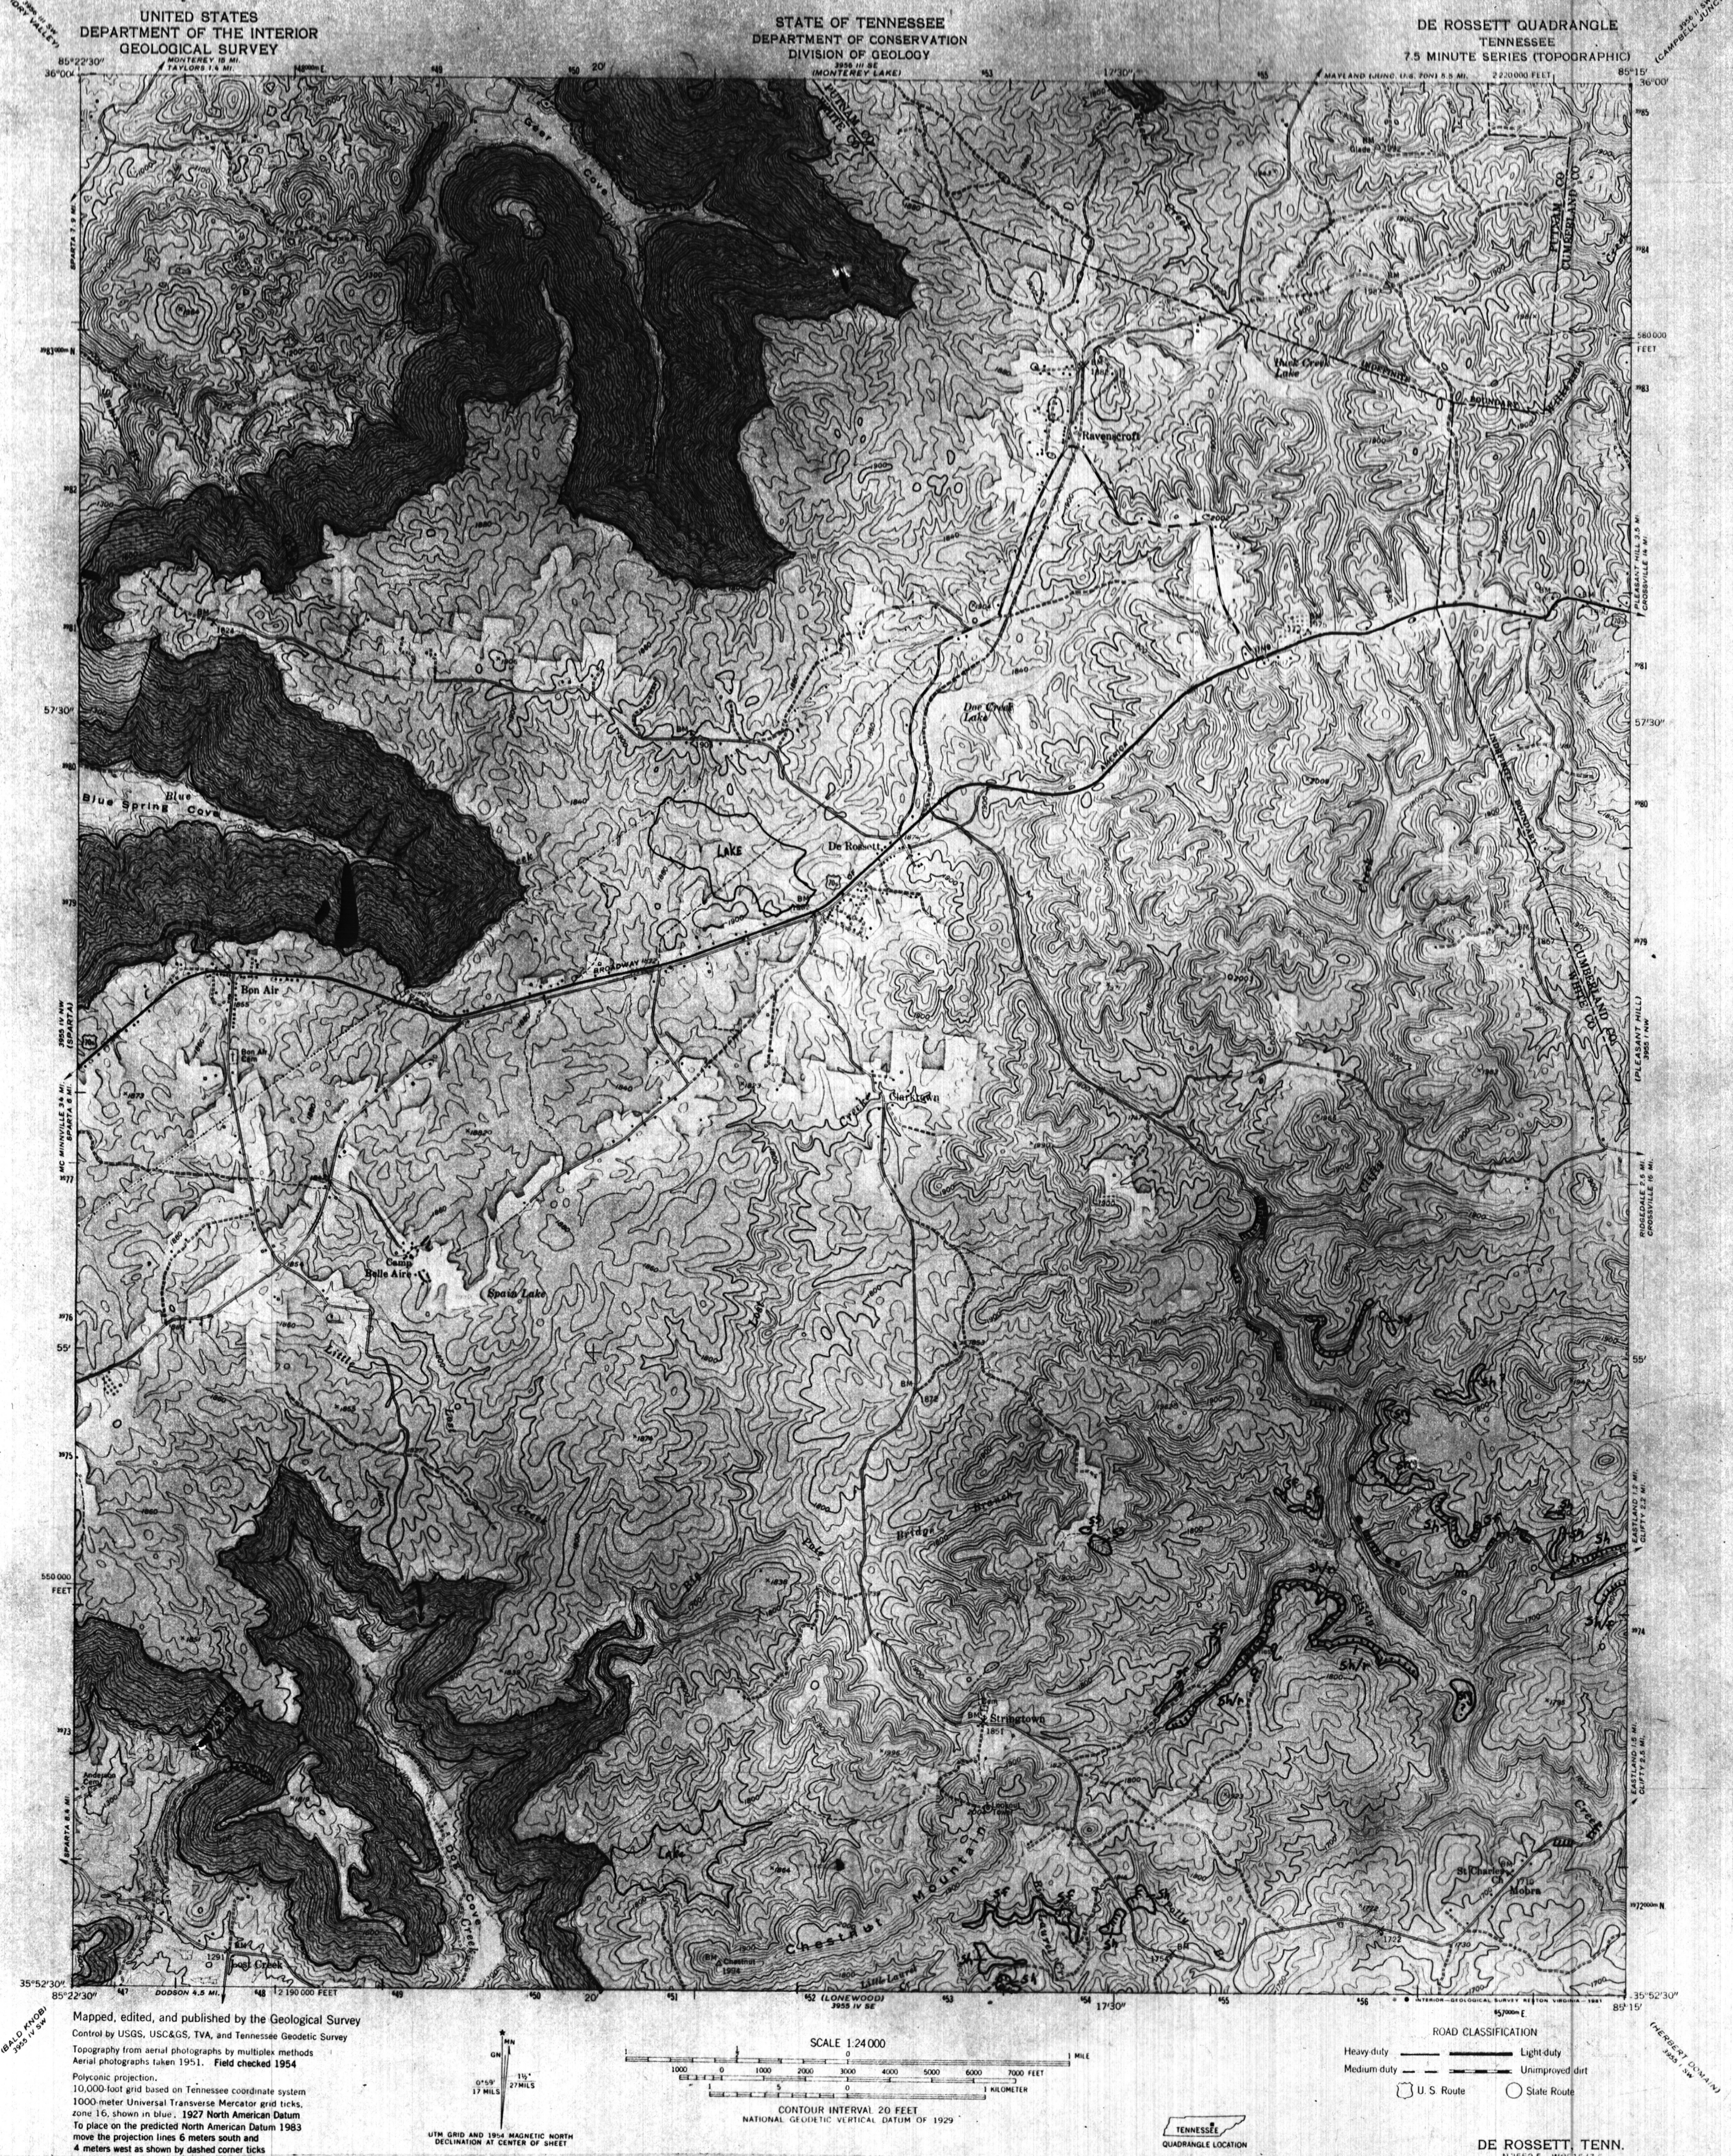
DE ROSSETT, TENN.
N3552.5-W8315.7.5
1954

NOTE
Information shown is intended as a general guide to ground conditions as of the date of field check. Additional landslides and rockfalls should be anticipated in all map units. The map unit depicts the dominant condition in the area delineated and variations in slope stability may occur at any point in the unit. This map is suitable for general planning purposes and as a supplement to more detailed studies for site selection. The map cannot be used as a substitute for detailed geologic and engineering investigations to establish design and construction criteria of specific sites. Some symbols may not appear on this map because the description is applicable to a series of maps.

- ACTIVE OR RECENTLY ACTIVE LANDSLIDE**
Complex landslide composed of earthflow, debris slide, earth and rock slump. Identified from historical records, and from scars, debris and other field evidence. Ground extremely unstable; sliding accelerated by excavation, loading and changes in drainage conditions. May include areas with several active slides too small to be shown separately. Questioned where doubtful.

- OLD LANDSLIDE**
Area of extensive hummocky ground caused by earthflow and earth and rock slump. Lacks clear evidence of active sliding. Relatively stable in natural, undisturbed state, generally not affected by small structures properly sited in areas away from the edge of the toe; can be reactivated by extensive, rapid excavation, loading, and changes in ground water and surface water conditions. Area of old landslide probably includes recent ones not identified from field evidence or otherwise documented. Upslope boundary of landslide generally defined by modified scarp, but downslope (toe) may be gradational and not well defined. Questioned where doubtful.

- COMBINATION LANDSLIDE**
Area of recent and old slides in which individual slides are not identified.
- COLLUVIAL SLOPE**
Valley wall along major streams with slope as steep as 40 (83%); stony, clayey silt soil up to 50 ft. (15 m) thick; commonly buttressed by a terrace or bench at the toe of the slope; very susceptible to sliding by cutting of toe area, removal of terrace or bench, and overloading; slide commonly activated without apparent cause.

- COLLUVIAL SLOPES WITH LANDSLIDES**
Landslides too small or obscure to map individually.
- AREAS SUSCEPTIBLE TO DEBRIS FLOWS AND DEBRIS AVALANCHES**
Primarily shallow, narrow ravines and chutes with accumulation of stony colluvium generally 10 ft. (3 m) or less in thickness; susceptible to rapid movement during intense rainfall. Most ravines and chutes designated show evidence of former debris flows and avalanches.

- AREAS SUSCEPTIBLE TO ROCKFALL**
Steep, locally vertical, natural and man-made slopes and cliffs, 15 ft. (4.5 m) or more high; formed dominantly of sandstone, limestone, sandy shale, mudstone and claystone. Interbedded mudstone, claystone and shale weather rapidly leaving sandstone and limestone rock faces unsupported.

- SOIL AND ROCK SUSCEPTIBLE TO LANDSLIDING**
Soil and rock similar to that involved in landslides elsewhere in map area; primarily areas underlain by claystone, mudstone and shale associated with other rock types. Rock weathers rapidly on exposure forming clayey soil highly susceptible to sliding. Includes coves (U-shaped, shallow valleys) containing thick layers of clayey soil that are very susceptible to sliding where excavation breaks continuity of slope and where overloaded by artificial fill.

- AREAS LEAST PRONE TO LANDSLIDES**
Map areas in which no patterns or symbols are shown; primarily valley floors, ridge tops and broad benches; modification by excavation and fill may lead to local landslides.

- MAN-MADE FEATURES**
Strip mines (combination of letter symbols indicates complex formed or more than one type of strip mine)
 - sh bench with high wall
 - sf furrowed with high wall
 - sd multiple furrows and multiple benches
 - as hilltop removed
 - strg reclaimed by grading
 - stru reclaimed by secondary use
 - sh/r regaded in part, high wall remains
- Coal refuse banks
 - r identified on aerial photographs; not classified in field check
 - rb not burnt nor on fire
 - rbb burnt
 - rbd burning
 - rbs sludge
- Quarries
 - q quarry site
- Gravel pits
 - g site of gravel pit
- Slides in man-made features
 - af earth flow in fill
 - a/s earth flow in strip castings
 - a/r earth flow in coal refuse

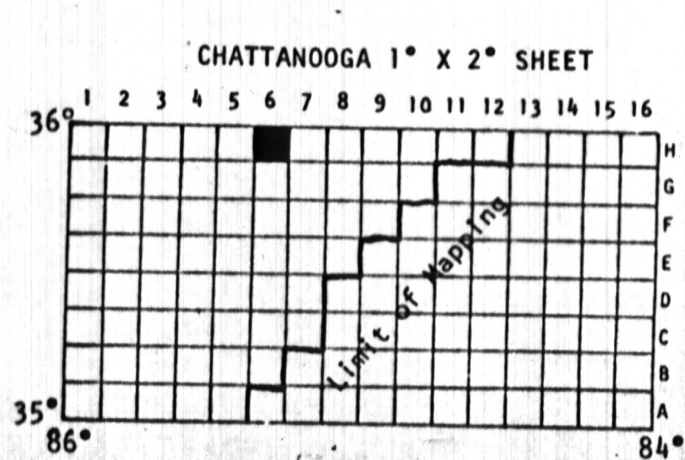
The first six digits of the open file number designate the specific 1:250,000 scale map sheet of which this quadrangle is a part. The last two digits designate the position of the quadrangle in a subdivision of the 1:250,000 scale map based on rows and tiers shown in the diagram to the right. The location of this quadrangle is shown by the black square.
