LANDSLIDES AND RELATED FEATURES

OF THE MEANS, KY. QUADRANGLE

by
William F. Outerbridge
1982

OPEN FILE MAP 82-51 (H-2)

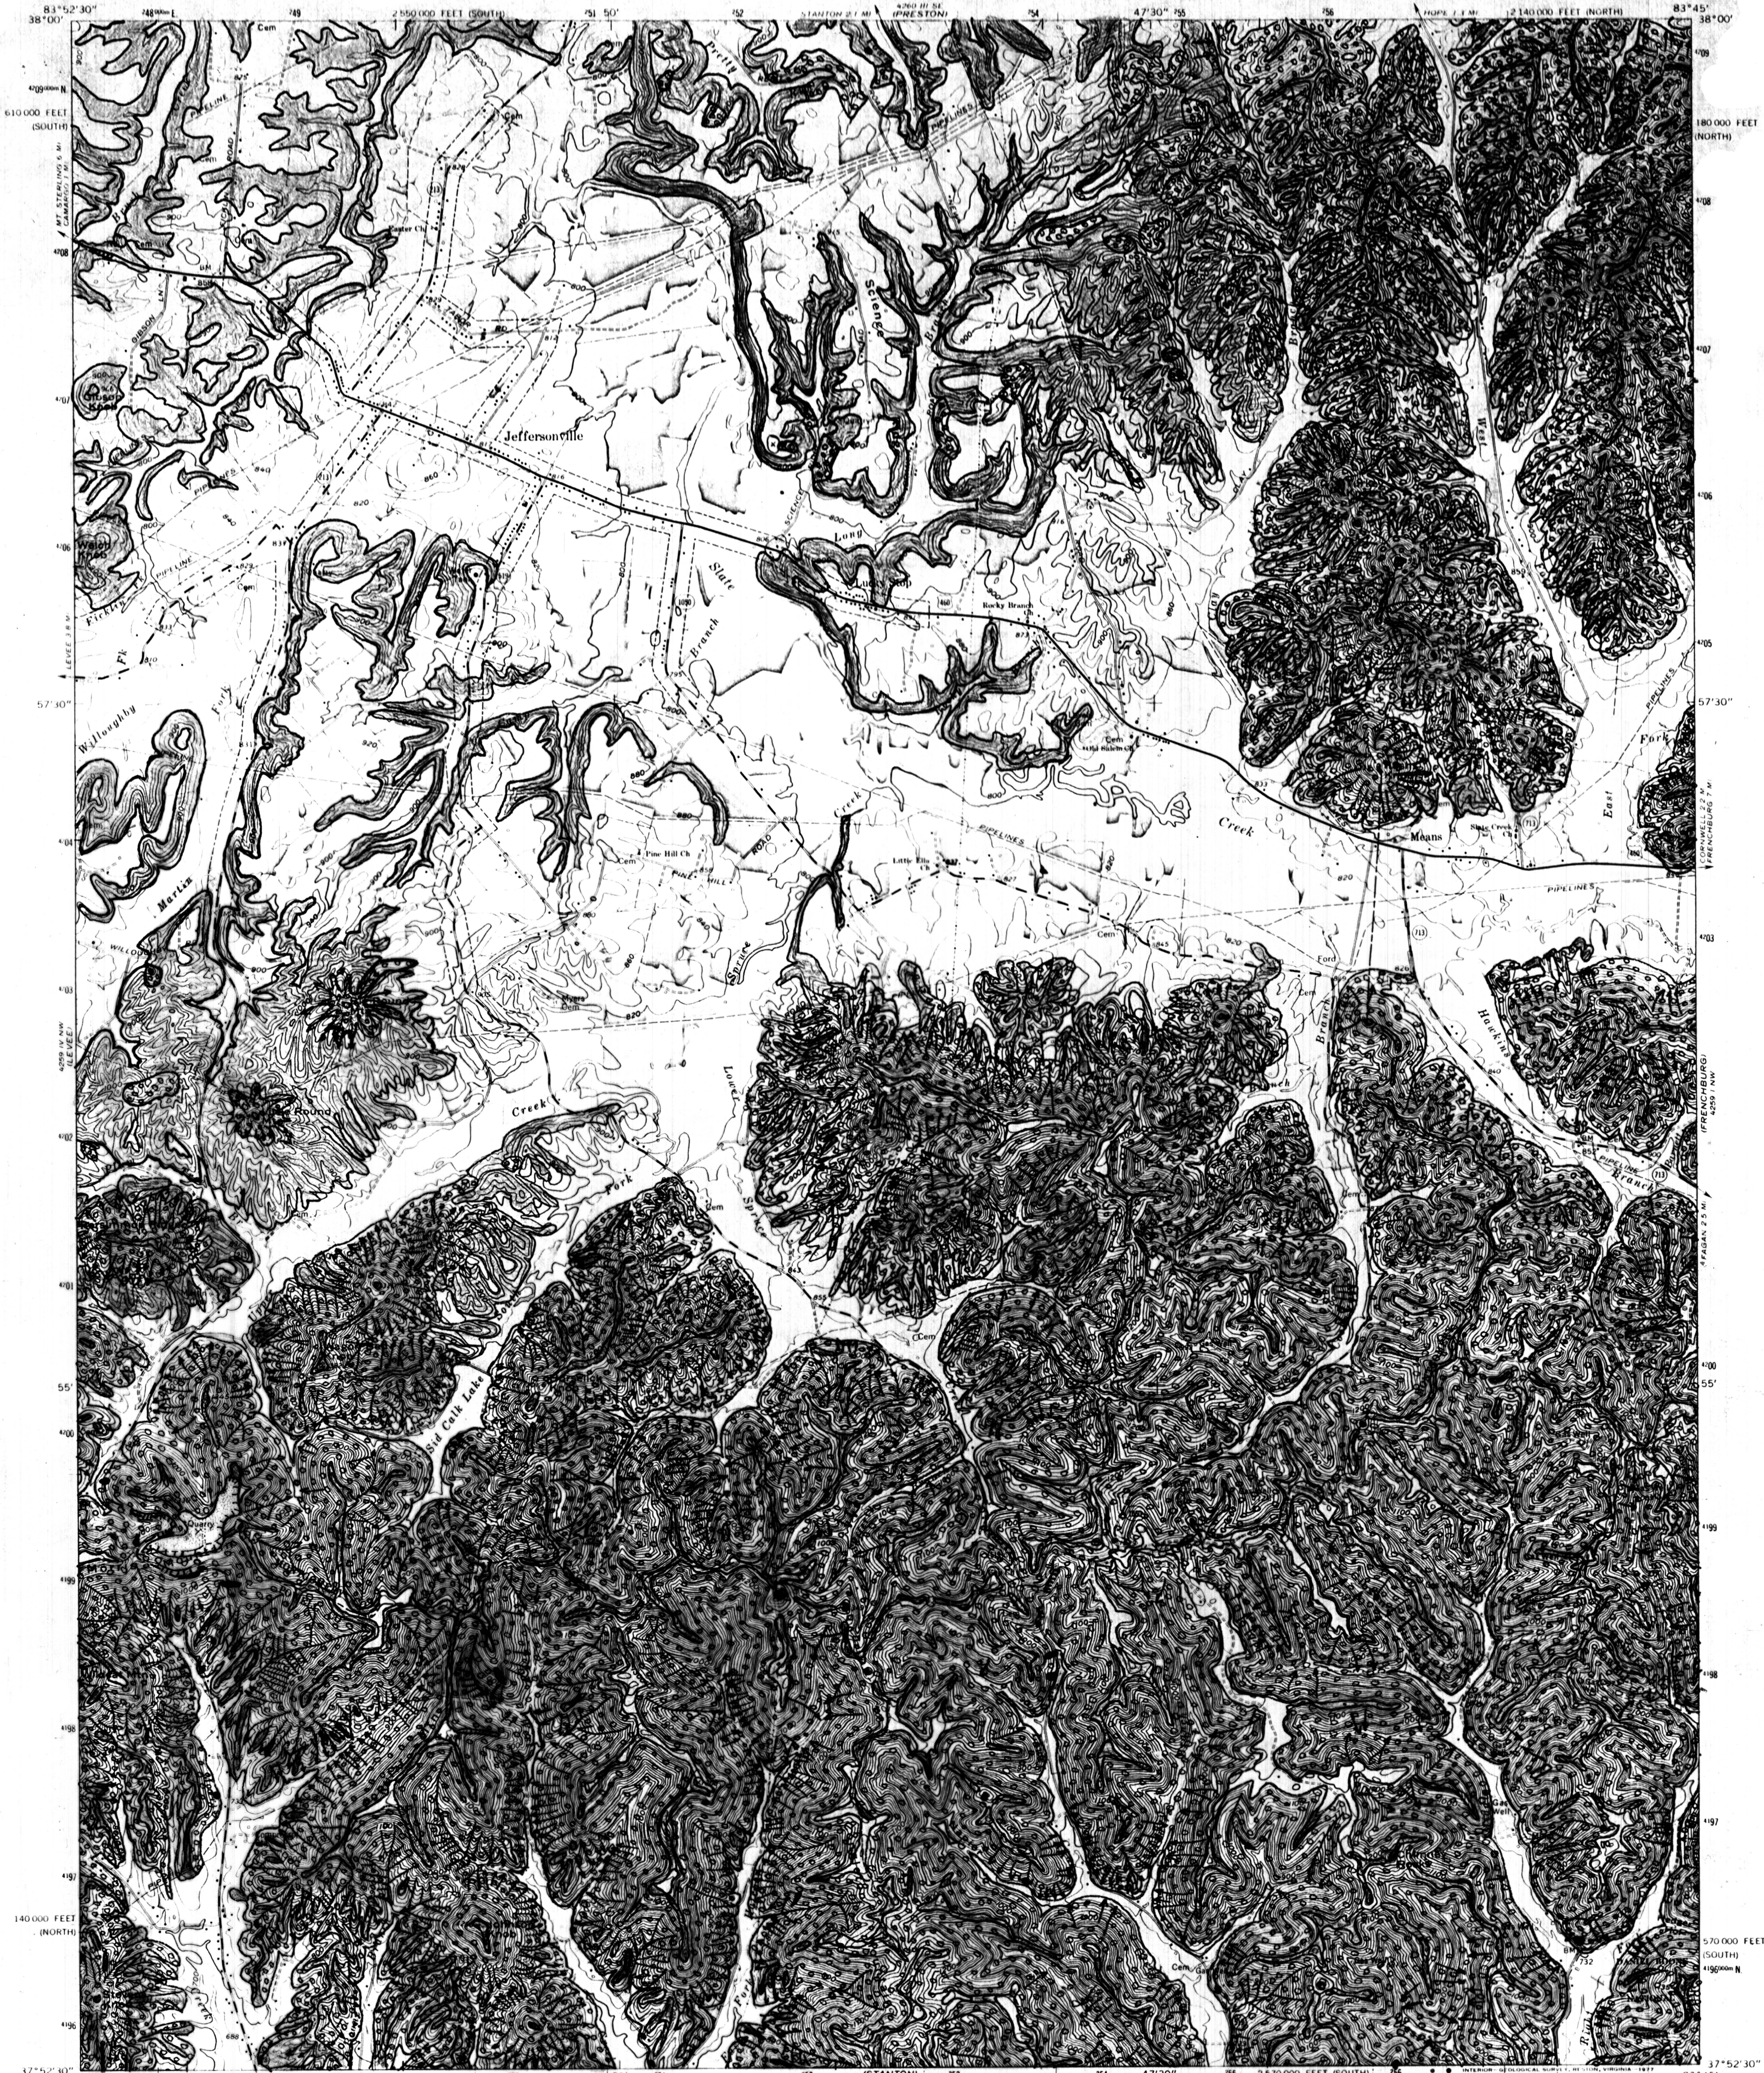
Landslides and related features interpreted
from aerial photographs:
1:60,000 (black and white) 1959
1:80,000 (black and white) 1975

ACTIVE OR RECENTLY ACTIVE LANDSLIDE
Complex landslide composed of earthflow, debris
slide, earth and rock slump. Identified from
historical records, and from scars, debris and
other field evidence. Ground extremely unstable;
sliding accelerated by excavation, loading and
changes in drainage conditions. May include
areas with several active slides too small to
be shown separately. Questioned where doubtful.

OLD LANDSLIDE
Area of extensive hummocky ground caused by
earthflow and earth and rock slump. Lacks
clear evidence of active sliding. Relatively
stable in natural, undisturbed state,
generally not affected by small structures properly
sited in areas away from the edge of the toe;
can be reactivated by extensive, rapid exca-
vation, loading, and changes in ground water and
surface water conditions. Area of old landslide
probably includes recent ones not identified
from field evidence or otherwise documented.
Upslope boundary of landslide generally defined
by modified scarp, but downslope (toe) may be
gradational and not well defined. Questioned
where doubtful.

COMBINATION LANDSLIDE
Area of recent and old slides in which
individual slides are not identified.

COLLUVIAL SLOPE
Valley wall along major streams with slope as
steep as 40° (85%); stony, clayey silt soil up
to 50 ft. (15 m) thick; commonly buttressed by
a terrace or bench at the toe of the slope; very
susceptible to sliding by cutting of toe area,
removal of terrace or bench, and overloading;
slide commonly activated without apparent cause.

COLLUVIAL SLOPES WITH LANDSLIDES
Landslides too small or obscure to map
individually.

**AREAS SUSCEPTIBLE TO DEBRIS FLOWS AND DEBRIS
AVALANCHES**
Primarily shallow, narrow ravines and chutes with
accumulation of stony colluvium generally 10 ft.
(3 m) or less in thickness; susceptible to rapid
movement during intense rainfall. Most ravines
and chutes designated show evidence of former
debris flows and avalanches. Symbol & design-
ates historical debris flow or debris avalanche.

AREAS SUSCEPTIBLE TO ROCKFALL
Steep, locally vertical, natural and man-made
slopes and cliffs, 15 ft. (4.5 m) or more high;
formed dominantly of sandstone, limestone, sandy
shale, mudstone and claystone. Interbedded mud-
stone, claystone and shale weather rapidly leaving
sandstone and limestone rock faces unsupported.

SOIL AND ROCK SUSCEPTIBLE TO LANDSLIDING
Soil and rock similar to that involved in land-
slides elsewhere in map area; primarily areas
underlain by claystone, mudstone and shale
associated with other rock types. Rock weathers
rapidly on exposure forming clayey soil highly
susceptible to sliding. Includes coves (U-shaped,
shallow valleys) containing thick layers of clayey
soil that are very susceptible to sliding where
excavation breaks continuity of slope and where
overloaded by artificial fill.

AREAS LEAST PRONE TO LANDSLIDES
Map areas in which no patterns or symbols are shown;
primarily valley floors, ridge tops and broad
benches; modification by excavation and fill may
lead to local landslides.
