LANDSLIDES AND RELATED FEATURES

OF THE OFFUTT, KY. QUADRANGLE

by
William F. Outerbridge
1982

OPEN FILE MAP 82-51 (6-11)

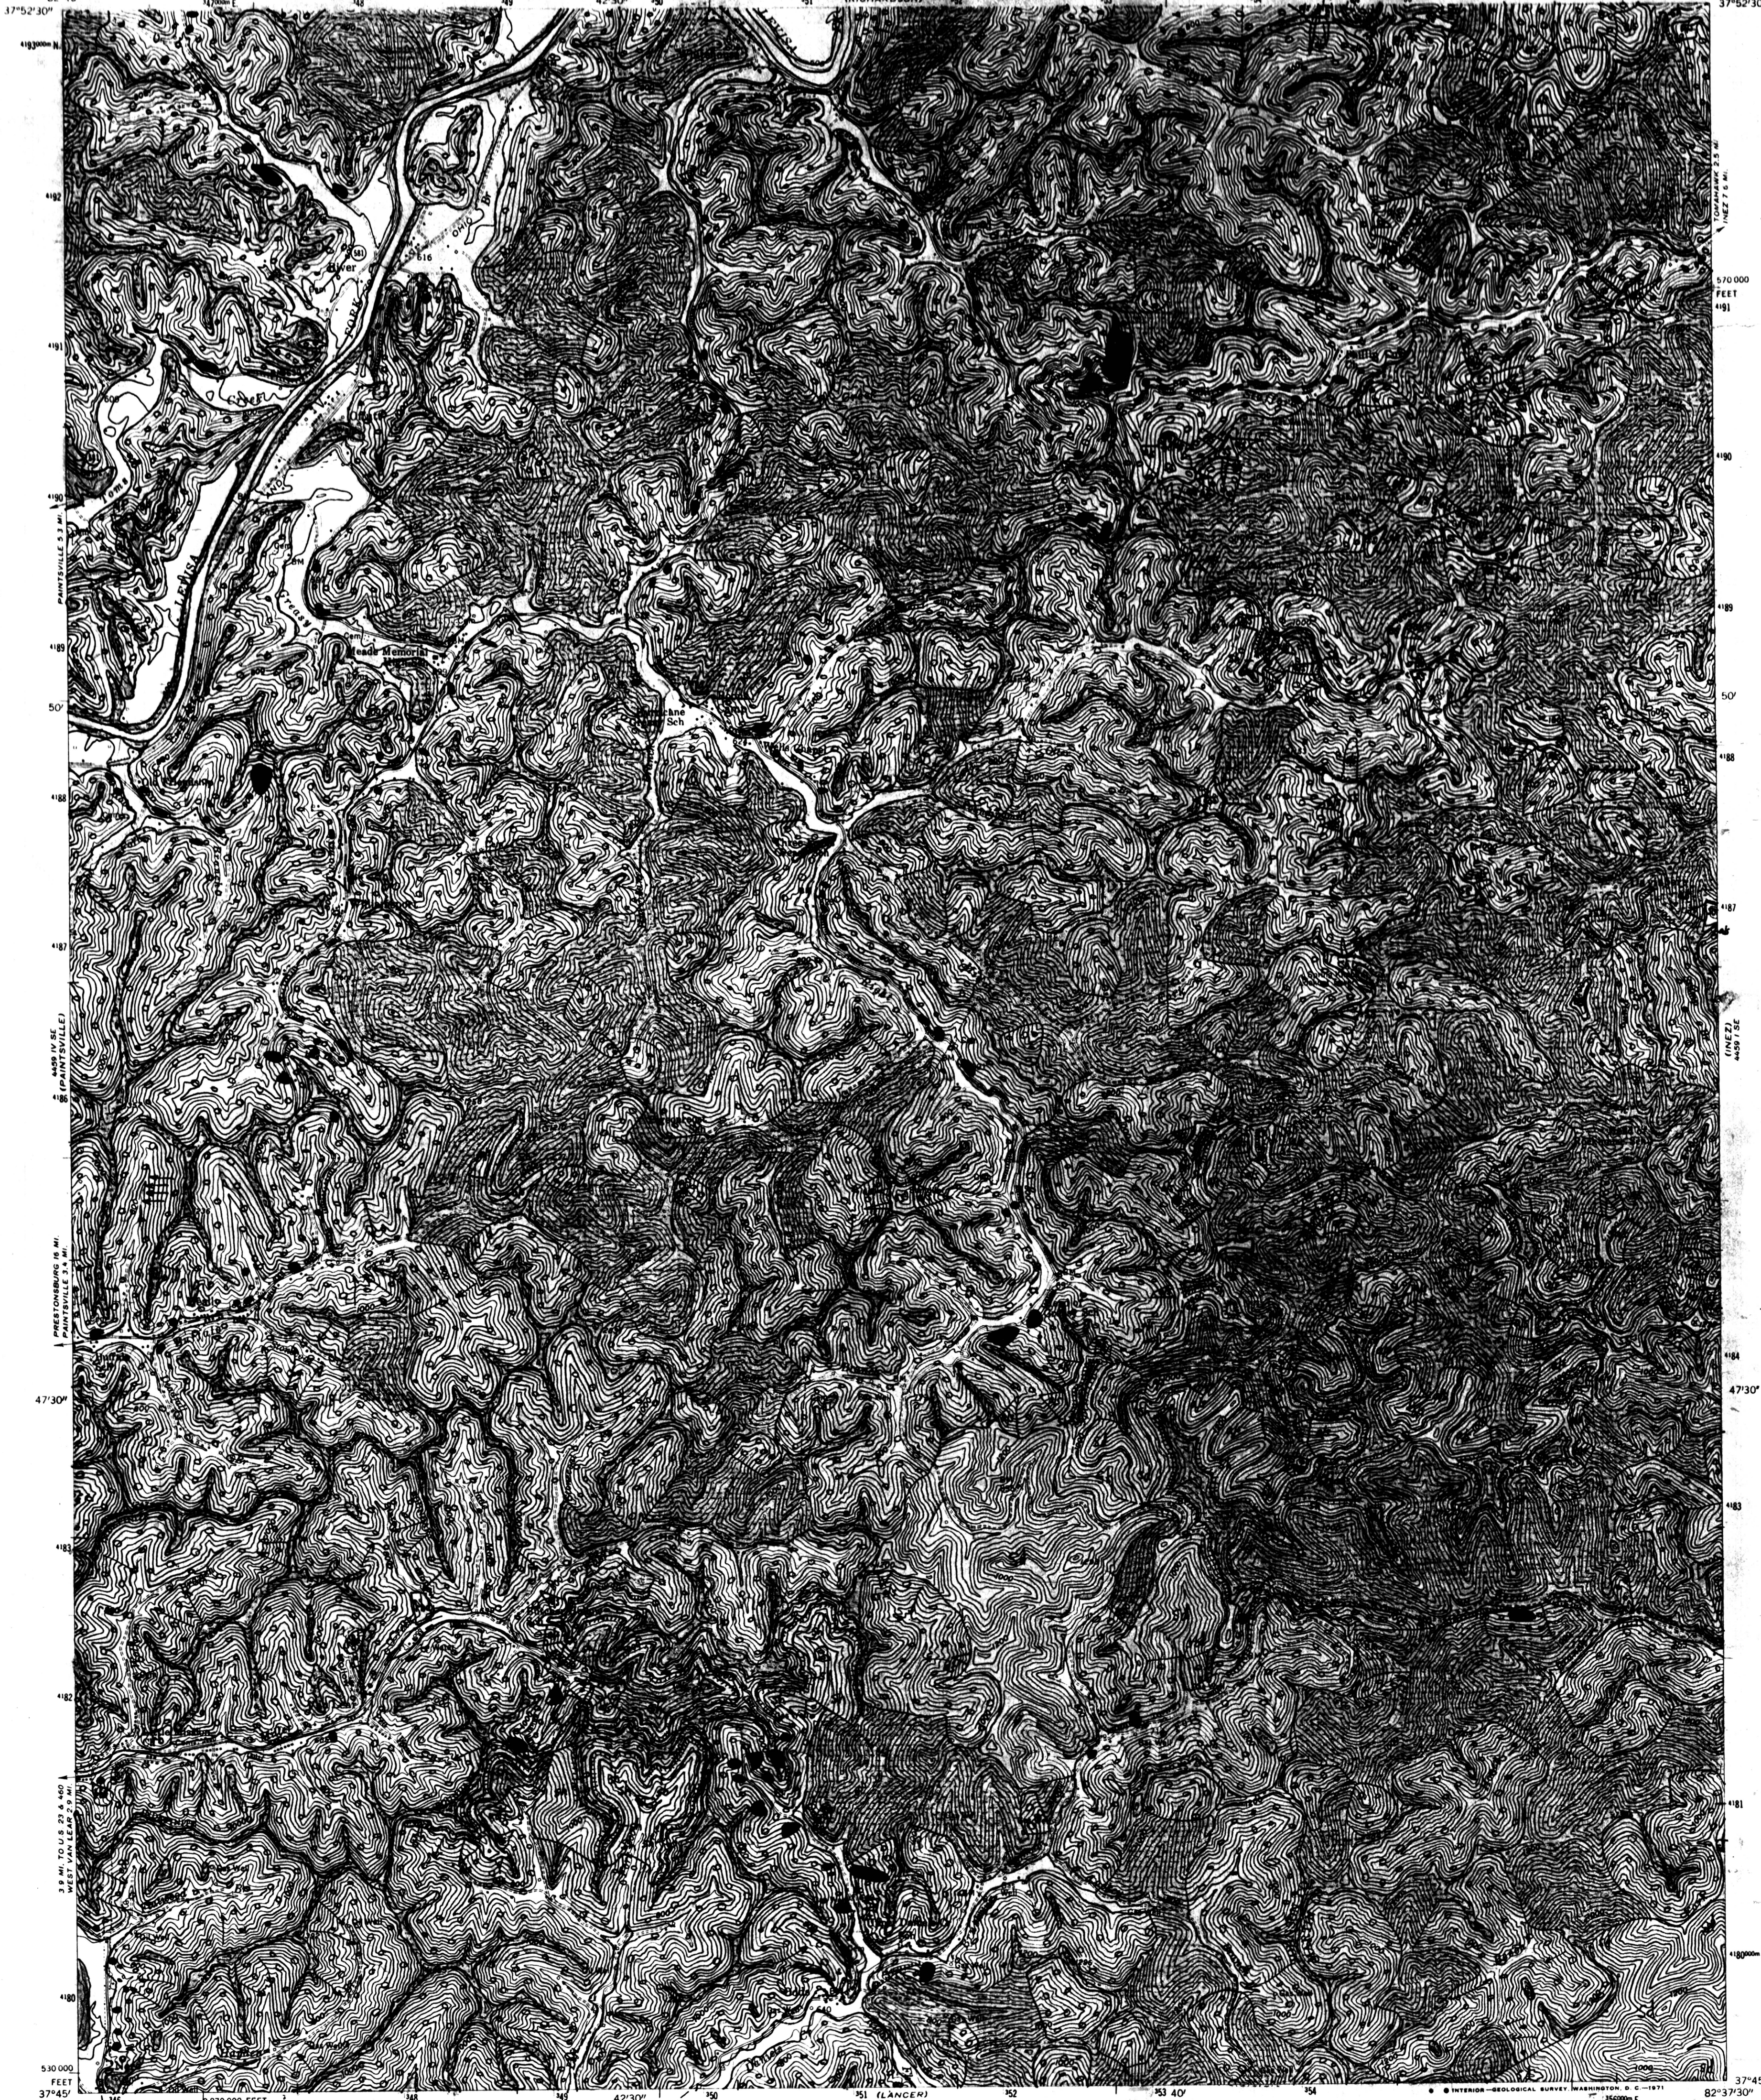
Landslides and related features interpreted
from aerial photographs:
1:60,000 (black and white) 1959
1:80,000 (black and white) 1975

Photointerpretation and field check 1977,8
This report is preliminary and has not
been reviewed for conformity with U. S.
Geological Survey editorial standards.
Data on location of strip mines in part from:
Outerbridge, William F., 1964, Geology of the
Offutt quadrangle, Kentucky: U. S. Geological
Survey Geologic Quadrangle Map GQ-348, scale
1:24,000.

ACTIVE OR RECENTLY ACTIVE LANDSLIDE

Complex landslide composed of earthflow, debris
slide, earth and rock slump. Identified from
historical records, and from scars, debris, and
other field evidence. Ground extremely unstable;
sliding accelerated by excavation, loading and
changes in drainage conditions. May include
areas with several active slides too small to
be shown separately. Questioned where doubtful.

OLD LANDSLIDE

Area of extensive hummocky ground caused by
earthflow and earth and rock slump. Lacks
clear evidence of active sliding. Relatively
stable in natural, undisturbed state,
generally not affected by small structures properly
sited in areas away from the edge of the toe;
can be reactivated by extensive, rapid exca-
vation, loading, and changes in ground water and
surface water conditions. Area of old landslide
probably includes recent ones not identified
from field evidence or otherwise documented.
Upslope boundary of landslide generally defined
by modified scarp, but downslope (toe) may be
gradational and not well defined. Questioned
where doubtful.

COMBINATION LANDSLIDE

Area of recent and old slides in which
individual slides are not identified.

COLLUVIAL SLOPE

Valley wall along major streams with slope as
steep as 40° (85%); stony, clayey silt soil up
to 50 ft. (15 m) thick; commonly buttressed by
a terrace or bench at the toe of the slope; very
susceptible to sliding by cutting of toe area,
removal of terrace or bench, and overloading;
slide commonly activated without apparent cause.

AREAS SUSCEPTIBLE TO DEBRIS FLOWS AND DEBRIS
AVALANCHES

Primarily shallow, narrow ravines and chutes with
accumulation of stony colluvium generally 10 ft.
(3 m) or less in thickness; susceptible to rapid
movement during intense rainfall. Most ravines
and chutes designated show evidence of former
debris flows and avalanches. Symbol & design-
ates historical debris flow or debris avalanche.

AREAS SUSCEPTIBLE TO ROCKFALL

Steep, locally vertical, natural and man-made
slopes and cliffs, 15 ft. (4.5 m) or more high;
formed dominantly of sandstone, limestone, sandy
shale, mudstone and claystone. Interbedded mud-
stone, claystone and shale weather rapidly leaving
sandstone and limestone rock faces unsupported.

SOIL AND ROCK SUSCEPTIBLE TO LANDSLIDING

Soil and rock similar to that involved in land-
slides elsewhere in map area; primarily areas
underlain by claystone, mudstone and shale
associated with other rock types. Rock weathers
rapidly on exposure forming clayey soil highly
susceptible to sliding. Includes coves (U-shaped,
shallow valleys) containing thick layers of clayey
soil that are very susceptible to sliding where
excavation breaks continuity of slope and where
overloaded by artificial fill.

AREAS LEAST PRONE TO LANDSLIDES

Map areas in which no patterns or symbols are shown;
primarily valley floors, ridge tops and broad
benches; modification by excavation and fill may
lead to local landslides.

Information shown is intended as a
general guide to ground conditions as of
the date of field check. Additional
landslides and rockfalls should be anticipated
in all map units. The map unit depicts
the dominant condition in the area delineated
and variations in slope stability may occur
at any point in the unit. This map is suit-
able for general planning purposes and as a
supplement to more detailed studies for site
selection. The map cannot be used as a sub-
stitute for detailed geologic and engineering
investigations to establish design and
construction criteria of specific sites.
Some symbols may not appear on this map
because the description is applicable to a
series of maps.
