LANDSLIDES AND RÉLATED FEATURES

OF THE ZACHARIAH, KY. QUADRANGLE

William F. Outerbridge 1982

OPEN FILE MAP 82-51 (F-3)

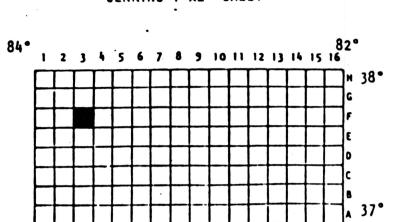
QUADRANGLE LOCATION

The first four digits of the open file number designate the specific 1:250,000 scale map sheet of which this quadrangle is a part. The last two digits designate the position of the quadrangle in a subdivision of the 1:250,000 scale map based on rows and tiers shown in the diagram to the right. The location of this quadrangle is shown by the black square.
