LANDSLIDES AND RELATED FEATURES

OF THE MUD CREEK, ALA. QUADRANGLE

by
John S. Pomeroy

OPEN FILE MAP 82-181 (G-16)

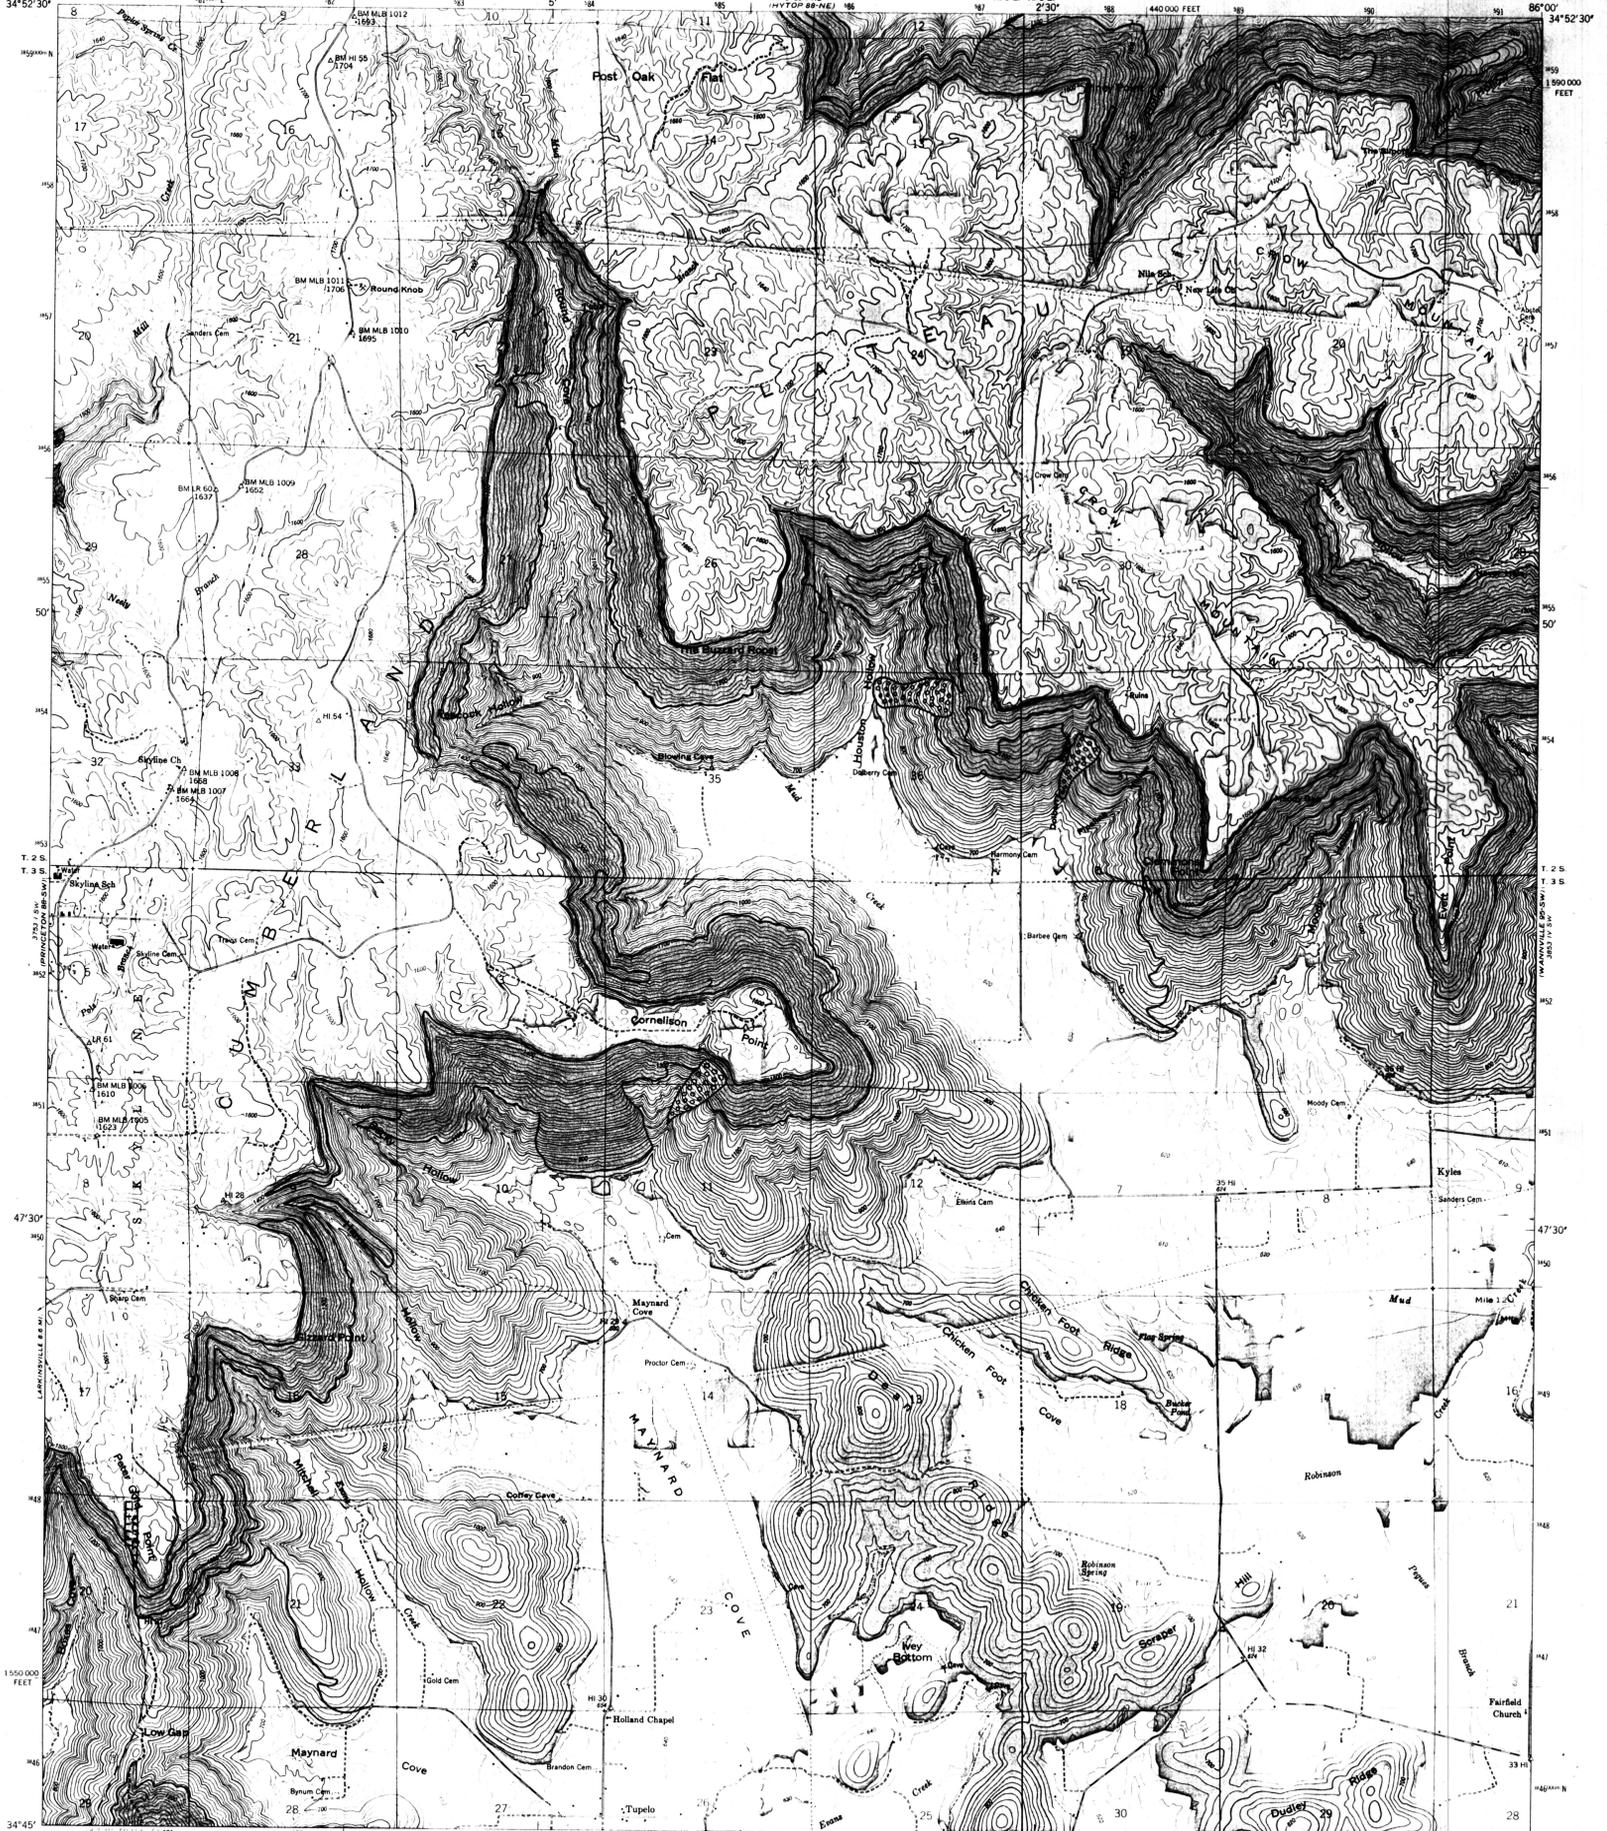
Landslides and related features interpreted from aerial photographs:

ACTIVE OR RECENTLY ACTIVE LANDSLIDE
Complex landslide composed of earthflow, debris slide, earth and rock slump. Identified from historical records, and from scars, debris and other field evidence. Ground extremely unstable; sliding accelerated by excavation, loading and changes in drainage conditions. May include areas with several active slides too small to be shown separately. Questioned where doubtful. May be shown with symbol (a) where difficult to discern

OLD LANDSLIDE
Area of extensive hummocky ground caused by earthflow and earth and rock slump. Lacks clear evidence of active sliding. Relatively stable in natural, undisturbed state, generally not affected by small structures properly sited in areas away from the edge of the toe; can be reactivated by extensive, rapid excavation, loading, and changes in ground water and surface water conditions. Area of old landslide probably includes recent ones not identified from field evidence or otherwise documented. Upslope boundary of landslide generally defined by modified scarp, but downslope (toe) may be gradational and not well defined. Questioned where doubtful.

AREAS SUSCEPTIBLE TO DEBRIS FLOWS AND DEBRIS AVALANCHES
Primarily shallow, narrow ravines and chutes with accumulation of stony colluvium generally 10 ft. (3 m) or less in thickness; susceptible to rapid movement during intense rainfall. Most ravines and chutes designated show evidence of former debris flows and avalanches. Symbol (a) designates historical debris flow or debris avalanche.

AREAS SUSCEPTIBLE TO ROCKFALL
Steep, locally vertical, natural and man-made slopes and cliffs, 15 ft. (4.5 m) or more high; formed dominantly of sandstone, limestone, sandy shale, mudstone and claystone. Interbedded mudstone, claystone and shale weather rapidly leaving sandstone and limestone rock faces unsupported.

SOIL AND ROCK SUSCEPTIBLE TO LANDSLIDING
Soil and rock similar to that involved in landslides elsewhere in map area; primarily areas underlain by claystone, mudstone and shale associated with other rock types. Rock weathers rapidly on exposure forming clayey soil highly susceptible to sliding. Includes coves (U-shaped, shallow valleys) containing thick layers of clayey soil that are very susceptible to sliding where excavation breaks continuity of slope and where overloaded by artificial fill.

AREAS LEAST PRONE TO LANDSLIDES
Map areas in which no patterns or symbols are shown primarily valley floors, ridge tops and broad benches; modification by excavation and fill may lead to local landslides. Includes slopes where landslides are sparse.
