### LANDSLIDES AND RELATED FEATURES

OF THE PLEASANT GROVE, ALA. QUADRANGLE

by  
**John S. Pomeroy**  
1982

U.S. Geological Survey  
OPEN FILE MAP 82-181 (E-1)

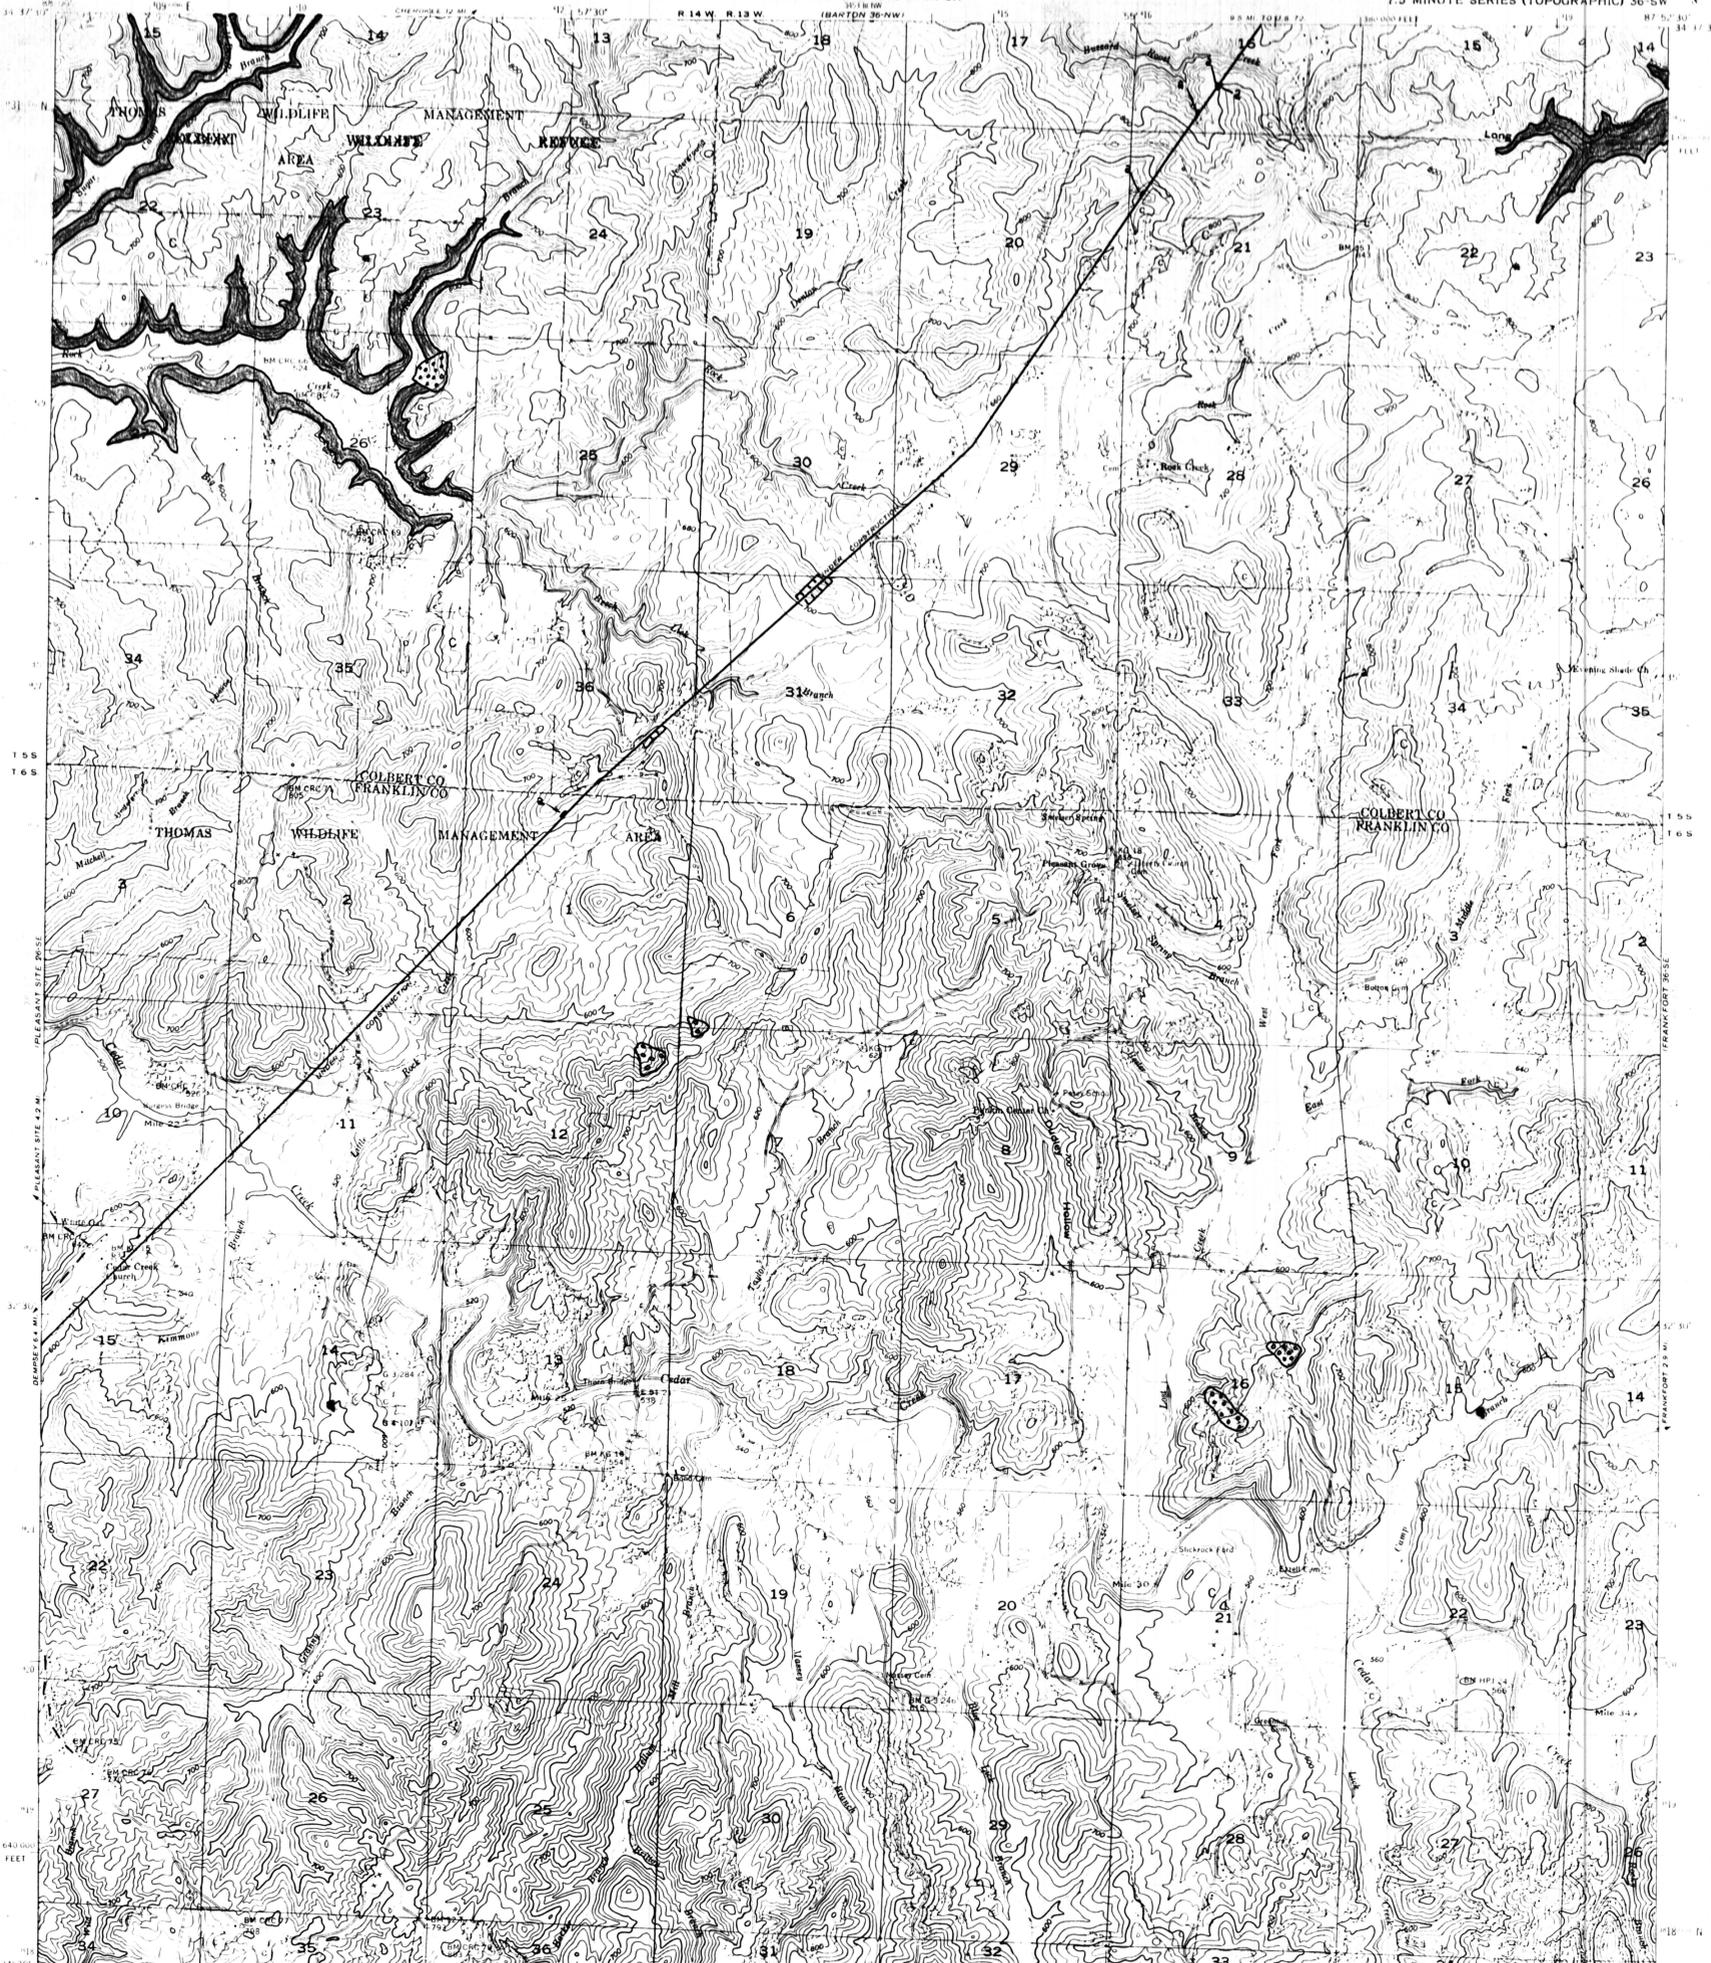
- ACTIVE OR RECENTLY ACTIVE LANDSLIDE**  
Complex landslide composed of earthflow, debris  
slide, earth and rock slump. Identified from  
historical records, and from scars, debris and  
other field evidence. Ground extremely unstable;  
sliding accelerated by excavation, loading and  
changes in drainage conditions. May include  
areas with several active slides too small to  
be shown separately. Questioned where doubtful.  
May be shown with symbol (a) where difficult to discern.

- OLD LANDSLIDE**  
Area of extensive hummocky ground caused by  
earthflow and earth and rock slump. Lacks  
clear evidence of active sliding. Relatively  
stable in natural, undisturbed state,  
generally not affected by small structures properly  
sited in areas away from the edge of the toe;  
can be reactivated by extensive, rapid excava-  
tion, loading, and changes in ground water and  
surface water conditions. Area of old landslide  
probably includes recent ones not identified  
from field evidence or otherwise documented.  
Upslope boundary of landslide generally defined  
by modified scarp, but downslope (toe) may be  
gradational and not well defined. Questioned  
where doubtful.

- AREAS SUSCEPTIBLE TO DEBRIS FLOWS AND DEBRIS  
AVALANCHES**  
Primarily shallow, narrow ravines and chutes with  
accumulation of stony colluvium generally 10 ft.  
(3 m) or less in thickness; susceptible to rapid  
movement during intense rainfall. Most ravines  
and chutes designated show evidence of former  
debris flows and avalanches. Symbol (a) designa-  
tes historical debris flow or debris avalanche.

- AREAS SUSCEPTIBLE TO ROCKFALL**  
Steep, locally vertical, natural and man-made  
slopes and cliffs, 15 ft. (4.5 m) or more high;  
formed dominantly of sandstone, limestone, sandy  
shale, mudstone and claystone. Interbedded mud-  
stone, claystone and shale weather rapidly leaving  
sandstone and limestone rock faces unsupported.

- SOIL AND ROCK SUSCEPTIBLE TO LANDSLIDING**  
Soil and rock similar to that involved in land-  
slides elsewhere in map area; primarily areas  
underlain by claystone, mudstone and shale  
associated with other rock types. Rock weathers  
rapidly on exposure forming clayey soil highly  
susceptible to sliding. Includes coves (U-shaped,  
shallow valleys) containing thick layers of clayey  
soil that are very susceptible to sliding where  
excavation breaks continuity of slope and where  
overloaded by artificial fill.

- AREAS LEAST PRONE TO LANDSLIDES**  
Map areas in which no patterns or symbols are shown;  
primarily valley floors, ridge tops and broad  
benches; modification by excavation and fill may  
lead to local landslides. Includes slopes where  
landslides are sparse.

- MAN-MADE FEATURES**  
Strip mines (combination of letter symbols  
indicates complex formed of more than one  
type of strip mine)
- sh bench with high wall
  - sf furrowed with high wall
  - sd multiple furrows and multiple benches
  - ss hilltop removed
  - srq reclaimed by grading
  - sru reclaimed by secondary use
  - sh/r regraded in part, high wall  
remains
- Coal refuse banks**  
r identified on aerial photographs;  
not classified in field check
- rb not burnt nor on fire
  - rbb burnt
  - rbd burning
  - rbs sludge
- Quarries**  
q quarry site  
qub spoil bank, quarry waste
- Gravel pits**  
g site of gravel pit
- Slides in man-made features**  
af earth flow in fill  
a/s earth flow in strip castings  
a/r earth flow in coal refuse
