LANDSLIDES AND RELATED FEATURES

OF THE MASTERSON, ALA. QUADRANGLE

U.S. Geological Survey

OPEN FILE MAP 82-181 (E-G)

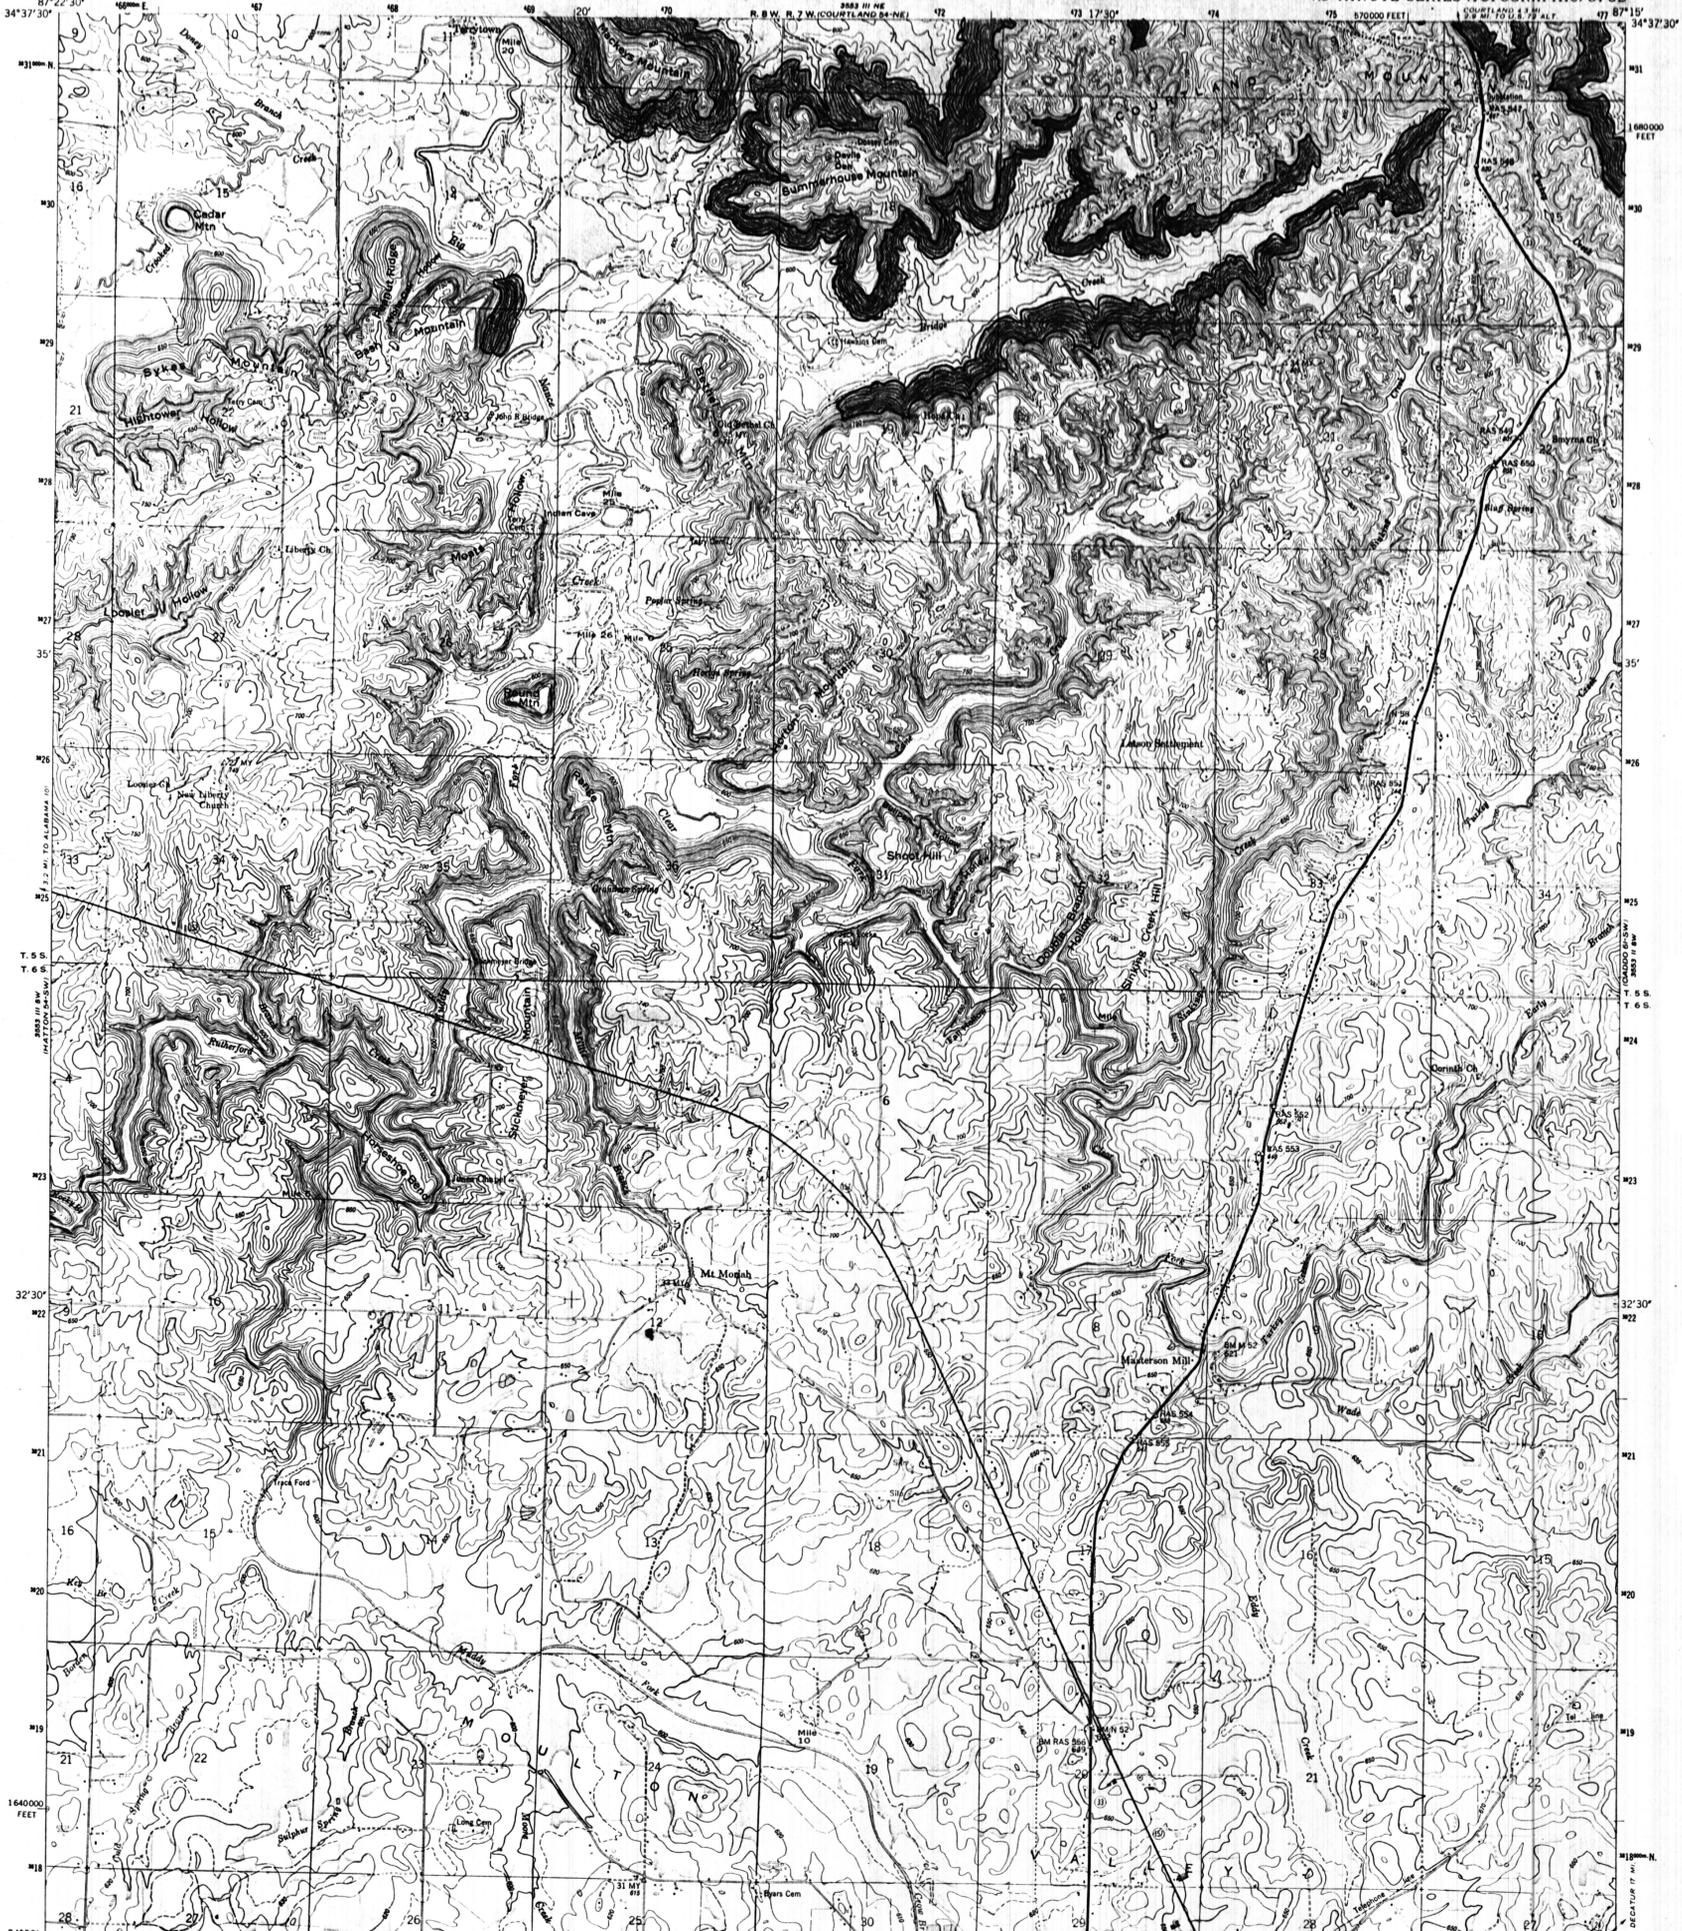
MASTERSON, ALA.
N3430 W8715/7.5
1948
PHOTO REVISÉ 1972

Landslides and related features interpreted
from aerial photographs:
1:20,000 (black and white) 1971, 1972
1:40,000 (black and white) 1978

Photointerpretation and field check 1980-1981
This map is preliminary and has not been reviewed
for conformity with U.S. Geological Survey editorial
standards

ACTIVE OR RECENTLY ACTIVE LANDSLIDE
Complex landslide composed of earthflow, debris
slide, earth and rock slump. Identified from
historical records, and from scars, debris and
other field evidence. Ground extremely unstable;
sliding accelerated by excavation, loading and
changes in drainage conditions. May include
areas with several active slides too small to
be shown separately. Questioned where doubtful.
May be shown with symbol (a) where difficult to discern.

OLD LANDSLIDE
Area of extensive hummocky ground caused by
earthflow and earth and rock slump. Lacks
clear evidence of active sliding. Relatively
stable in natural, undisturbed state,
generally not affected by small structures properly
sited in areas away from the edge of the toe;
can be reactivated by extensive, rapid excava-
tion, loading, and changes in ground water and
surface water conditions. Area of old landslide
probably includes recent ones not identified
from field evidence or otherwise documented.
Upslope boundary of landslide generally defined
by modified scarp, but downslope (toe) may be
gradational and not well defined. Questioned
where doubtful.

**AREAS SUSCEPTIBLE TO DEBRIS FLOWS AND DEBRIS
AVALANCHES**
Primarily shallow, narrow ravines and chutes with
accumulation of stony colluvium generally 10 ft.
(3 m) or less in thickness; susceptible to rapid
movement during intense rainfall. Most ravines
and chutes designated show evidence of former
debris flows and avalanches. Symbol (a) desig-
nates historical debris flow or debris avalanche.

AREAS SUSCEPTIBLE TO ROCKFALL
Steep, locally vertical, natural and man-made
slopes and cliffs, 15 ft. (4.5 m) or more high;
formed dominantly of sandstone, limestone, sandy
shale, mudstone and claystone. Interbedded mud-
stone, claystone and shale weather rapidly leaving
sandstone and limestone rock faces unsupported.

SOIL AND ROCK SUSCEPTIBLE TO LANDSLIDING
Soil and rock similar to that involved in land-
slides elsewhere in map area; primarily areas
underlain by claystone, mudstone and shale
associated with other rock types. Rock weathers
rapidly on exposure forming clayey soil highly
susceptible to sliding. Includes cohes (U-shaped,
shallow valleys) containing thick layers of clayey
soil that are very susceptible to sliding where
excavation breaks continuity of slope and where
overloaded by artificial fill.

AREAS LEAST PRONE TO LANDSLIDES
Map areas in which no patterns or symbols are shown;
primarily valley floors, ridge tops and broad
benches; modification by excavation and fill may
lead to local landslides. Includes slopes where
landslides are sparse.
