LANDSLIDES AND RELATED FEATURES

OF THE COLUMBUS CITY, ALA. QUADRANGLE

by
 John S. Pomeroy
 1982

U.S. Geological Survey
 OPEN FILE MAP 82-181 (P-15)

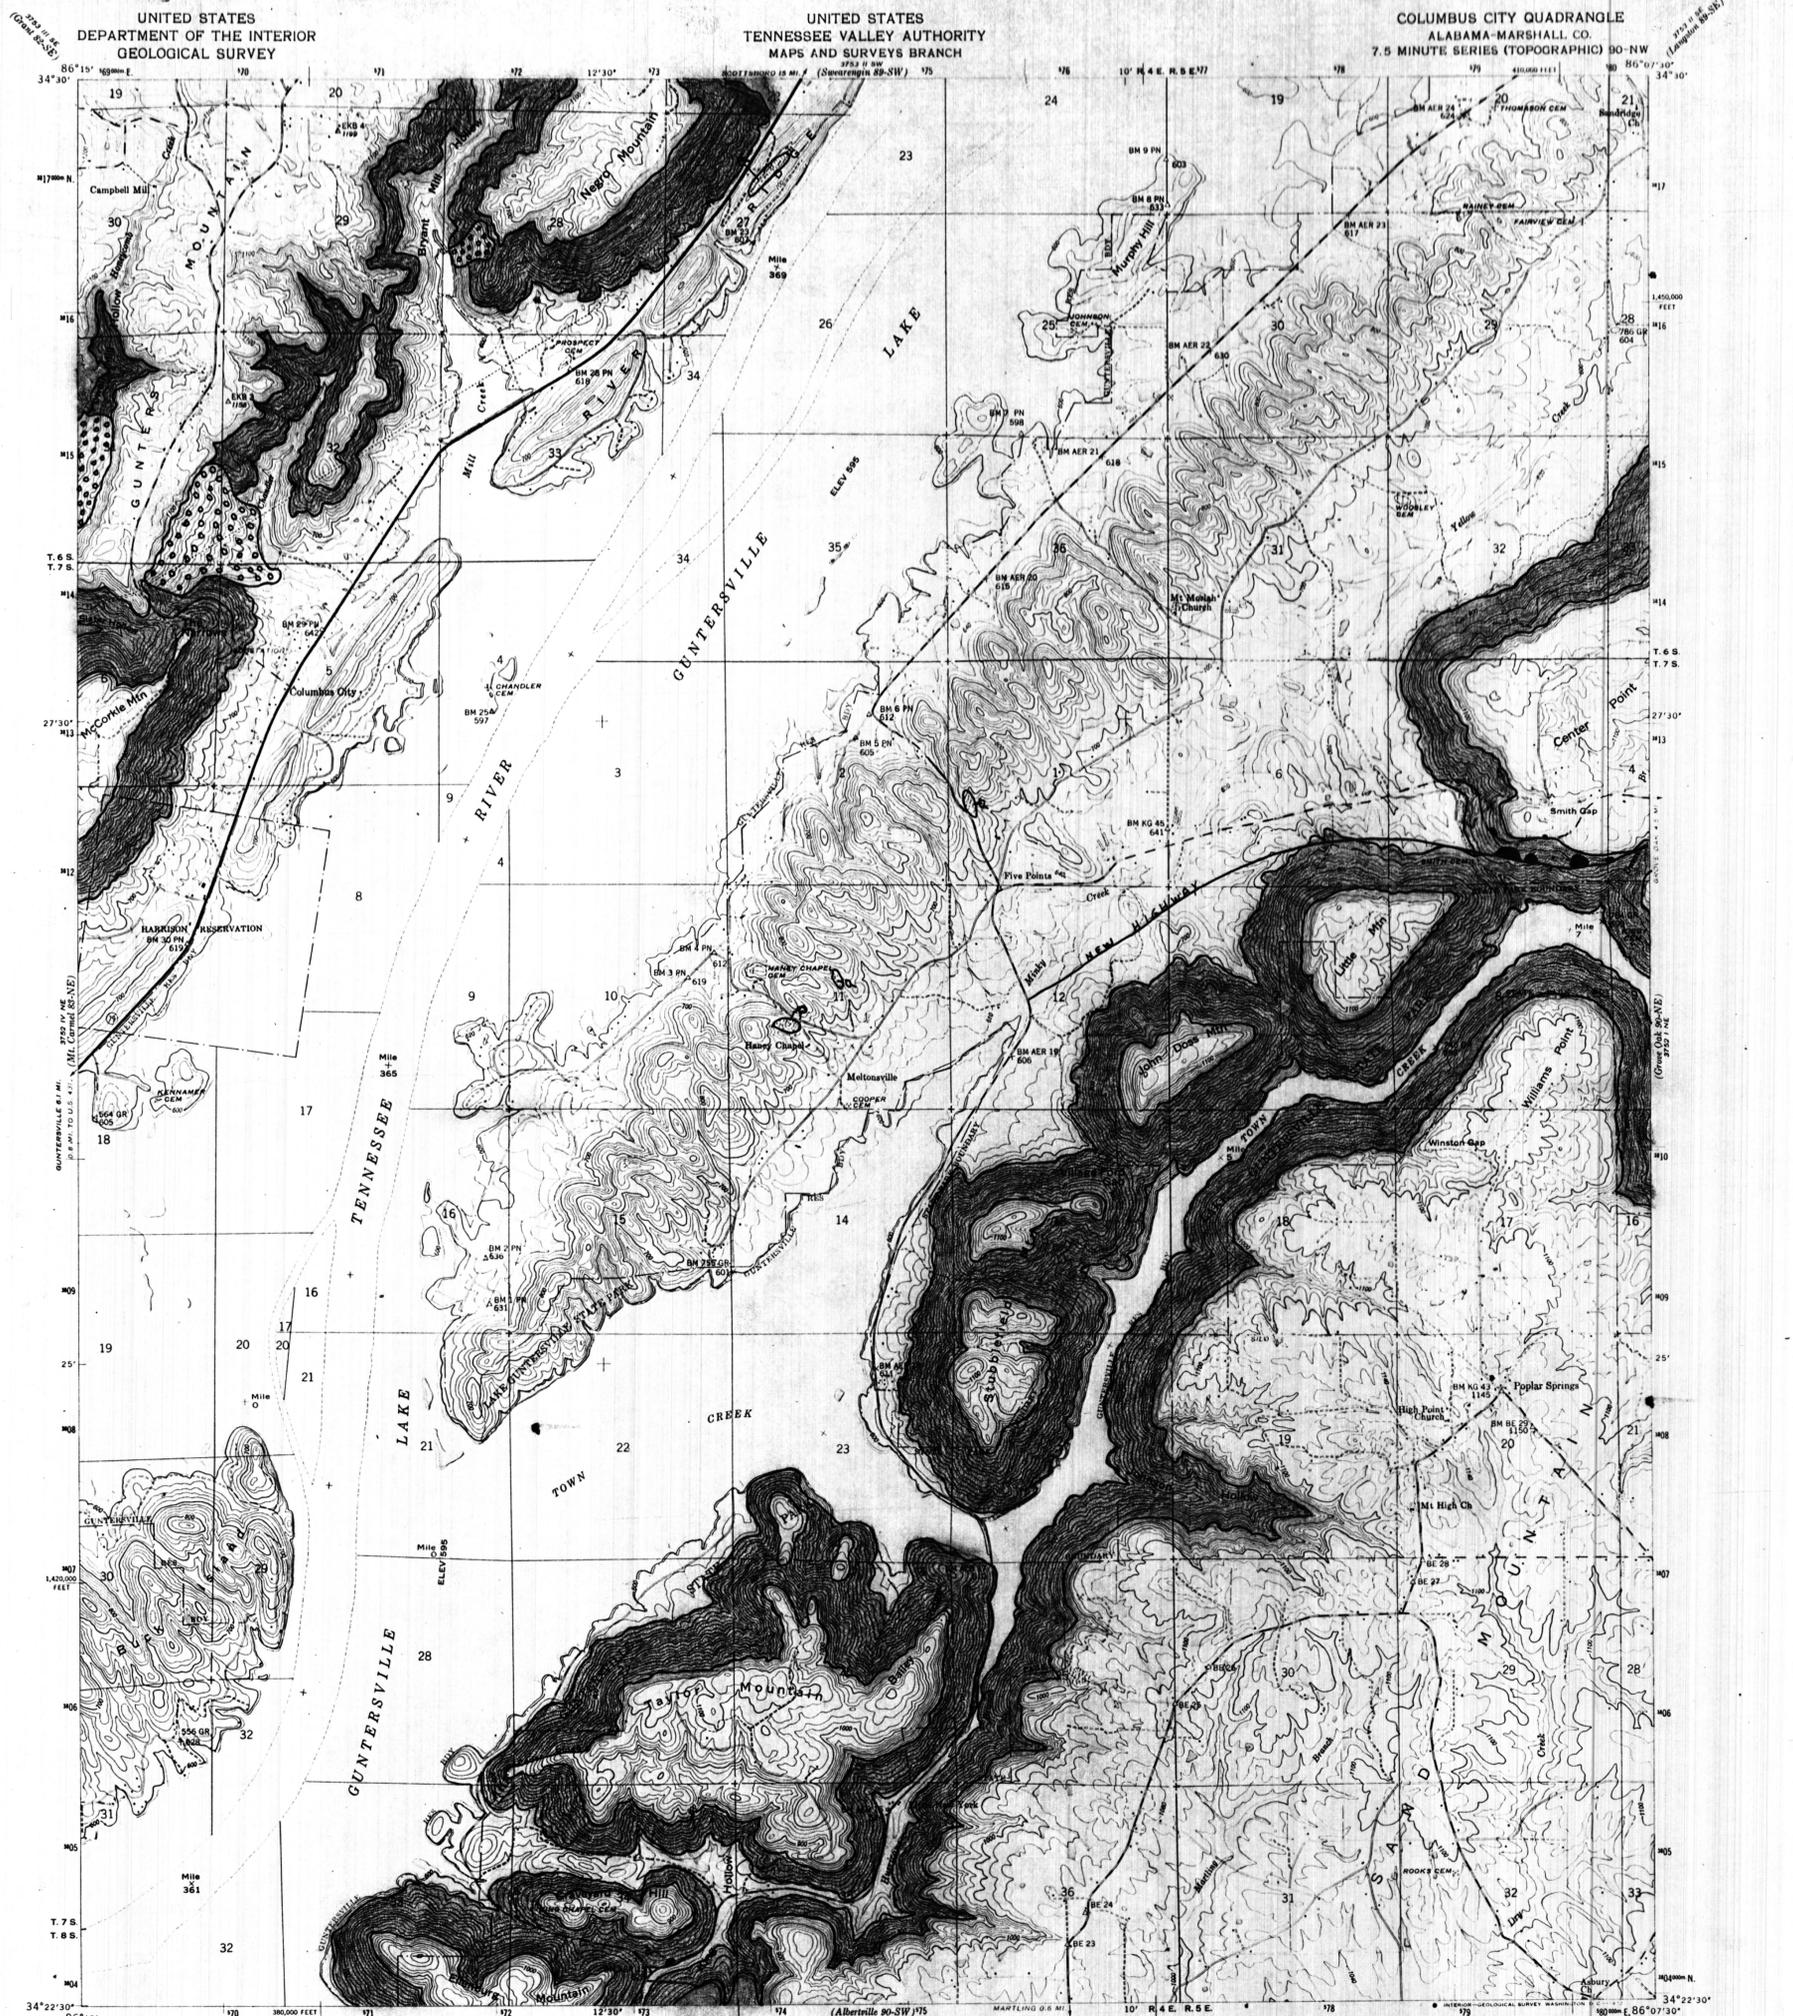
- ACTIVE OR RECENTLY ACTIVE LANDSLIDE**
 Complex landslide composed of earthflow, debris slide, earth and rock slump. Identified from historical records, and from scars, debris and other field evidence. Ground extremely unstable; sliding accelerated by excavation, loading and changes in drainage conditions. May include areas with several active slides too small to be shown separately. Questioned where doubtful. May be shown with symbol (a) where difficult to discern.

- OLD LANDSLIDE**
 Area of extensive hummocky ground caused by earthflow and earth and rock slump. Lacks clear evidence of active sliding. Relatively stable in natural, undisturbed state, generally not affected by small structures properly sited in areas away from the edge of the toe; can be reactivated by extensive, rapid excavation, loading, and changes in ground water and surface water conditions. Area of old landslide probably includes recent ones not identified from field evidence or otherwise documented. Upslope boundary of landslide generally defined by modified scarp, but downslope (toe) may be gradational and not well defined. Questioned where doubtful.

- AREAS SUSCEPTIBLE TO DEBRIS FLOWS AND DEBRIS AVALANCHES**
 Primarily shallow, narrow ravines and chutes with accumulation of stony colluvium generally 10 ft. (3 m) or less in thickness; susceptible to rapid movement during intense rainfall. Most ravines and chutes designated show evidence of former debris flows and avalanches. Symbol & designates historical debris flow or debris avalanche.

- AREAS SUSCEPTIBLE TO ROCKFALL**
 Steep, locally vertical, natural and man-made slopes and cliffs, 15 ft. (4.5 m) or more high; formed dominantly of sandstone, limestone, sandy shale, mudstone and claystone. Interbedded mudstone, claystone and shale weather rapidly leaving sandstone and limestone rock faces unsupported.

- SOIL AND ROCK SUSCEPTIBLE TO LANDSLIDING**
 Soil and rock similar to that involved in landslides elsewhere in map area; primarily areas underlain by claystone, mudstone and shale associated with other rock types. Rock weathers rapidly on exposure forming clayey soil highly susceptible to sliding. Includes coves (U-shaped, shallow valleys) containing thick layers of clayey soil that are very susceptible to sliding where excavation breaks continuity of slope and where overloaded by artificial fill.

- AREAS LEAST PRONE TO LANDSLIDES**
 Map areas in which no patterns or symbols are shown; primarily valley floors, ridge tops and broad benches; modification by excavation and fill may lead to local landslides. Includes slopes where landslides are sparse.

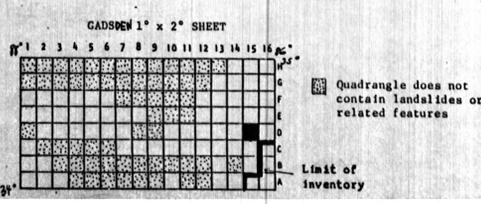
The first five digits of the open file number designate the specific 1:250,000 scale map sheet of which this quadrangle is a part. The last two digits designate the position of the quadrangle in a subdivision of the 1:250,000 scale map based on rows and tiers shown in the diagram to the right. The location of this quadrangle is shown by the black square.
