SULPHUR LICK, KY.  
SW/4 EDMONTON 15' QUADRANGLE  
N3645-W8537 5/7.5  
1953

## LANDSLIDES AND RELATED FEATURES

OF THE SULPHUR LICK, KY. QUADRANGLE  
by  
Alfred R. Taylor and Roger E. Thomas

U.S. Geological Survey  
OPEN FILE MAP 82-653(G-3)

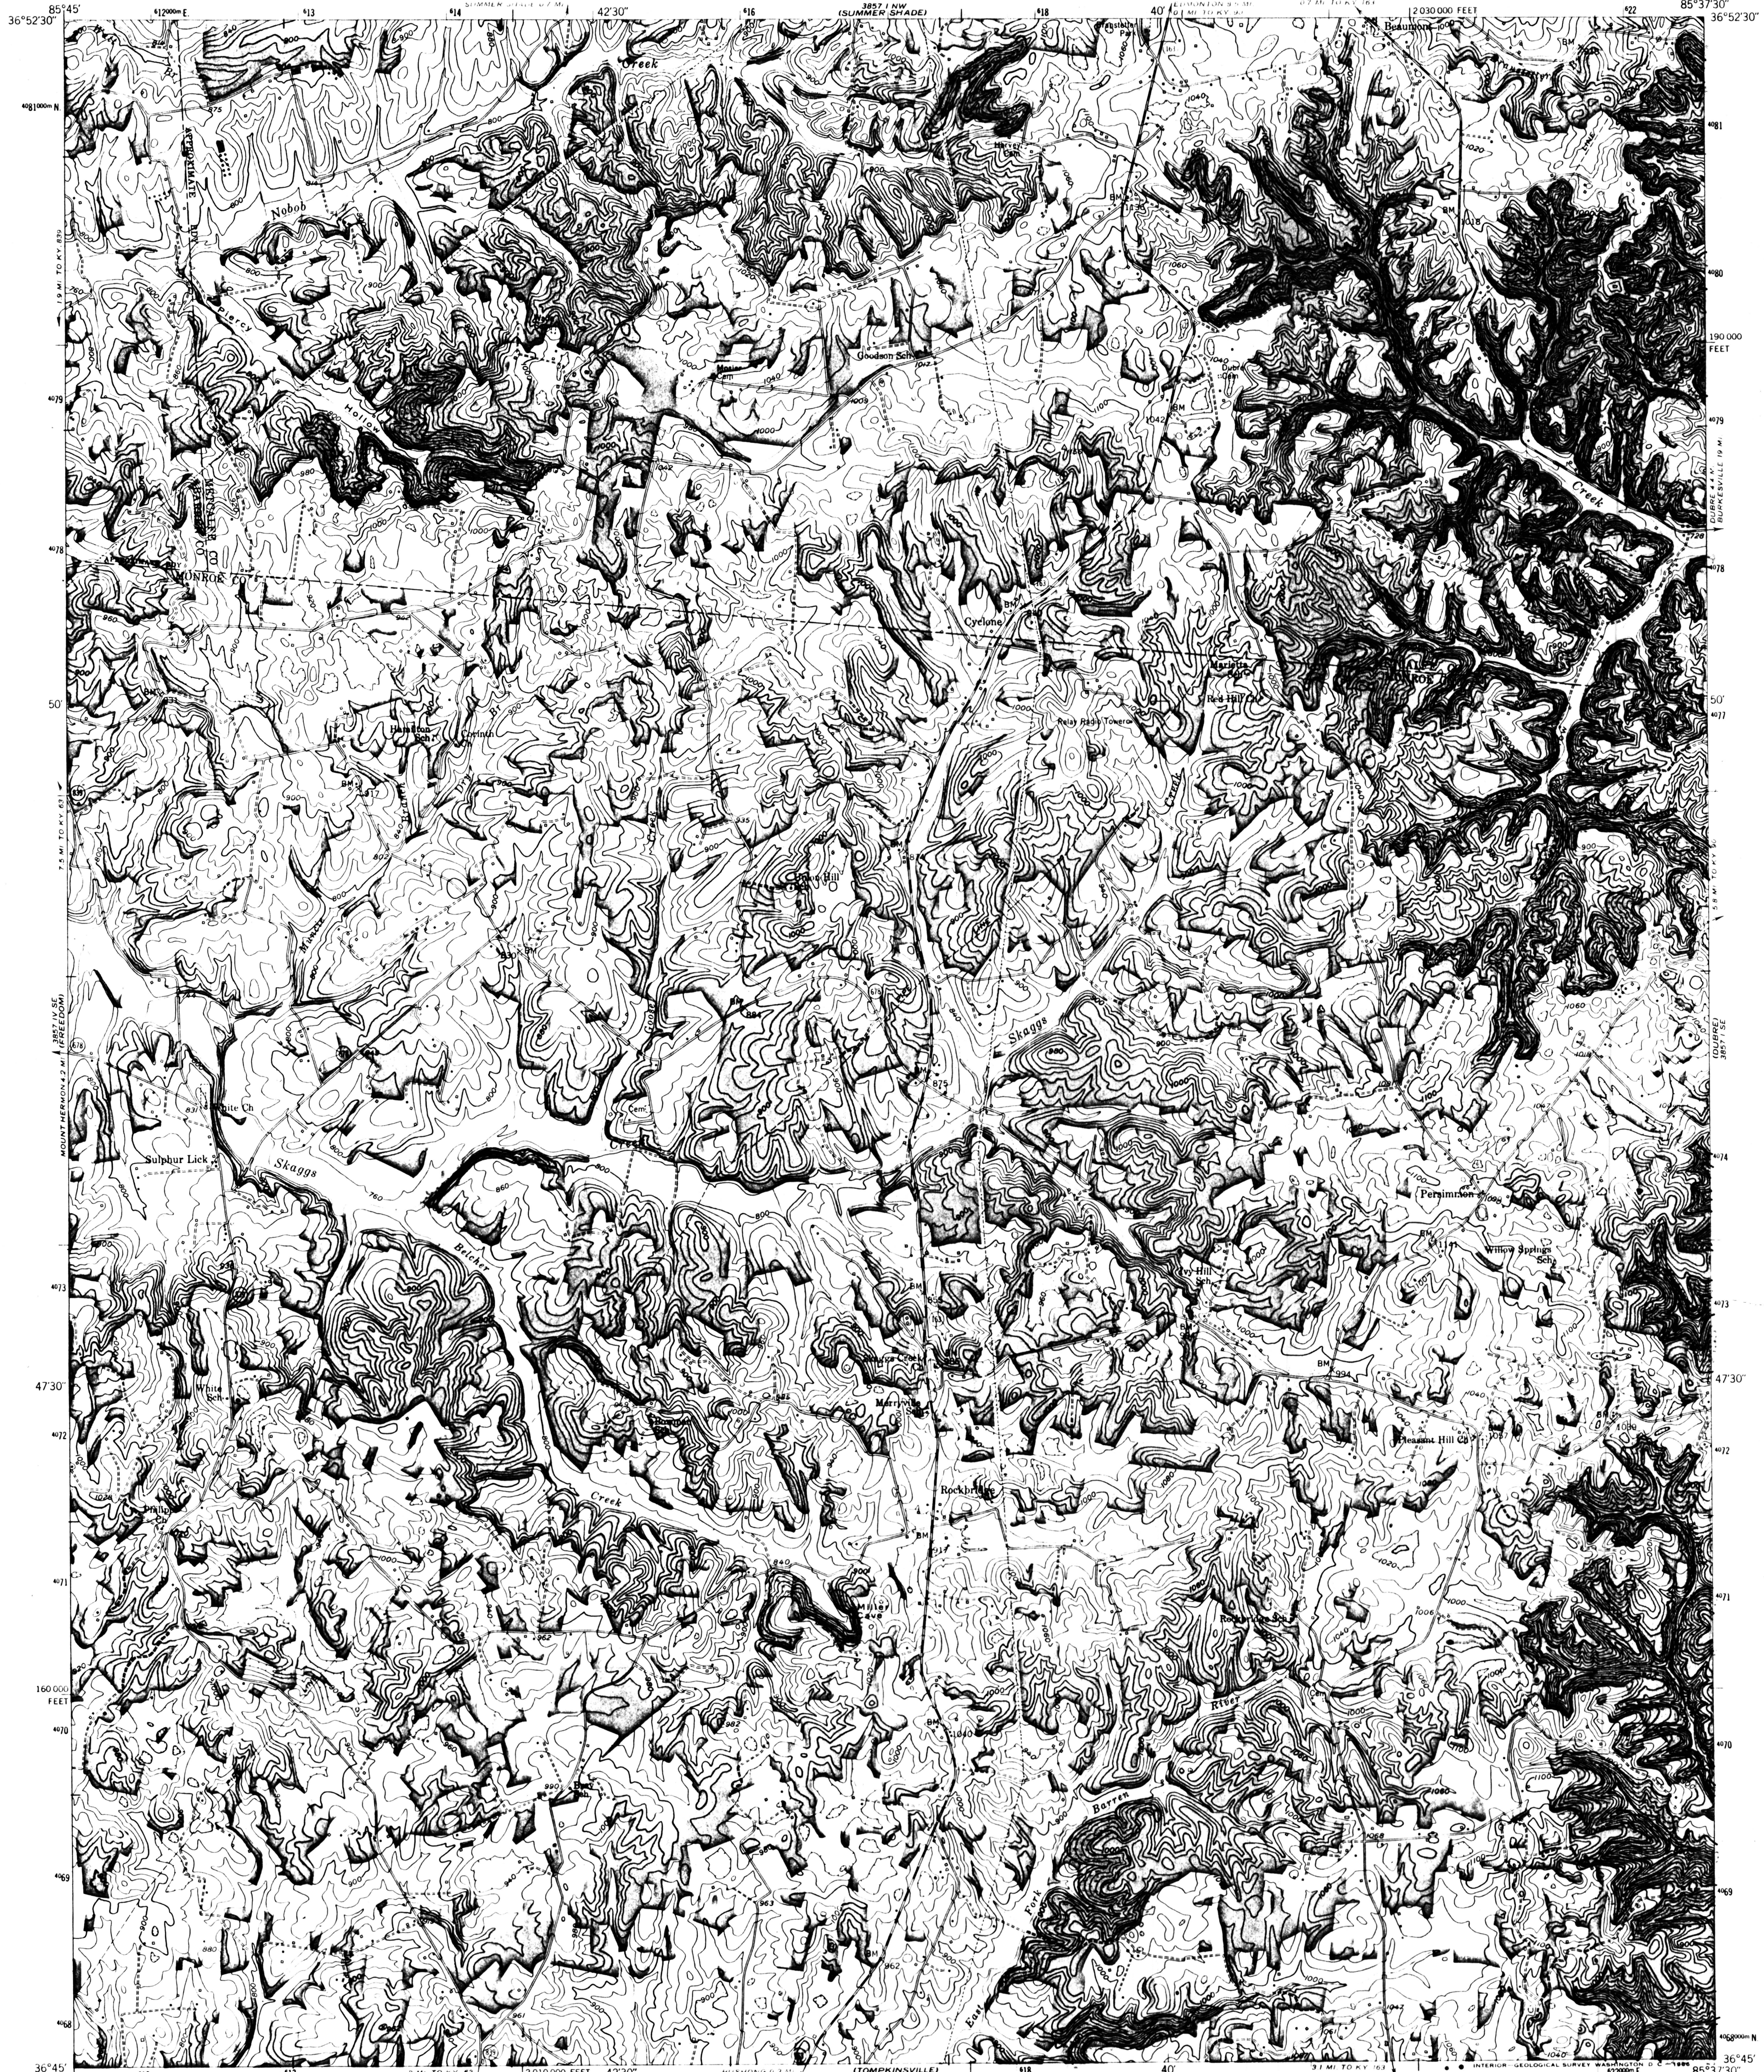
Landslides and related features interpreted  
from field check 1979-1980

Complex landslide composed of earthflow, debris  
slide, earth and rock slump. Identified from  
historical records, and from scars, debris and  
other field evidence. Ground extremely unstable;  
sliding accelerated by excavation, loading and  
changes in drainage conditions. May include  
areas with several active slides too small to  
be shown separately. Questioned where doubtful.

Area of extensive hummocky ground caused by  
earthflow and earth and rock slump. Lacks  
clear evidence of active sliding. Relatively  
stable in natural, undisturbed state,  
generally not affected by small structures properly  
sited in areas away from the edge of the toe;  
can be reactivated by extensive, rapid exca-  
vation, loading, and changes in ground water and  
surface water conditions. Area of old landslide  
probably includes recent ones not identified  
from field evidence or otherwise documented.  
Upslope boundary of landslide generally defined  
by modified scarp, but downslope (toe) may be  
gradational and not well defined. Questioned  
where doubtful.

Valley wall along major streams with slope as  
steep as 40° (85%); stony, clayey silt soil up  
to 50 ft. (15 m) thick; commonly buttressed by  
a terrace or bench at the toe of the slope; very  
susceptible to sliding by cutting of toe area,  
removal of terrace or bench, and overloading;  
slide commonly activated without apparent cause.

Primarily shallow, narrow ravines and chutes with  
accumulation of stony colluvium generally 10 ft.  
(3 m) or less in thickness; susceptible to rapid  
movement during intense rainfall. Most ravines  
and chutes designated show evidence of former  
debris flows and avalanches.

Steep, locally vertical, natural and man-made  
slopes and cliffs, 15 ft. (4.5 m) or more high;  
formed dominantly of sandstone, limestone, sandy  
shale, mudstone and claystone. Interbedded mud-  
stone, claystone and shale weather rapidly leaving  
sandstone and limestone rock faces unsupported.

Soil and rock similar to that involved in land-  
slides elsewhere in map area; primarily areas  
underlain by claystone, mudstone and shale  
associated with other rock types. Rock weathers  
rapidly on exposure forming clayey soil highly  
susceptible to sliding. Includes coves (U-shaped,  
shallow valleys) containing thick layers of clayey  
soil that are very susceptible to sliding where  
excavation breaks continuity of slope and where  
overloaded by artificial fill.

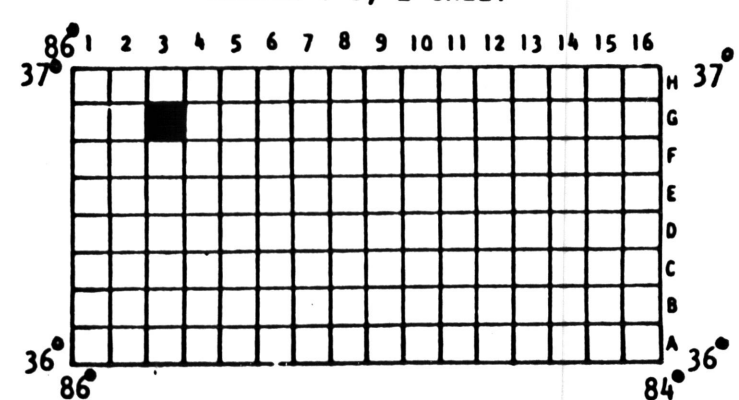
### CORBIN 1 by 2 SHEET

The first five digits of the open file number designate the  
specific 1:250,000 scale map sheet of which this quadrangle  
is a part. The last two digits designate the position of the  
quadrangle in a subdivision of the 1:250,000 scale map based  
on rows and tiers shown in the diagram to the right. The  
location of this quadrangle is shown by the black square.
