ONEIDA NORTH, TENN.-KY.
S84 BARTHELL 15' QUADRANGLE
N 3630 - W 8430/7.5
1955
PHOTO REVISED 1979

LANDSLIDES AND RELATED FEATURES

OF THE ONEIDA NORTH, TENN.-KY. QUADRANGLE

U.S. Geological Survey
OPEN FILE MAP 82-653 (E-12)

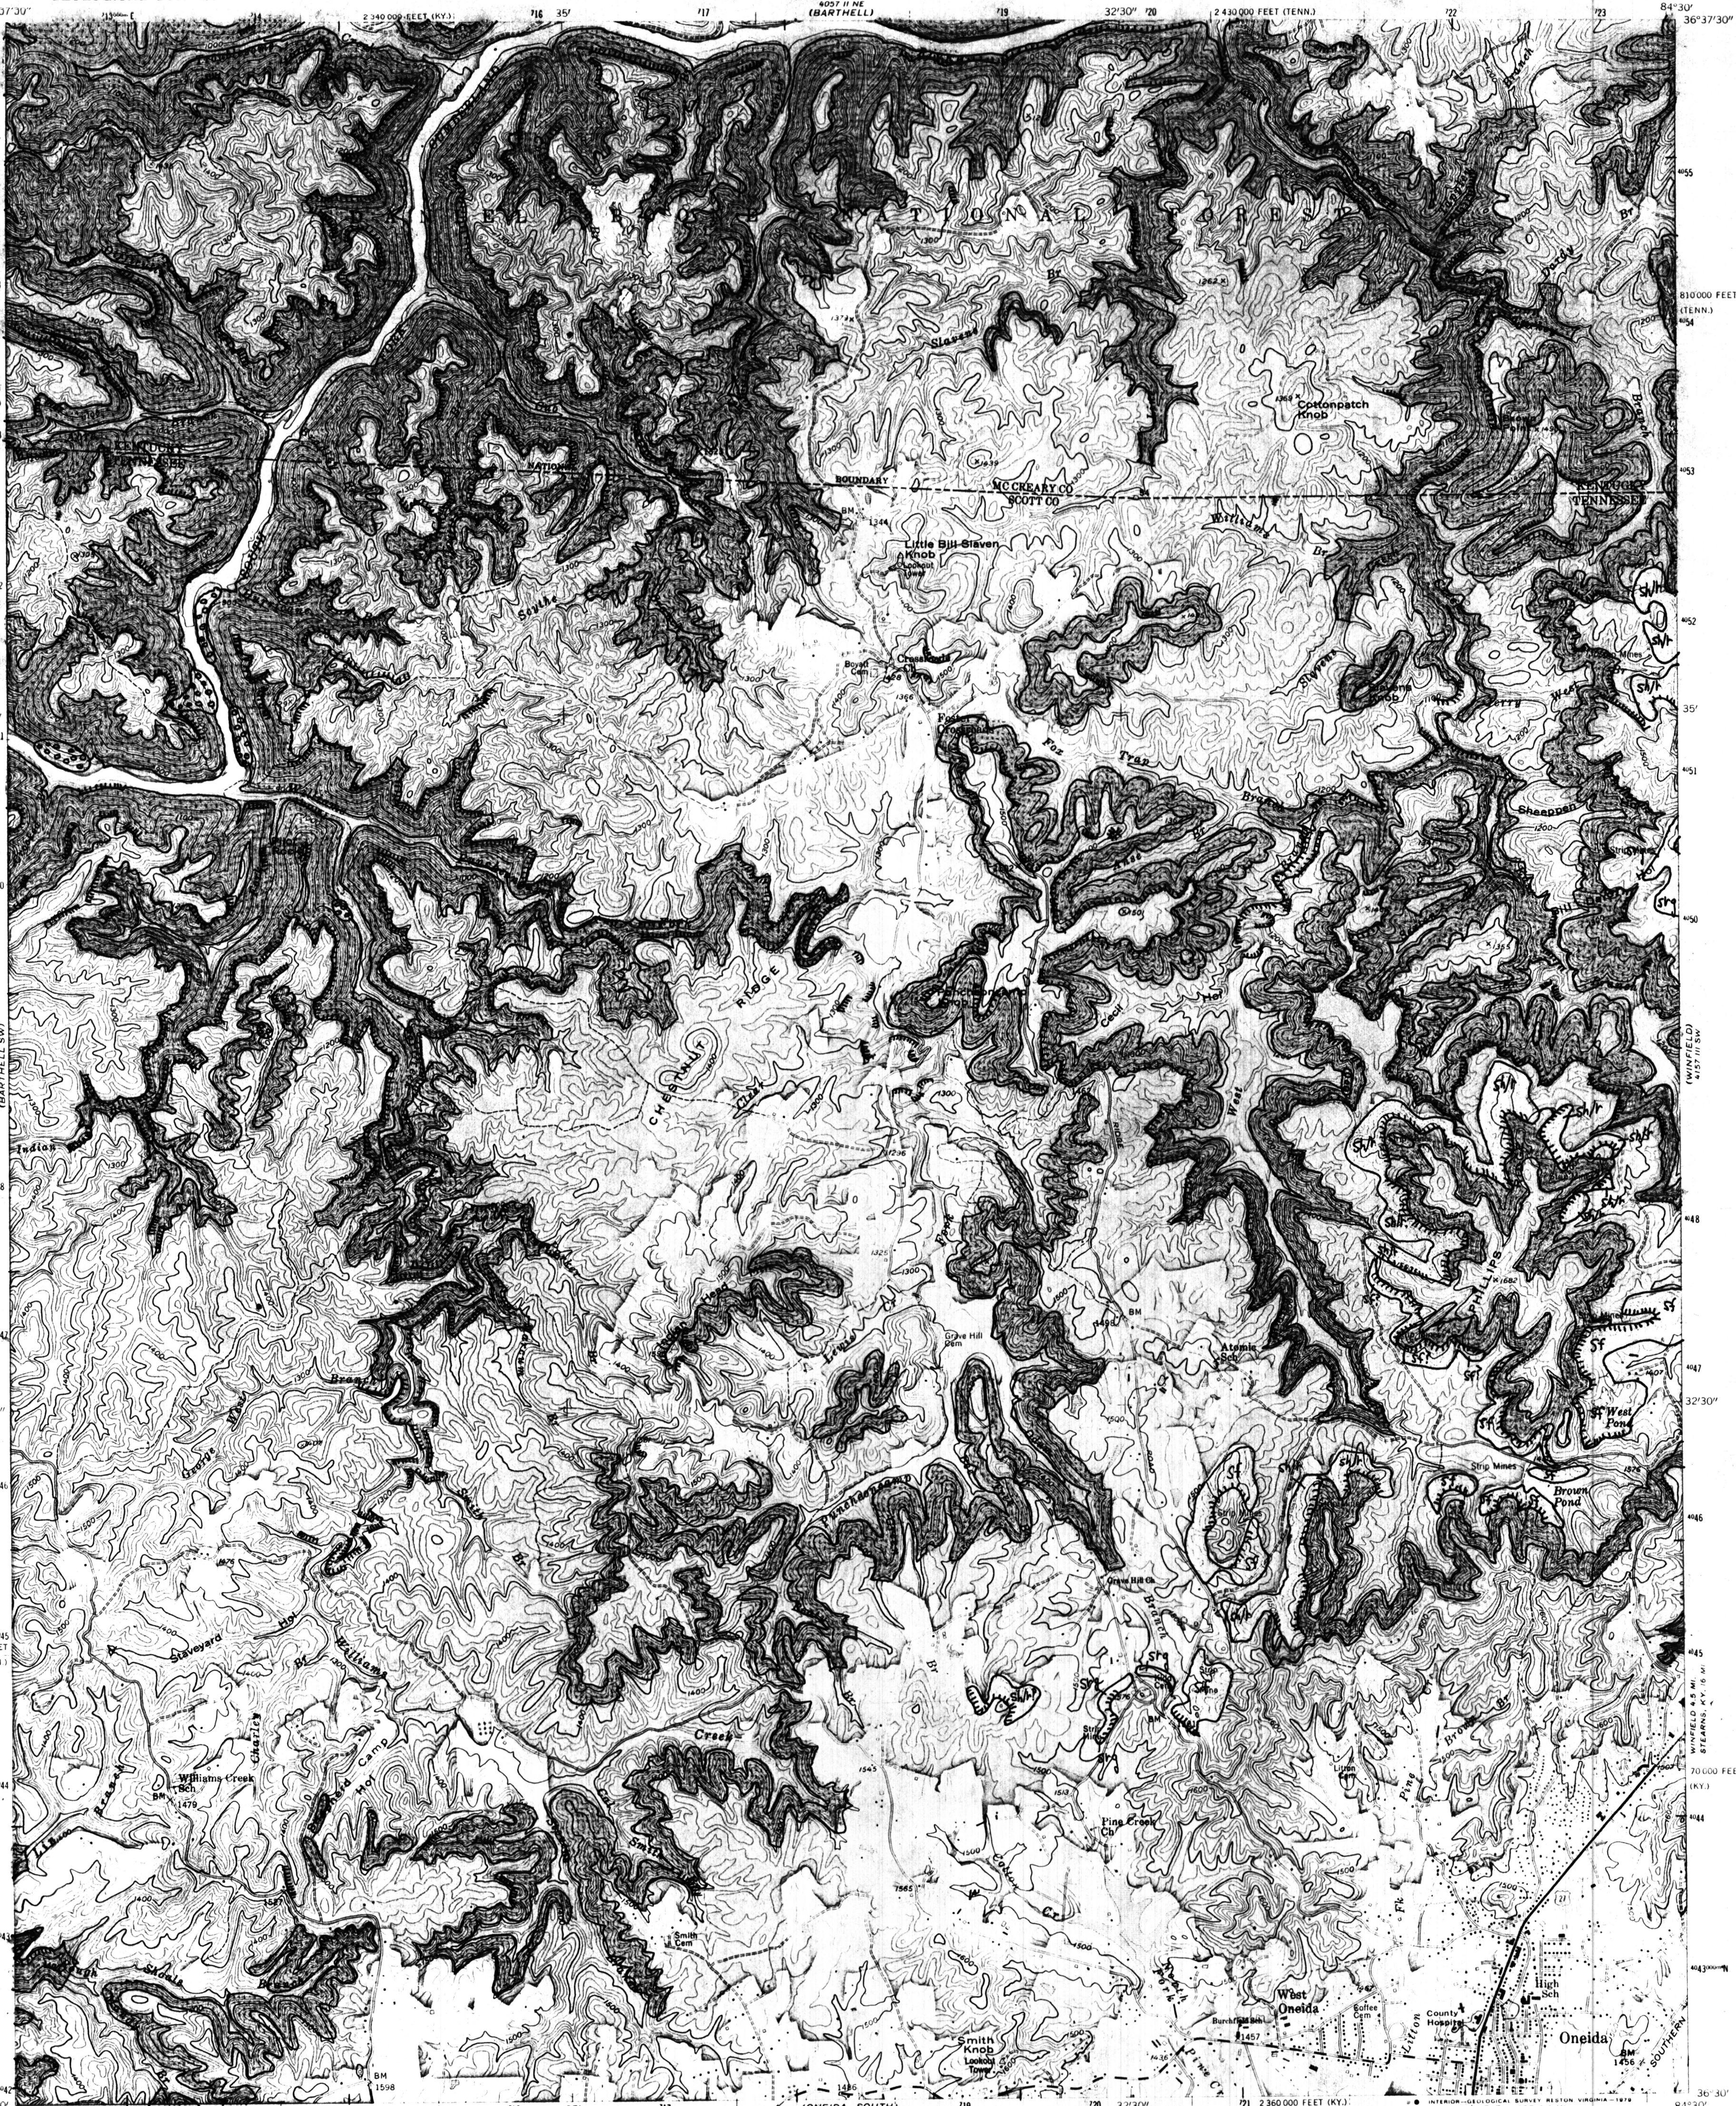
Landslides and related features interpreted from aerial photographs:

ACTIVE OR RECENTLY ACTIVE LANDSLIDE
Complex landslide composed of earthflow, debris slide, earth and rock slump. Identified from historical records, and from scars, debris and other field evidence. Ground extremely unstable; sliding accelerated by excavation, loading and changes in drainage conditions. May include areas with several active slides too small to be shown separately. Questioned where doubtful.

OLD LANDSLIDE
Area of extensive hummocky ground caused by earthflow and earth and rock slump. Lacks clear evidence of active sliding. Relatively stable in natural, undisturbed state, generally not affected by small structures properly sited in areas away from the edge of the toe; can be reactivated by extensive, rapid excavation, loading, and changes in ground water and surface water conditions. Area of old landslide probably includes recent ones not identified from field evidence or otherwise documented. Upslope boundary of landslide generally defined by modified scarp, but downslope (toe) may be gradational and not well defined. Questioned where doubtful.

COMBINATION LANDSLIDE
Area of recent and old slides in which individual slides are not identified.

COLLUVIAL SLOPE
Valley wall along major streams with slope as steep as 40° (85%); stony, clayey silt soil up to 50 ft. (15 m) thick; commonly buttressed by a terrace or bench at the toe of the slope; very susceptible to sliding by cutting of toe area, removal of terrace or bench, and overloading; slide commonly activated without apparent cause.

COLLUVIAL SLOPES WITH LANDSLIDES
Landslides too small or obscure to map individually.

AREAS SUSCEPTIBLE TO DEBRIS FLOWS AND DEBRIS AVALANCHES
Primarily shallow, narrow ravines and chutes with accumulation of stony colluvium generally 10 ft. (3 m) or less in thickness; susceptible to rapid movement during intense rainfall. Most ravines and chutes designated show evidence of former debris flows and avalanches.

AREAS SUSCEPTIBLE TO ROCKFALL
Steep, locally vertical, natural and man-made slopes and cliffs, 15 ft. (4.5 m) or more high; formed dominantly of sandstone, limestone, sandy shale, mudstone and claystone. Interbedded mudstone, claystone and shale weather rapidly leaving sandstone and limestone rock faces unsupported.

SOIL AND ROCK SUSCEPTIBLE TO LANDSLIDING
Soil and rock similar to that involved in landslides elsewhere in map area; primarily areas underlain by claystone, mudstone and shale associated with other rock types. Rock weathers rapidly on exposure forming clayey soil highly susceptible to sliding. Includes coves (U-shaped, shallow valleys) containing thick layers of clayey soil that are very susceptible to sliding where excavation breaks continuity of slope and where overloaded by artificial fill.

AREAS LEAST PRONE TO LANDSLIDES
Map areas in which no patterns or symbols are shown; primarily valley floors, ridge tops and broad benches; modification by excavation and fill may lead to local landslides.
